## **ASBESTOS MANAGEMENT SURVEY REPORT**

GLASGOW SCHOOL OF ART

**Mackintosh Building, Glasgow**

**ASL1821-Mac**

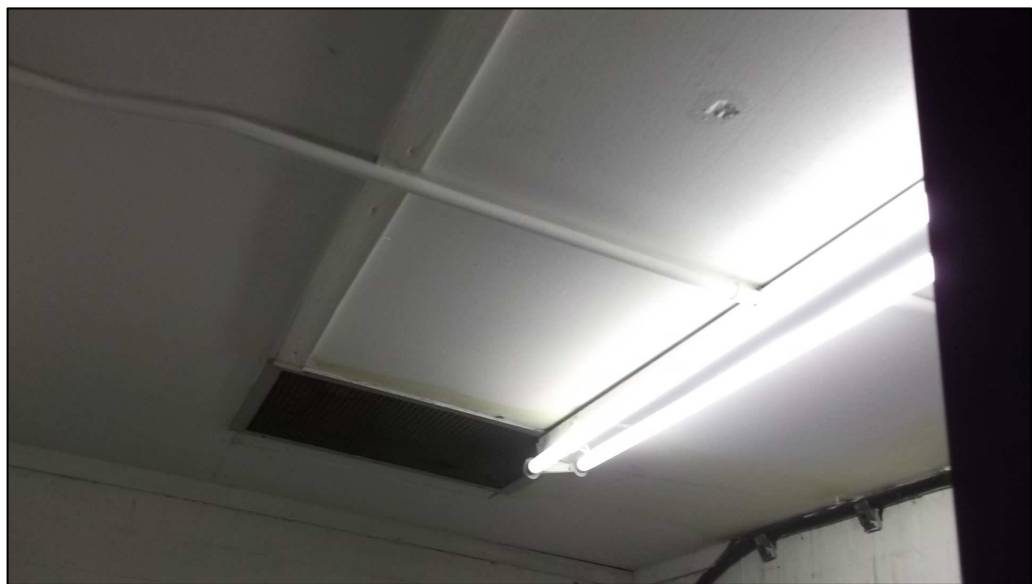
<b>Client:</b>	Glasgow School of Art	<b>Area No:</b>	1.05
<b>Site Address:</b>	Mackintosh Building, Glasgow	<b>Floor:</b>	Sub - Basement
<b>Building:</b>	Mackintosh Building	<b>Area Description:</b>	Lift motor room (ceiling )
<b>Building Address:</b>	As Above	<b>Material Description:</b>	Supalux panels
		<b>Survey Report Reference:</b>	ASL1821-Mac-Mac

**Material Risk:** 0  
Asbestos Type: 0 - No asbestos detected

Recommendation: No further action required

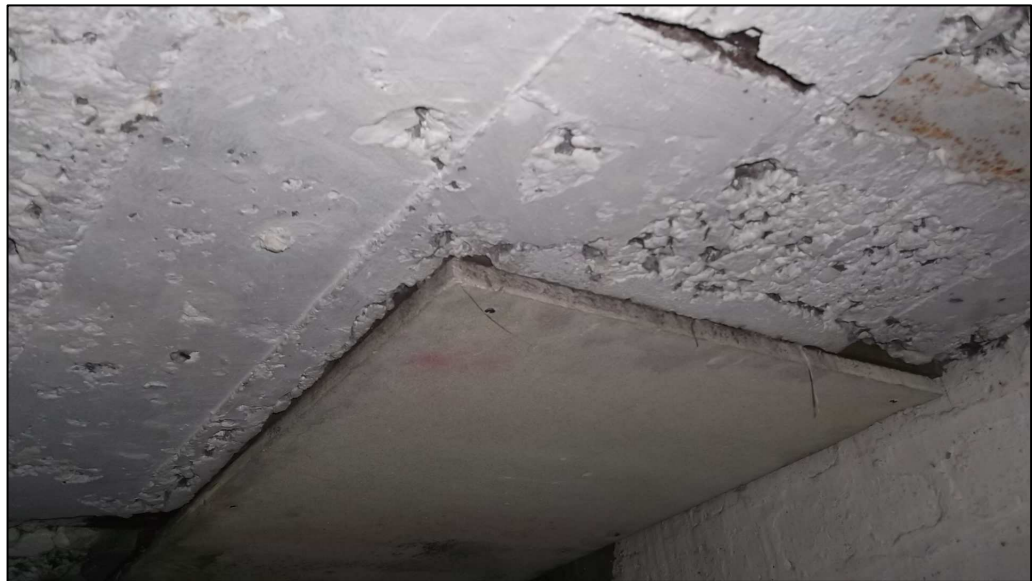
<b>Client:</b>	Glasgow School of Art	<b>Area No:</b>	1.05a
		<b>Floor:</b>	Sub - Basement
<b>Site Address:</b>	Mackintosh Building, Glasgow	<b>Area Description:</b>	Lift motor room roof space (fitting)
<b>Building:</b>	Mackintosh Building	<b>Material Description:</b>	Supalux panelling to ceiling
<b>Building Address:</b>	As Above	<b>Survey Report Reference:</b>	ASL1821-Mac-Mac

**Material Risk:** 0  
Asbestos Type: 0 - No asbestos detected

Recommendation: No further action required

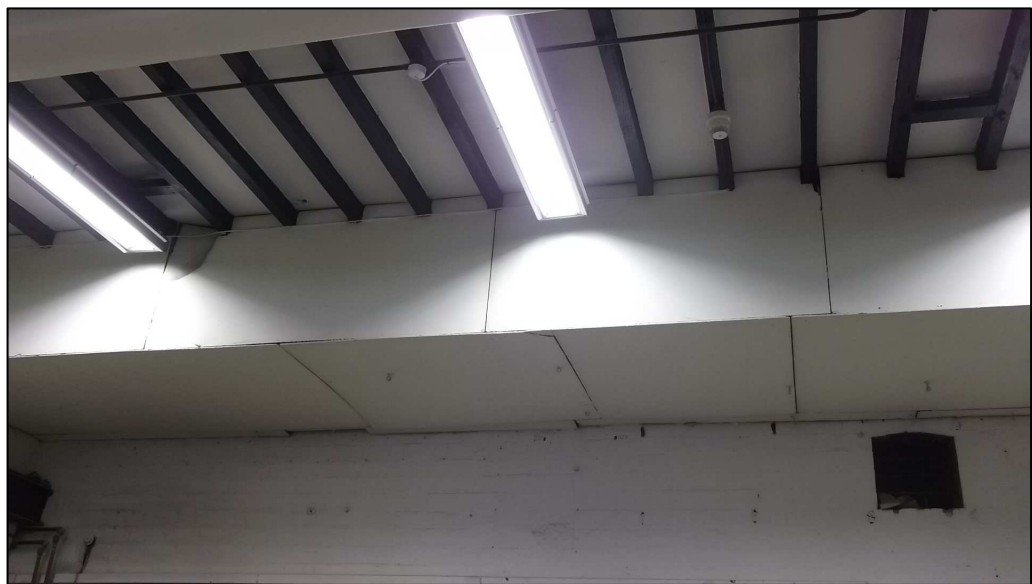
1.07	Sub - Basement Floor - Workshop (high level boxing )	Cement panels	20 m <sup>2</sup>	010	1	1	1	1	4	0	1	2	0	3	7	Encapsulate/Repair - 12m
1.09	Sub - Basement Floor - Store (ceiling /walls /floor)	Concrete /brick /concrete		No sample required

<b>Client:</b>	Glasgow School of Art	<b>Area No:</b>	1.07
		<b>Floor:</b>	Sub - Basement
<b>Site Address:</b>	Mackintosh Building, Glasgow	<b>Area Description:</b>	Workshop (high level boxing )
<b>Building:</b>	Mackintosh Building	<b>Material Description:</b>	Cement panels
<b>Building Address:</b>	As Above	<b>Survey Report Reference:</b>	ASL1821-Mac-Mac

<b>Material Risk:</b>	<b>4</b>
Asbestos Type:	1 - Chrysotile
Product Type:	1 - Asbestos composites, decorative finishes, AC
Extent of Damage:	1 - Low damage
Surface Treatment:	1 - Enclosed sprays and lagging, AIB, AC sheets etc
<b>Priority Risk:</b>	<b>3</b>
Normal Occupant Activity:	0 - Rare Disturbance
Likelihood of Disturbance:	1 - Low Likelihood of Disturbance
Human Exposure Potential:	2 - Medium Human Exposure Potential
Maintenance Activity :	0 - Minor Risk Maintenance Activity

Timescale for Recommendation :	Within 12 months
Recommendation:	Encapsulate/Repair
Comments:	
<b>Total Risk Score:</b>	<b>7</b>

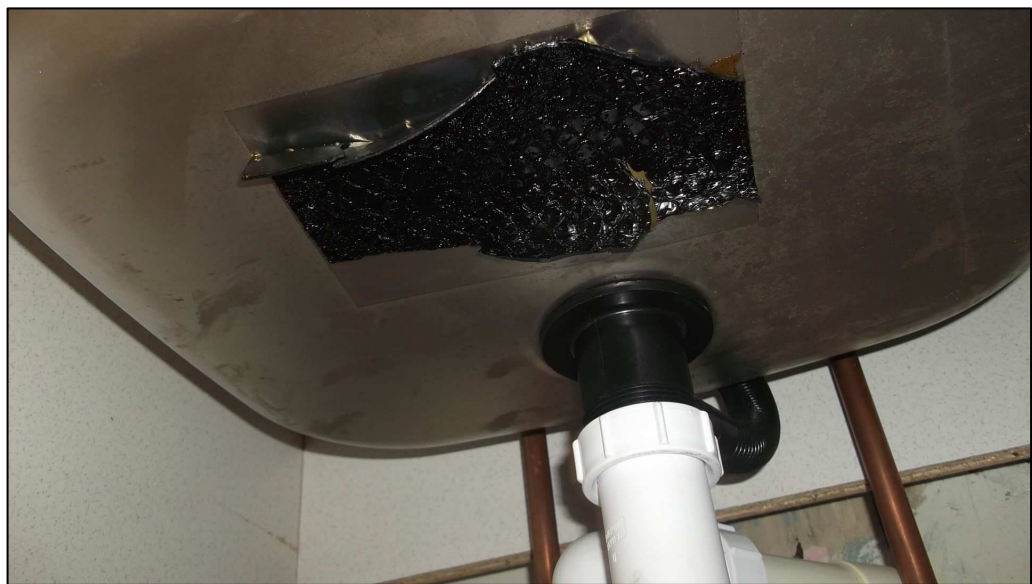
<b>Client:</b>	Glasgow School of Art	<b>Area No:</b>	2.29
		<b>Floor:</b>	Basement
<b>Site Address:</b>	Mackintosh Building, Glasgow	<b>Area Description:</b>	Kitchen (fitting )
<b>Building:</b>	Mackintosh Building	<b>Material Description:</b>	Sink pad
<b>Building Address:</b>	As Above	<b>Survey Report Reference:</b>	ASL1821-Mac-Mac

**Material Risk:** 0

Recommendation: No further action required

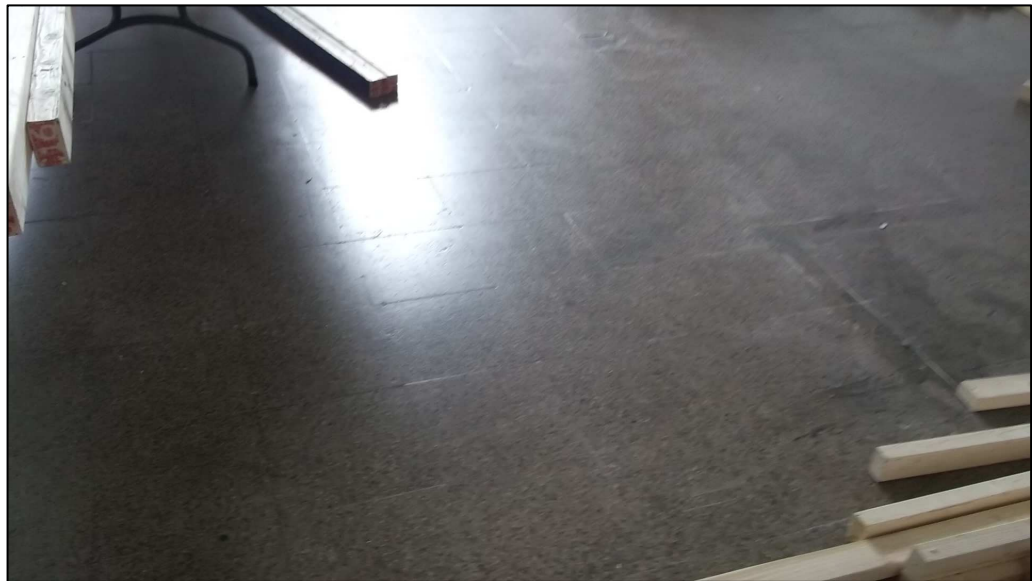
<b>Client:</b>	Glasgow School of Art	<b>Area No:</b>	2.36
		<b>Floor:</b>	Basement
<b>Site Address:</b>	Mackintosh Building, Glasgow	<b>Area Description:</b>	Toilet area (flooring)
<b>Building:</b>	Mackintosh Building	<b>Material Description:</b>	Composite flooring throughout
<b>Building Address:</b>	As Above	<b>Survey Report Reference:</b>	ASL1821-Mac-Mac

**Material Risk:** 0  
Asbestos Type: 0 - No asbestos detected

Recommendation: No further action required

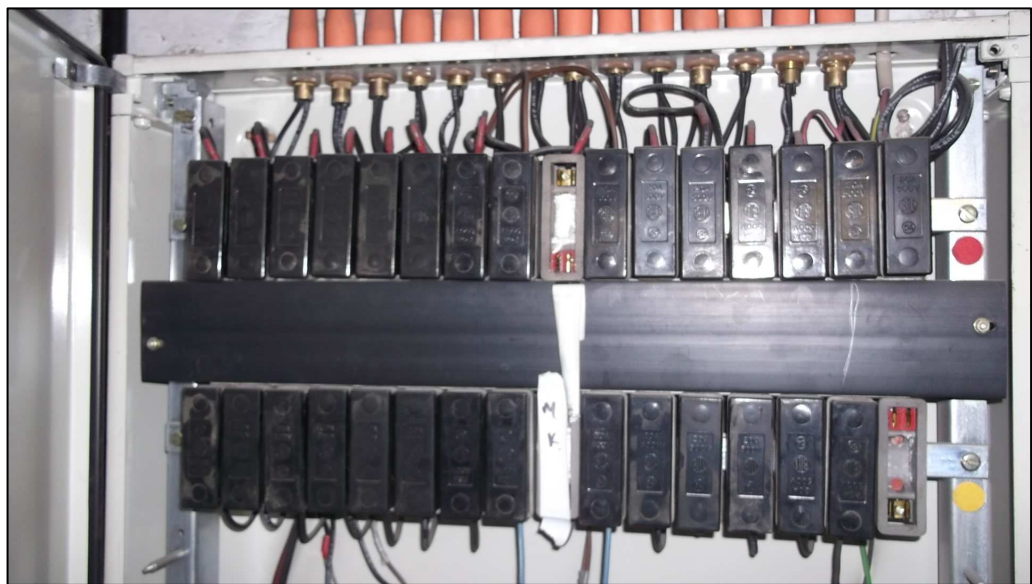
<b>Client:</b>	Glasgow School of Art	<b>Area No:</b>	2.53
		<b>Floor:</b>	Basement
<b>Site Address:</b>	Mackintosh Building, Glasgow	<b>Area Description:</b>	Fan room (fitting )
<b>Building:</b>	Mackintosh Building	<b>Material Description:</b>	Flash guards
<b>Building Address:</b>	As Above	<b>Survey Report Reference:</b>	ASL1821-Mac-Mac

<b>Material Risk:</b>	3
Asbestos Type:	1 - Chrysotile
Product Type:	2 - AIB, Milboard, gaskets, paper etc
Extent of Damage:	0 - Good
Surface Treatment:	0 - Composite materials containing asbestos (reinforced plastics, vinyl, etc)
<b>Priority Risk:</b>	<b>1</b>
Normal Occupant Activity:	0 - Rare Disturbance
Likelihood of Disturbance:	1 - Low Likelihood of Disturbance
Human Exposure Potential:	0 - Very Low Human Exposure Potential
Maintenance Activity :	0 - Minor Risk Maintenance Activity

Timescale for Recommendation :	Within 12 months
Recommendation:	Manage
Comments:	
<b>Total Risk Score:</b>	<b>4</b>

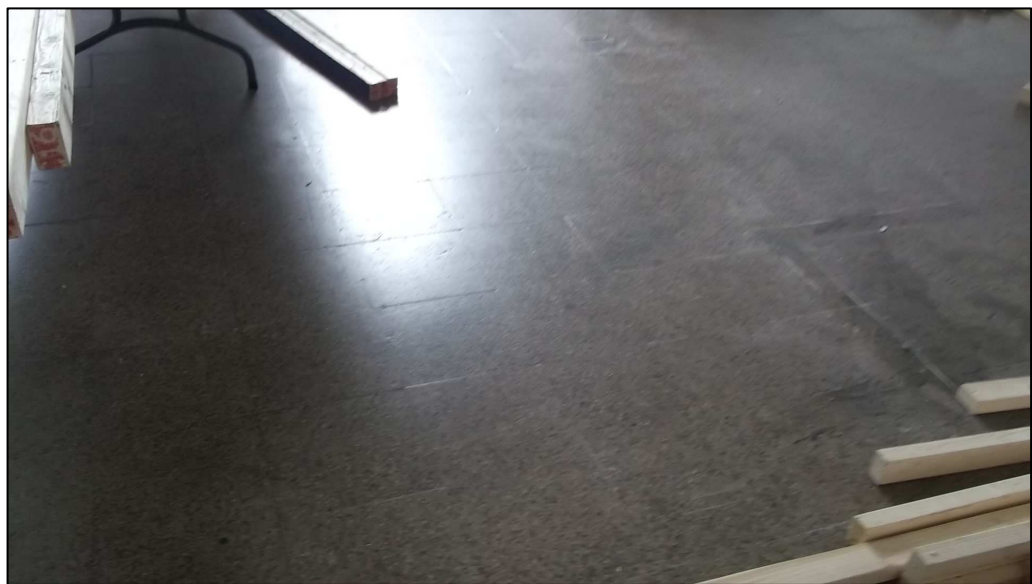
<b>Client:</b>	Glasgow School of Art	<b>Area No:</b>	2.61
<b>Site Address:</b>	Mackintosh Building, Glasgow	<b>Floor:</b>	Basement
<b>Building:</b>	Mackintosh Building	<b>Area Description:</b>	Studio (flooring)
<b>Building Address:</b>	As Above	<b>Material Description:</b>	composite flooring
		<b>Survey Report Reference:</b>	ASL1821-Mac-Mac

**Material Risk:** 0  
Asbestos Type: 0 - No asbestos detected

Recommendation: No further action required

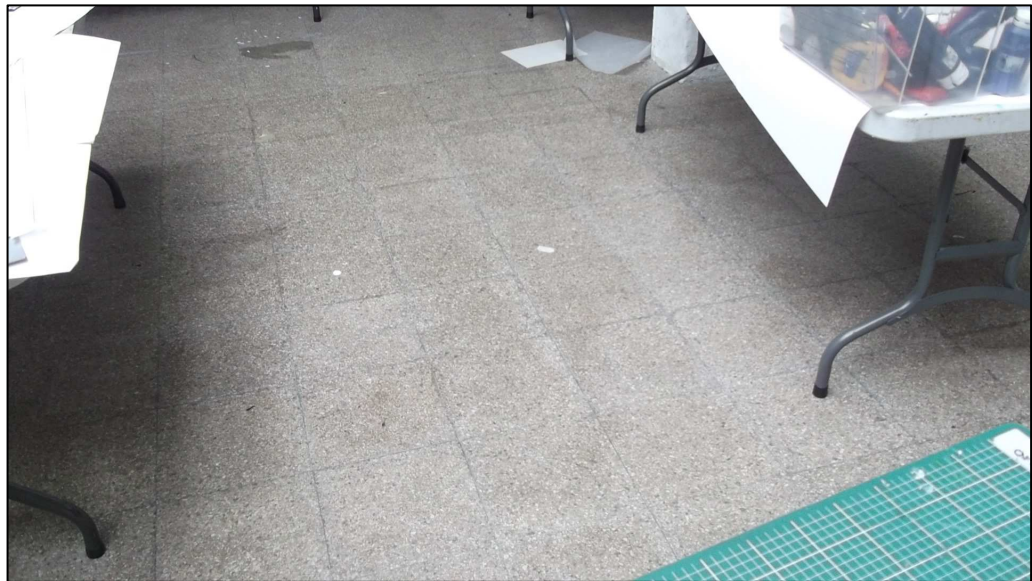
<b>Client:</b>	Glasgow School of Art	<b>Area No:</b>	2.64
		<b>Floor:</b>	Basement
<b>Site Address:</b>	Mackintosh Building, Glasgow	<b>Area Description:</b>	Studio (flooring)
<b>Building:</b>	Mackintosh Building	<b>Material Description:</b>	Composite flooring
<b>Building Address:</b>	As Above	<b>Survey Report Reference:</b>	ASL1821-Mac-Mac

**Material Risk:** 0  
Asbestos Type: 0 - No asbestos detected

Recommendation: No further action required  
Comments: No further action required

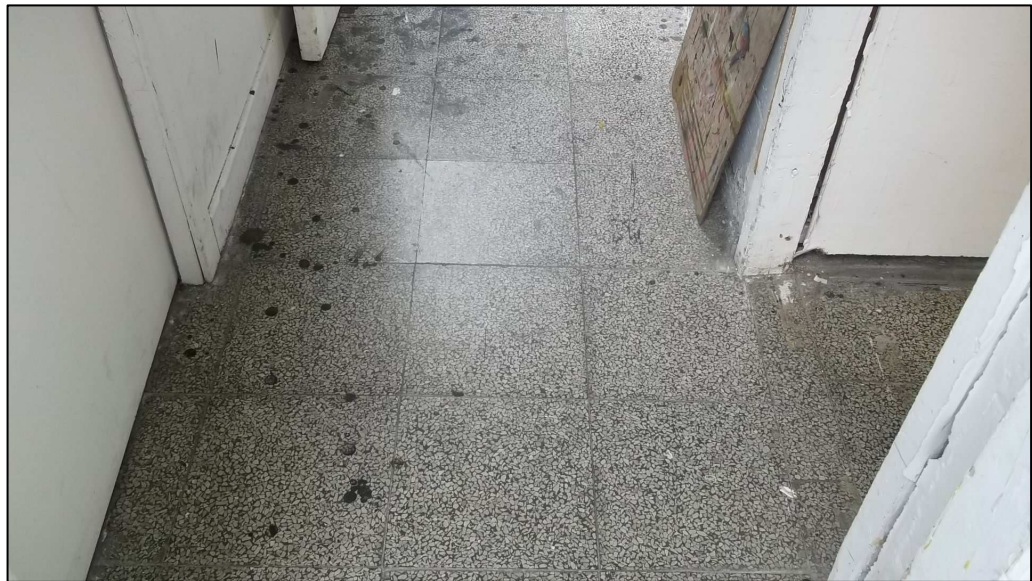
<b>Client:</b>	Glasgow School of Art	<b>Area No:</b>	2.66
		<b>Floor:</b>	Basement
<b>Site Address:</b>	Mackintosh Building, Glasgow	<b>Area Description:</b>	Corridor (flooring)
<b>Building:</b>	Mackintosh Building	<b>Material Description:</b>	Composite flooring
<b>Building Address:</b>	As Above	<b>Survey Report Reference:</b>	ASL1821-Mac-Mac

**Material Risk:** 0

Recommendation: No further action required

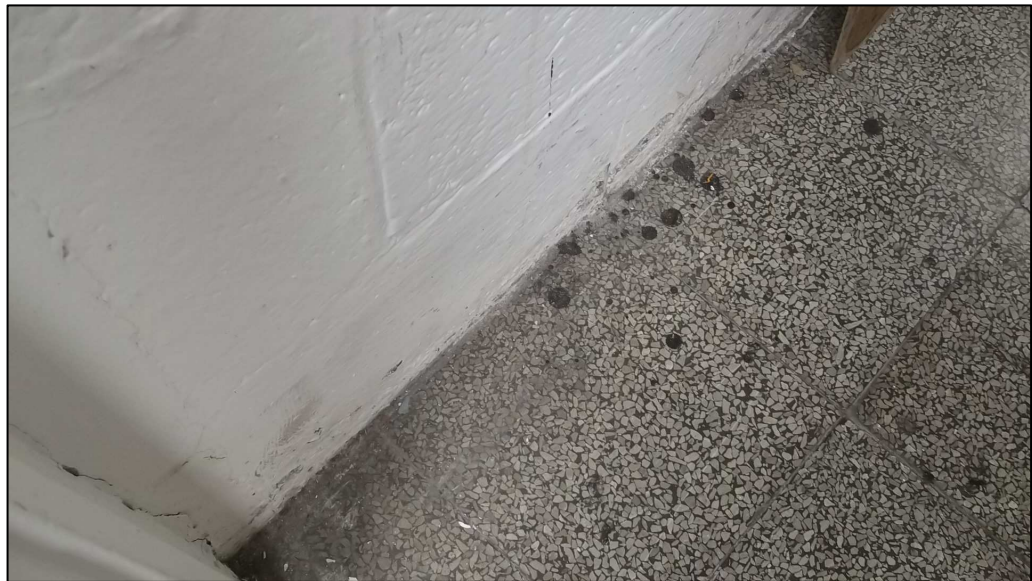
<b>Client:</b>	Glasgow School of Art	<b>Area No:</b>	2.67
<b>Site Address:</b>	Mackintosh Building, Glasgow	<b>Floor:</b>	Basement
<b>Building:</b>	Mackintosh Building	<b>Area Description:</b>	Store (flooring)
<b>Building Address:</b>	As Above	<b>Material Description:</b>	Composite flooring
		<b>Survey Report Reference:</b>	ASL1821-Mac-Mac

**Material Risk:** 0  
Asbestos Type: 0 - No asbestos detected

Recommendation: No further action required

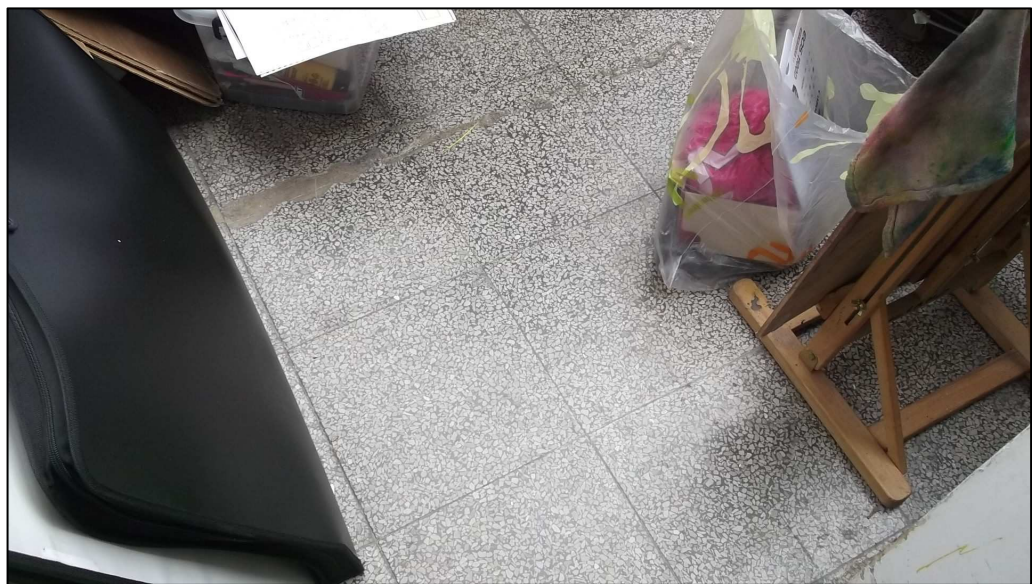
<b>Client:</b>	Glasgow School of Art	<b>Area No:</b>	2.68
<b>Site Address:</b>	Mackintosh Building, Glasgow	<b>Floor:</b>	Basement
<b>Building:</b>	Mackintosh Building	<b>Area Description:</b>	Store (flooring)
<b>Building Address:</b>	As Above	<b>Material Description:</b>	Composite flooring
		<b>Survey Report Reference:</b>	ASL1821-Mac-Mac

**Material Risk:** 0  
Asbestos Type: 0 - No asbestos detected

Recommendation: No further action required

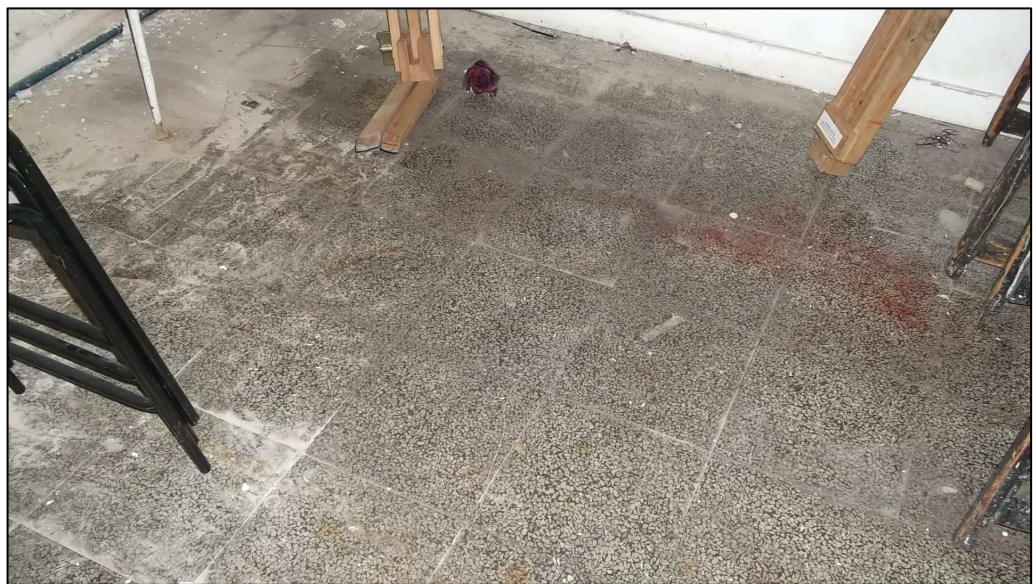
<b>Client:</b>	Glasgow School of Art	<b>Area No:</b>	2.69
		<b>Floor:</b>	Basement
<b>Site Address:</b>	Mackintosh Building, Glasgow	<b>Area Description:</b>	Store (flooring)
<b>Building:</b>	Mackintosh Building	<b>Material Description:</b>	Composite flooring
<b>Building Address:</b>	As Above	<b>Survey Report Reference:</b>	ASL1821-Mac-Mac

**Material Risk:** 0  
Asbestos Type: 0 - No asbestos detected

Recommendation: No further action required

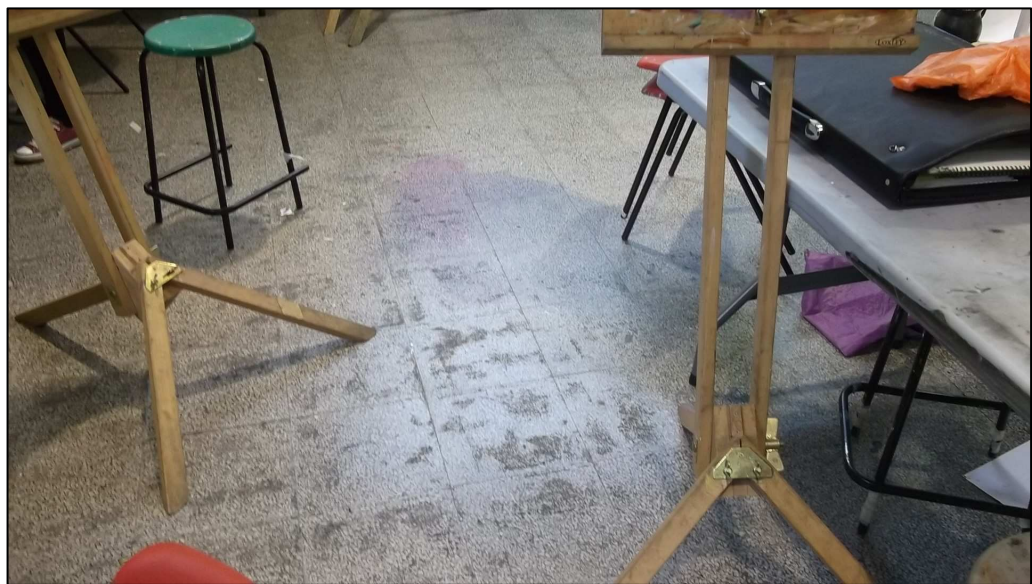
<b>Client:</b>	Glasgow School of Art	<b>Area No:</b>	2.70
		<b>Floor:</b>	Basement
<b>Site Address:</b>	Mackintosh Building, Glasgow	<b>Area Description:</b>	Studio (floor )
<b>Building:</b>	Mackintosh Building	<b>Material Description:</b>	Composition flooring
<b>Building Address:</b>	As Above	<b>Survey Report Reference:</b>	ASL1821-Mac-Mac

**Material Risk:** 0  
Asbestos Type: 0 - No asbestos detected

Recommendation: No further action required

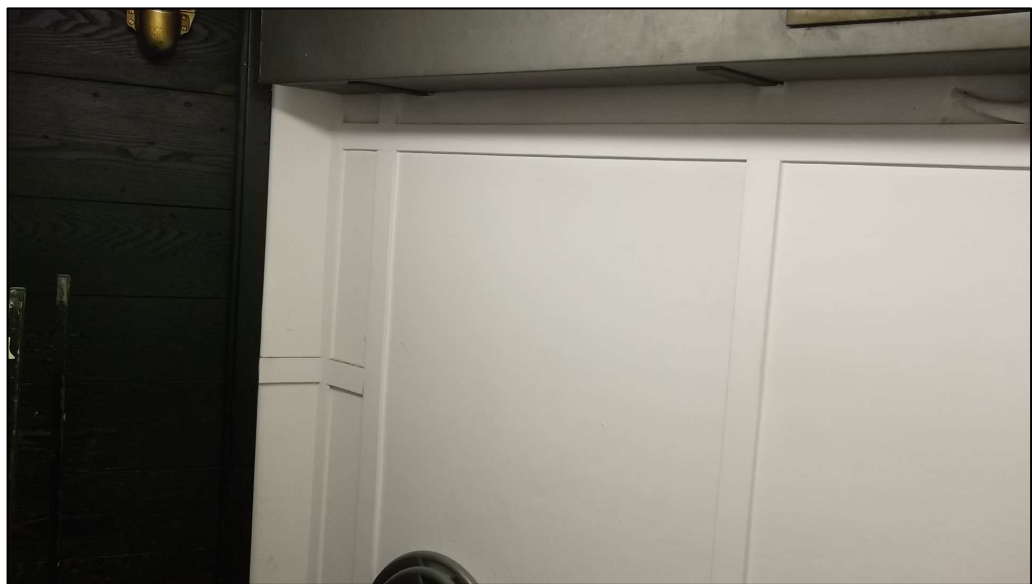
<b>Client:</b>	Glasgow School of Art	<b>Area No:</b>	2.75
		<b>Floor:</b>	Basement
<b>Site Address:</b>	Mackintosh Building, Glasgow	<b>Area Description:</b>	Projection room (wall )
<b>Building:</b>	Mackintosh Building	<b>Material Description:</b>	Cement panels
<b>Building Address:</b>	As Above	<b>Survey Report Reference:</b>	ASL1821-Mac-Mac

<b>Material Risk:</b>	<b>4</b>
Asbestos Type:	1 - Chrysotile
Product Type:	1 - Asbestos composites, decorative finishes, AC
Extent of Damage:	1 - Low damage
Surface Treatment:	1 - Enclosed sprays and lagging, AIB, AC sheets etc
<b>Priority Risk:</b>	<b>2</b>
Normal Occupant Activity:	0 - Rare Disturbance
Likelihood of Disturbance:	1 - Low Likelihood of Disturbance
Human Exposure Potential:	1 - Low Human Exposure Potential
Maintenance Activity :	0 - Minor Risk Maintenance Activity

Timescale for Recommendation : Within 12 months

Recommendation: Manage

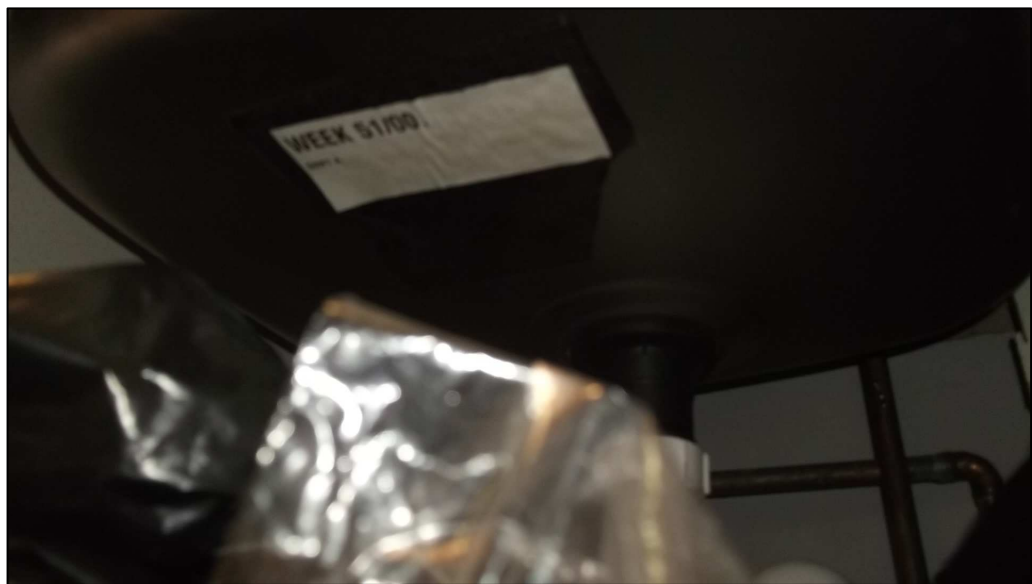
<b>Client:</b>	Glasgow School of Art	<b>Area No:</b>	5.07
<b>Site Address:</b>	Mackintosh Building, Glasgow	<b>Floor:</b>	Mezzanine layout (G & F)
<b>Building:</b>	Mackintosh Building	<b>Area Description:</b>	Exhibitions (fitting)
<b>Building Address:</b>	As Above	<b>Material Description:</b>	Sink pad
		<b>Survey Report Reference:</b>	ASL1821-Mac-Mac

**Material Risk:** 0  
Asbestos Type: 0 - No asbestos detected

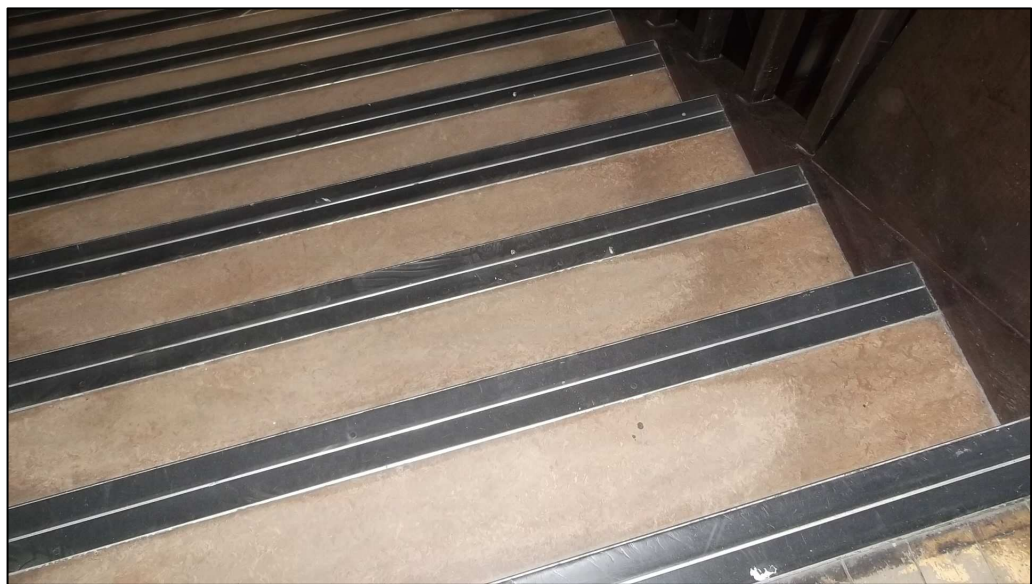
<b>Client:</b>	Glasgow School of Art	<b>Area No:</b>	6.01
<b>Site Address:</b>	Mackintosh Building, Glasgow	<b>Floor:</b>	First
<b>Building:</b>	Mackintosh Building	<b>Area Description:</b>	Half landing (fitting )
<b>Building Address:</b>	As Above	<b>Material Description:</b>	Stair tread
		<b>Survey Report Reference:</b>	ASL1821-Mac-Mac

**Material Risk:** 0  
Asbestos Type: 0 - No asbestos detected

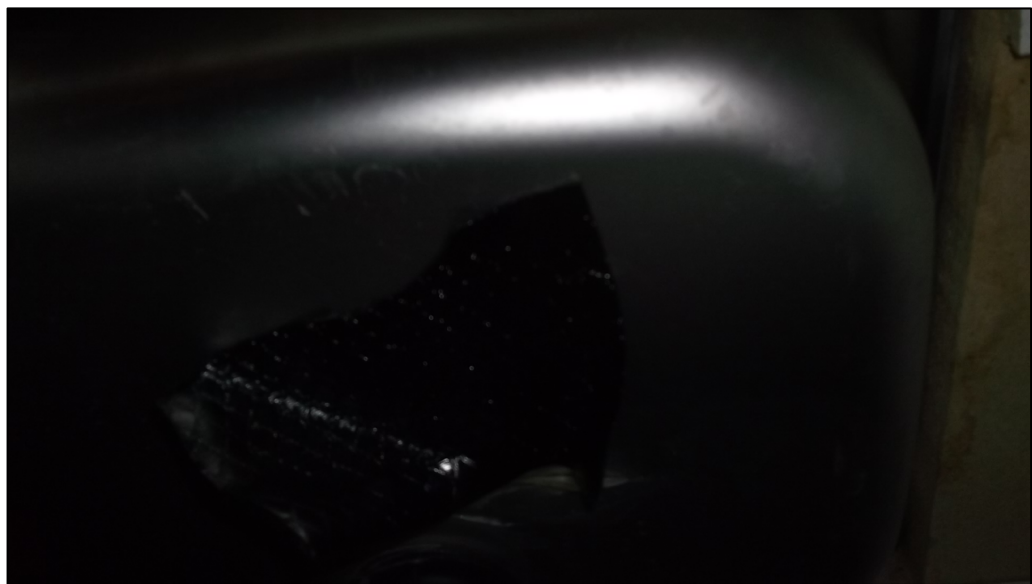
<b>Client:</b>	Glasgow School of Art	<b>Area No:</b>	6.11
<b>Site Address:</b>	Mackintosh Building, Glasgow	<b>Floor:</b>	First
<b>Building:</b>	Mackintosh Building	<b>Area Description:</b>	Kitchen (fitting )
<b>Building Address:</b>	As Above	<b>Material Description:</b>	Sink pad
		<b>Survey Report Reference:</b>	ASL1821-Mac-Mac

**Material Risk:** 0  
Asbestos Type: 0 - No asbestos detected

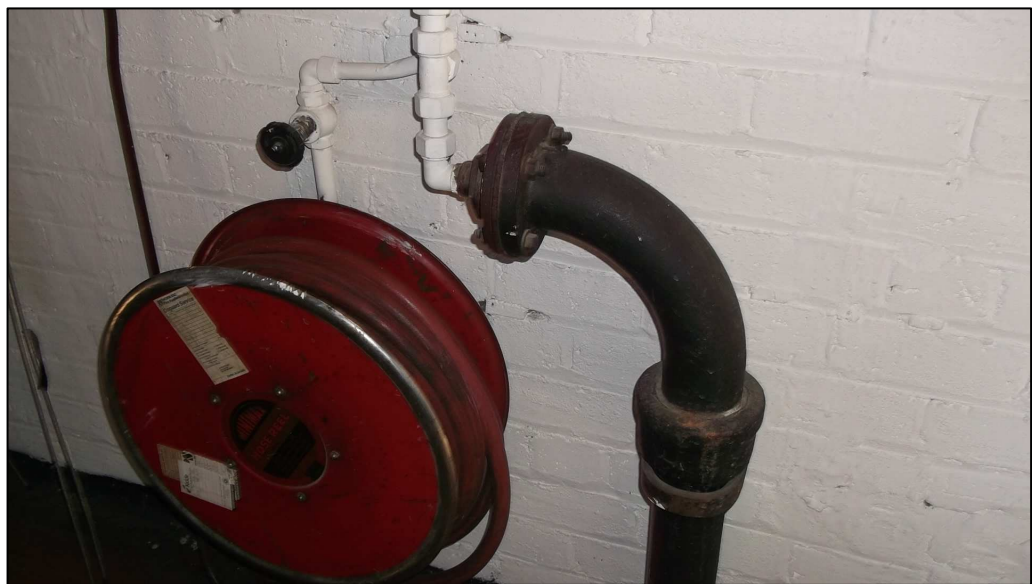
<b>Client:</b>	Glasgow School of Art	<b>Area No:</b>	9.02
		<b>Floor:</b>	Second
<b>Site Address:</b>	Mackintosh Building, Glasgow	<b>Area Description:</b>	Corridor (fitting )
<b>Building:</b>	Mackintosh Building	<b>Material Description:</b>	Gasket to pipe
<b>Building Address:</b>	As Above	<b>Survey Report Reference:</b>	ASL1821-Mac-Mac

**Material Risk:** 0

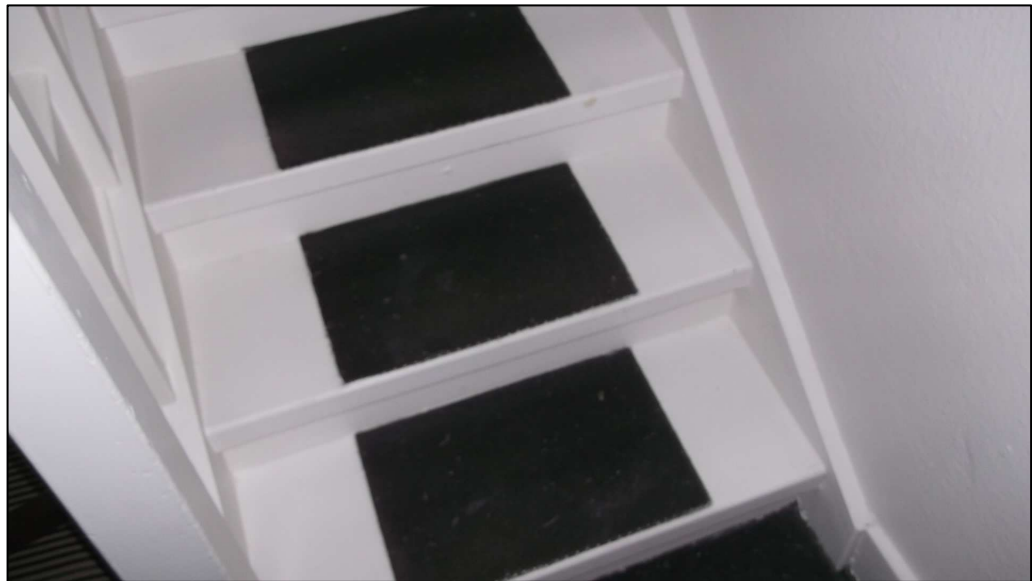
<b>Client:</b>	Glasgow School of Art	<b>Area No:</b>	9.17
<b>Site Address:</b>	Mackintosh Building, Glasgow	<b>Floor:</b>	Second
<b>Building:</b>	Mackintosh Building	<b>Area Description:</b>	Stairwell to mezzanine (floor)
<b>Building Address:</b>	As Above	<b>Material Description:</b>	Vinyl covering to stairs
		<b>Survey Report Reference:</b>	ASL1821-Mac-Mac

**Material Risk:** 0  
Asbestos Type: 0 - No asbestos detected

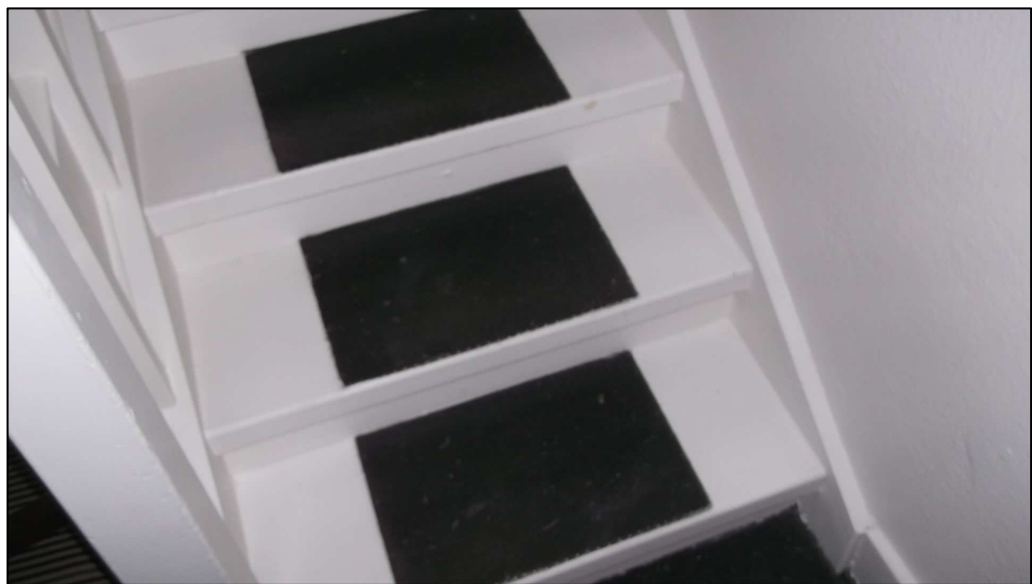
<b>Client:</b>	Glasgow School of Art	<b>Area No:</b>	9.17
<b>Site Address:</b>	Mackintosh Building, Glasgow	<b>Floor:</b>	Second
<b>Building:</b>	Mackintosh Building	<b>Area Description:</b>	Stair to mezzanine (fitting )
<b>Building Address:</b>	As Above	<b>Material Description:</b>	Stair nosing
		<b>Survey Report Reference:</b>	ASL1821-Mac-Mac

**Material Risk:** 0  
Asbestos Type: 0 - No asbestos detected

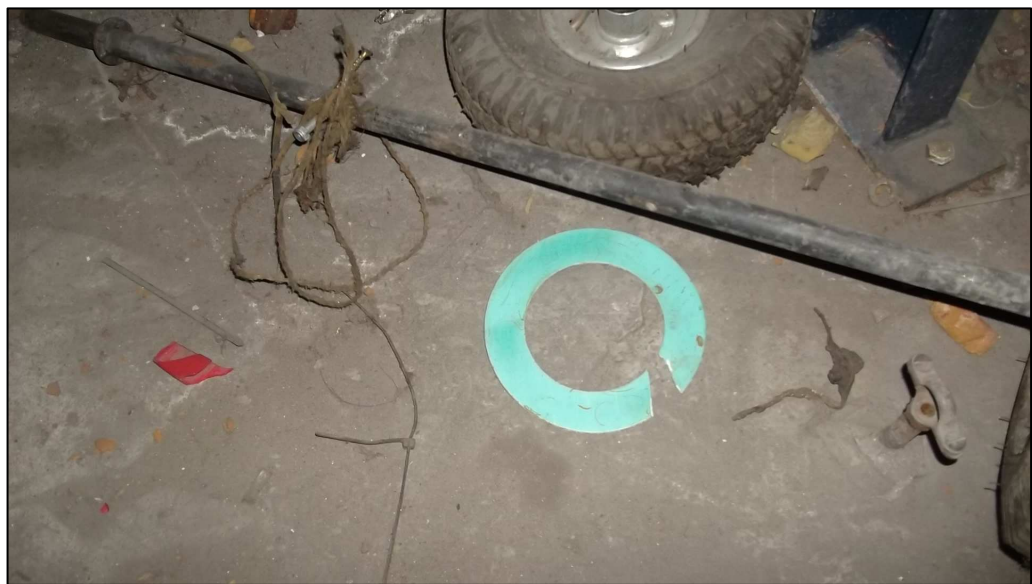
<b>Client:</b>	Glasgow School of Art	<b>Area No:</b>	Service
<b>Site Address:</b>	Mackintosh Building, Glasgow	<b>Floor:</b>	Sub - Basement
<b>Building:</b>	Mackintosh Building	<b>Area Description:</b>	Service area (debris )
<b>Building Address:</b>	As Above	<b>Material Description:</b>	Loose gasket to to left handside of service area
		<b>Survey Report Reference:</b>	ASL1821-Mac-Mac

**Material Risk:** 0  
Asbestos Type: 0 - No asbestos detected
