CHAMIC INDUSTRIAL SERVICES LIMITED

REPORT OF AN ASBESTOS SURVEY & REGISTER
AT
THE MacKINTOSH BUILDING, GLASGOW SCHOOL OF ART
FOR
GLASGOW SCHOOL OF ART
COPY NO: 1

Asbestos Survey: ASG164
Issue A:
Date: 18/07/03

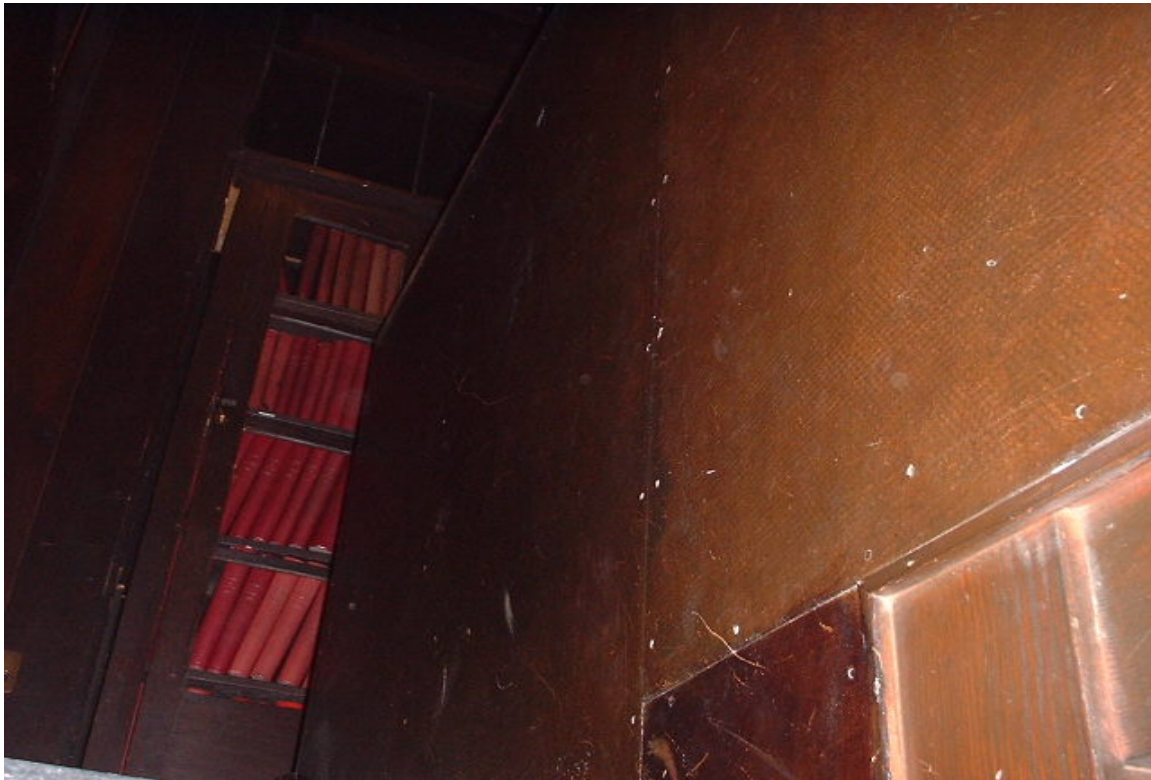
The asbestos cement boards were found to contain Chrysotile (white) asbestos and was in fair condition and so assigned a low risk factor (4)

Asbestos Cement Boards @ Library Stairwell

LOCATION		MATERIAL		SURVEY DETAILS	
Library Stairwell		Asbestos Cement Board		Date of Survey	15/07/03
				Survey Type	Type 2
				Surveyor	CG
Asbestos Type	Chrysotile	Accessibility	Unlikely to be Disturbed	Condition of Material	Fair
Material Type	Board	Approx. Size	8m2	Risk Factor Algorithm	4
Surface Treatment	Sealed	Location	Library Stairwell	Re-inspection Date	15/07/04
Extent of damage	None	Likelihood of sustaining damage	Low	Priority Actions	Low
REMEDIAL ACTION		Manage & Label

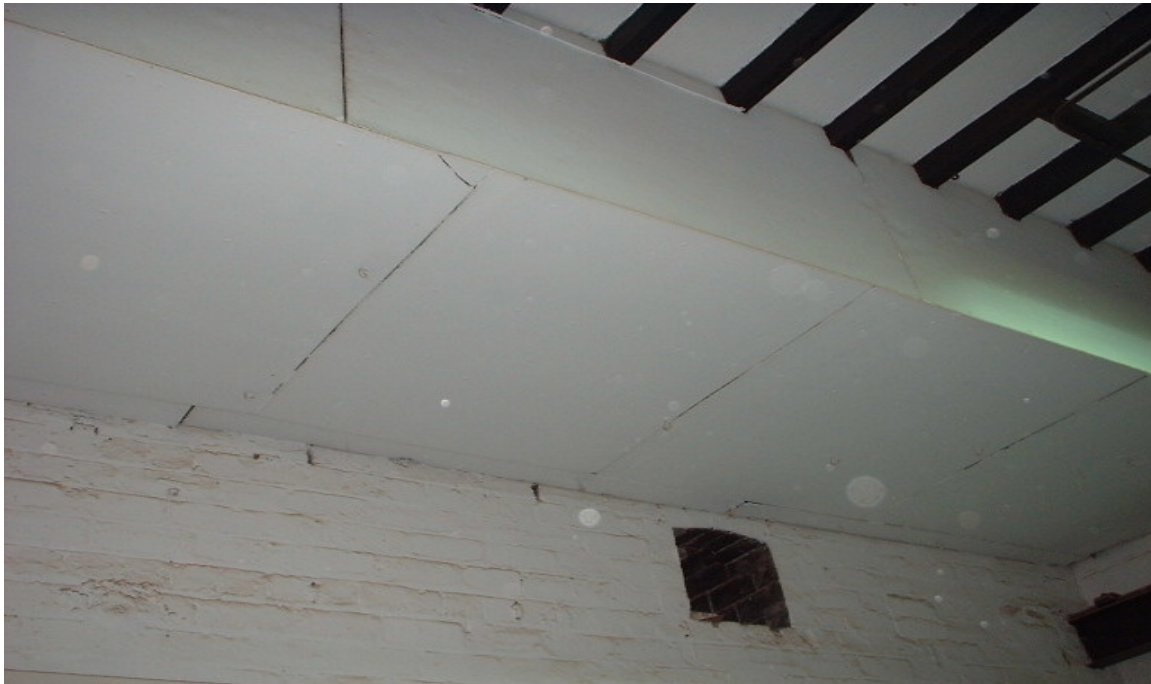
Asbestos Cement Boards @ Sub-basement, Woodwork Workshop, Bulkhead

LOCATION		MATERIAL		SURVEY DETAILS	
Sub-basement, Woodwork Workshop, Bulkhead		Asbestos Cement Board		Date of Survey	15/07/03
				Survey Type	Type 2
				Surveyor	CG
Asbestos Type	Chrysotile	Accessibility	Unlikely to be Disturbed	Condition of Material	Fair
Material Type	Board	Approx. Size	25m2	Risk Factor Algorithm	4
Surface Treatment	Sealed	Location	Sub-basement, Woodwork Workshop, Bulkhead	Re-inspection Date	15/07/04
Extent of damage	None	Likelihood of sustaining damage	Low	Priority Actions	Low
REMEDIAL ACTION		Manage & Label
