SCOTTISH  
FIRE AND RESCUE SERVICE

# Fire Investigation Report

The Glasgow School of Art

15 June 2018

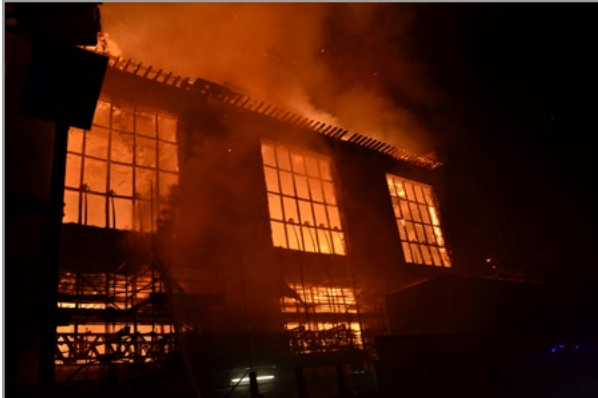
Figure 5 – Northeast corner

The Fire Investigation Unit from Yorkhill attended at 23:50hrs and observed a very well-developed fire visible through openings at most levels involving the east side of the building (Figure 5 above).

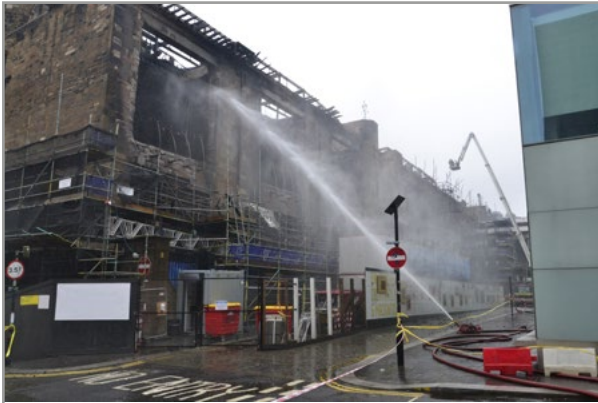
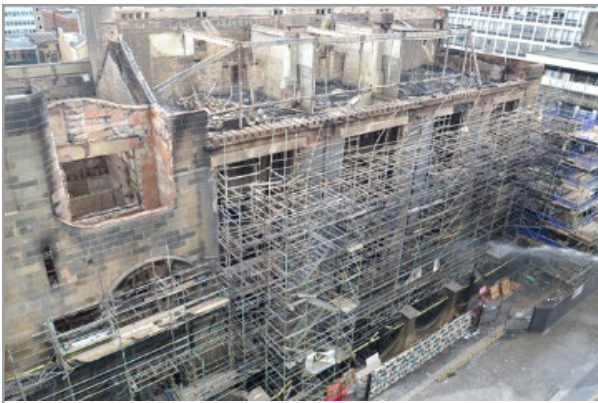
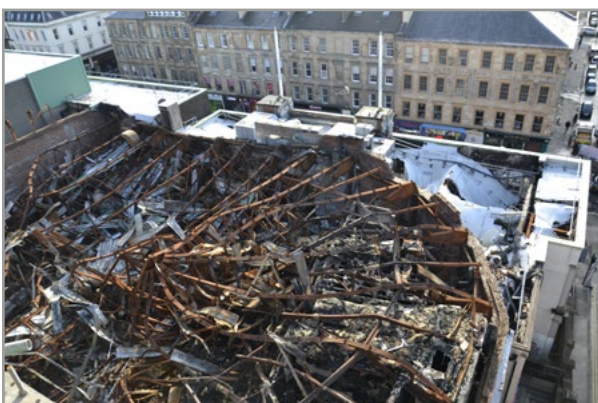
Figure 7 – fire damage

Firefighting operations continued throughout the day with pockets of fire being attacked and crews damping down fire debris across the Mackintosh and O2 ABC buildings. Cordons had been extended to Sauchiehall Street with evacuations taking place on Dalhousie Street and Scott Street (Figure 7 on the following page).

North Elevation, east end  
Dalhousie Street/Renfrew Street corner

North Elevation, west end  
Renfrew Street Scott Street corner

O2 ABC, looking south  
Scott Street/Sauchiehall Street corner

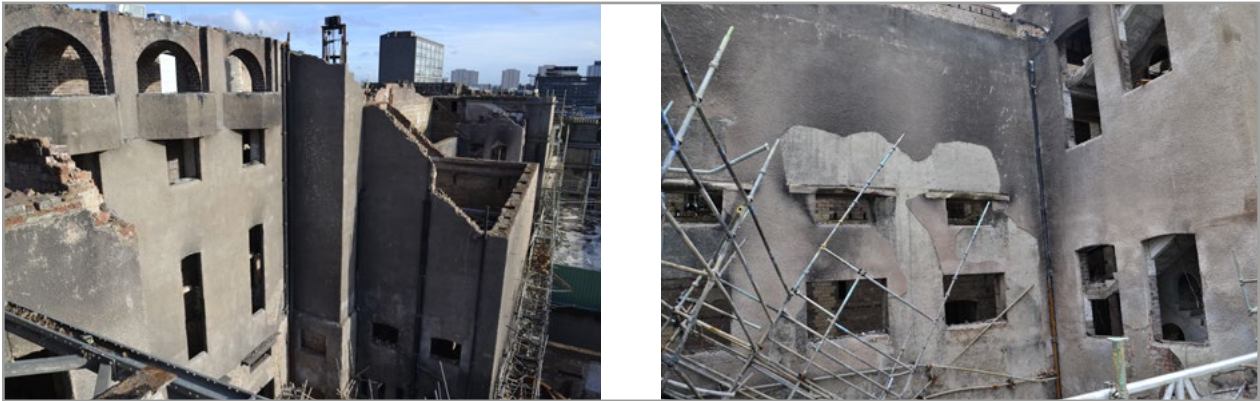
Figure 8 – South Elevations

The external view of the building indicated that there had been an intense internal fire. This resulted in the failure of approximately 97% of the windows, severe spalling of the sandstone outer façade, warping of steel beams and severe fire and heat damage to the scaffolding structure that encased the building. The entire roof structure had perished with only stone, brick and distorted steel structural members remaining (Figure 8).

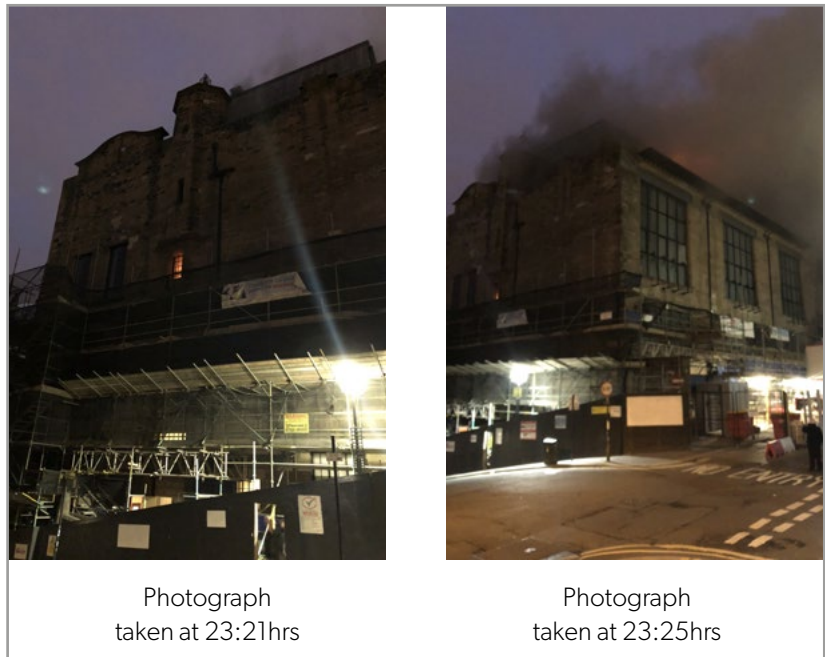
Figure 9 – Northeast Corner

As the fire developed further, it spread to involve all levels in the east side and progressed through the central area to the west of the building. Later, it would spread to the adjoining O2 ABC building, which also suffered catastrophic fire damage. The remaining adjoining building, Jumpin Jaks nightclub suffered minor fire, heat and smoke damage.

Major contributory factors for the fire spreading in a rapid and uncontrolled way, are attributed to the compromised compartmentation and separation and, open brick and timber lined ducts running vertically and horizontally throughout the building.

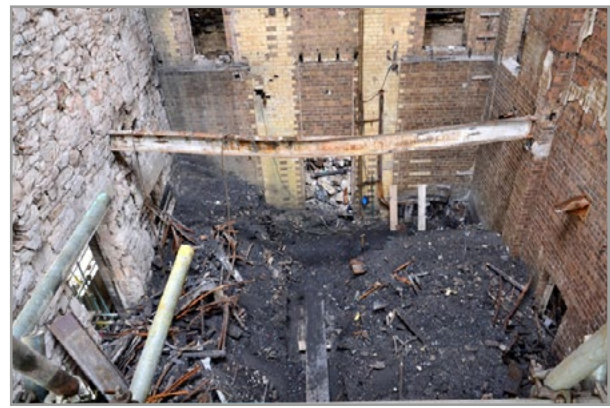
Figure 10 – Main contractor office level 2

This area was the route to the first "area of interest" to be excavated as part of Phase 1 excavation work. On the 15th October 2018, work commenced to create a safe forensic path through the main contractor office on level 2 towards the security guards' desk area. The excavation was limited to creating a safe 1-metre-wide passageway with minimum excavation towards the known location of the desk, with the objective to recover the FWS control panel and the CCTV hard drive (Figure 10).

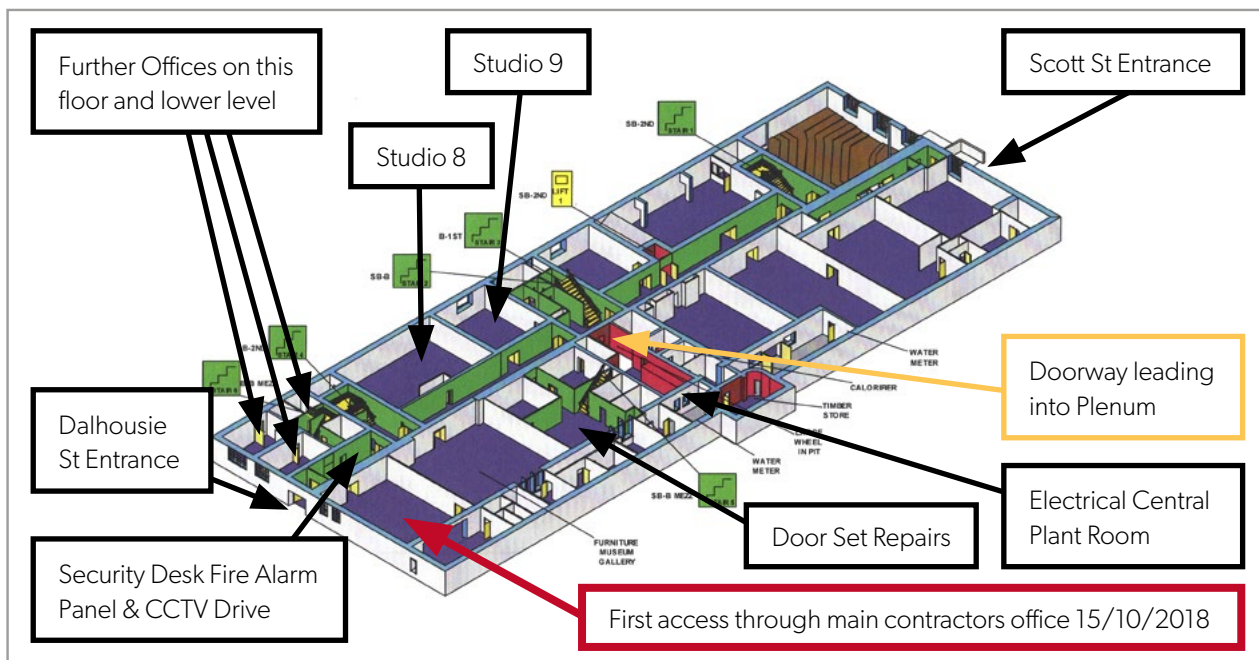
Figure 11 – Level 2

Entry into the corridor on level 2 at the east end of the building was achieved on the 30th October 2018 (Figure 11).

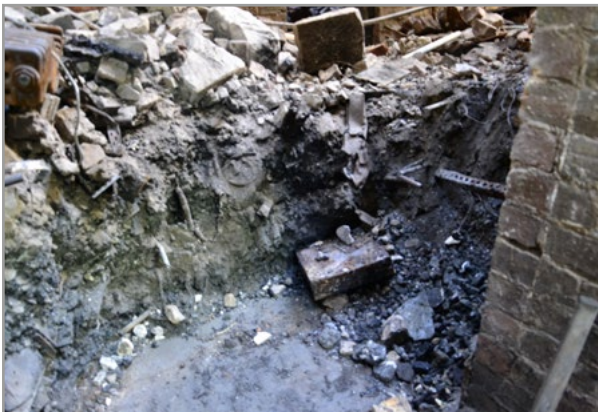
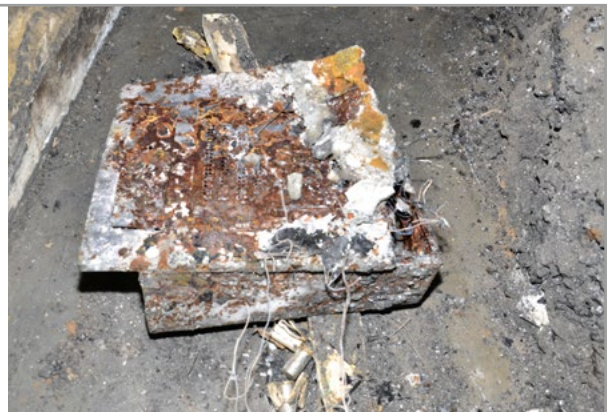
At 14:45hrs, the external housing of the FWS control panel was located below approximately one and a half metres of fire debris behind the location of the remains of the desk. The housing was located adjacent to the right-hand side of the corridor wall when facing west and 3 metres from the doorway leading to the main contractor office (Figure 12).

Location of FWS control panel

FWS control panel prior to impounding

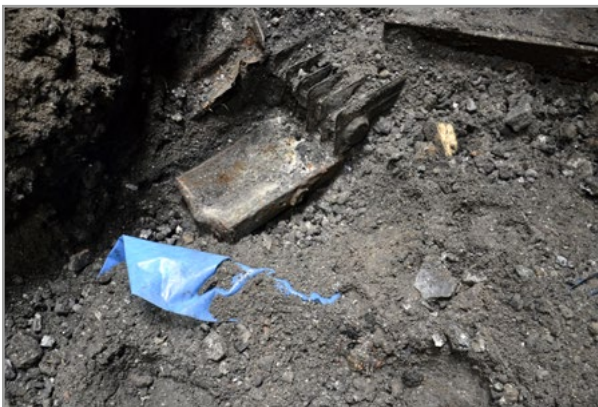
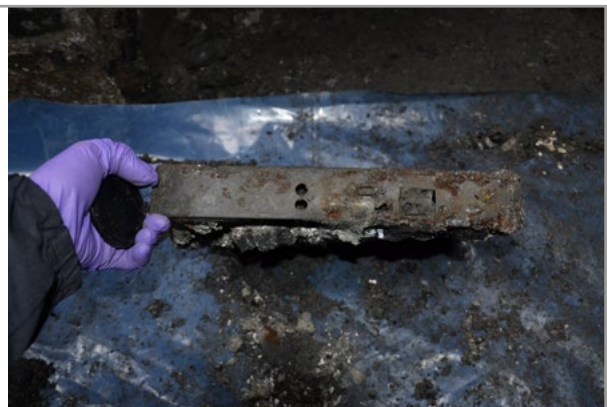
On 5th November 2018 at 14:47hrs, the exterior metal housing of the CCTV hard drive (measuring about 300mm x 300mm x 60mm) was located and observed to have suffered severe fire and heat damage. The housing was photographed prior to being removed and impounded at 16:30hrs and sent for forensic data retrieval (Figure 13).

*Figure 13 – Location and condition of CCTV Hard drive*

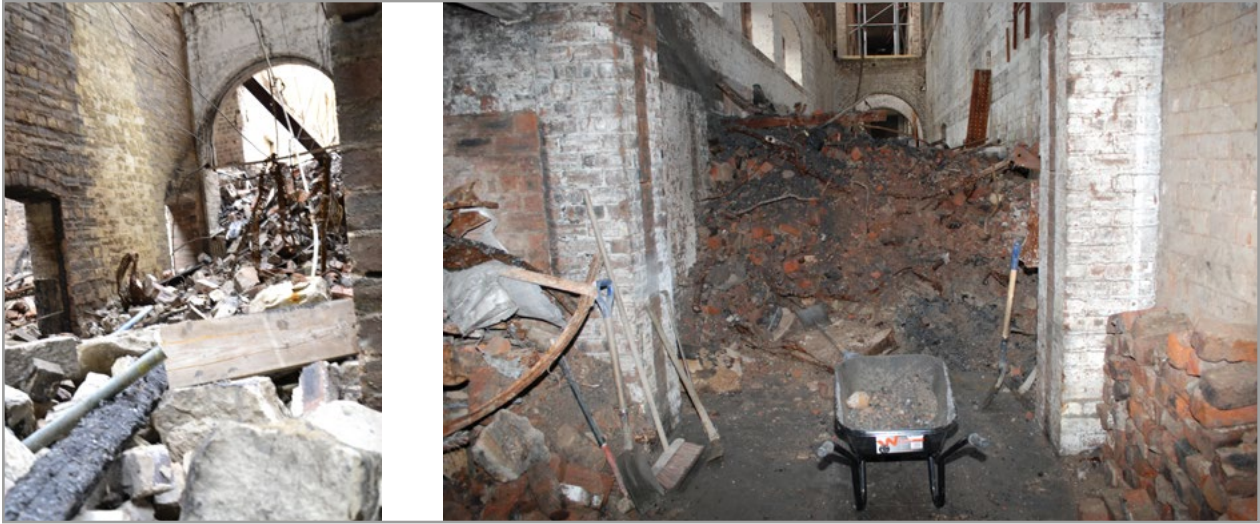
Figure 15 – Central Corridor level 2

Large quantities (several hundred tons) of fire debris were observed in the remains of both areas. Significant time, effort and resourcefulness was required to create safe systems of work to ensure safe access for FIOs (Figure 15 below).

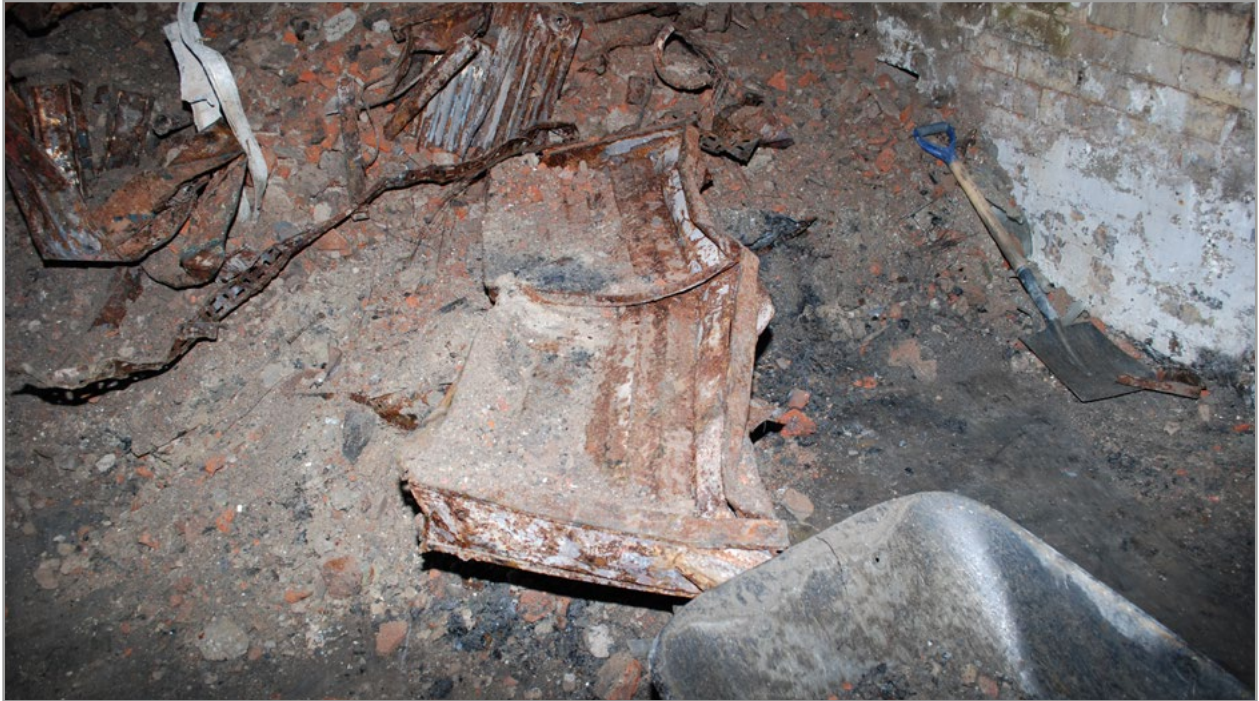
No recovered items of interest offered any information to support origin and cause.

Figure 16 – Metal duct work installed in level 6 plenum, found on level 2

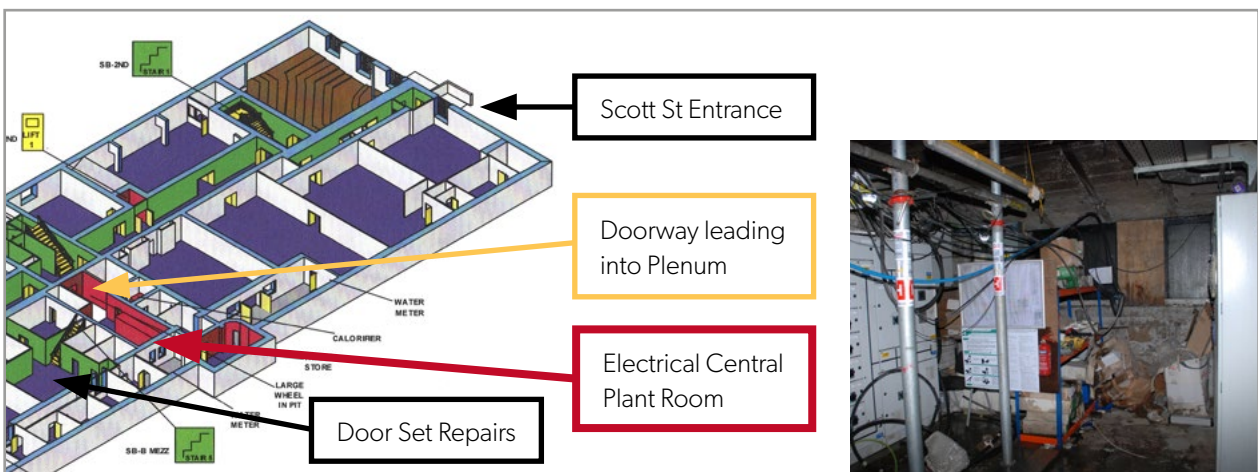
Figure 17 – Level 2 location (and photograph) of Electrical Central Plant Room

An energised three-phase distribution board was located to the righthand side of the new equipment. The three-phase lift supply, the supply to the temporary distribution board located in the plenum below level 2 (which supplied the temporary site electrical system) and the mains powered office supply originated from here. There was no evidence to suggest that the electrical equipment in this area should be considered as a possible origin or cause, due to no fire damage being observed or noted.

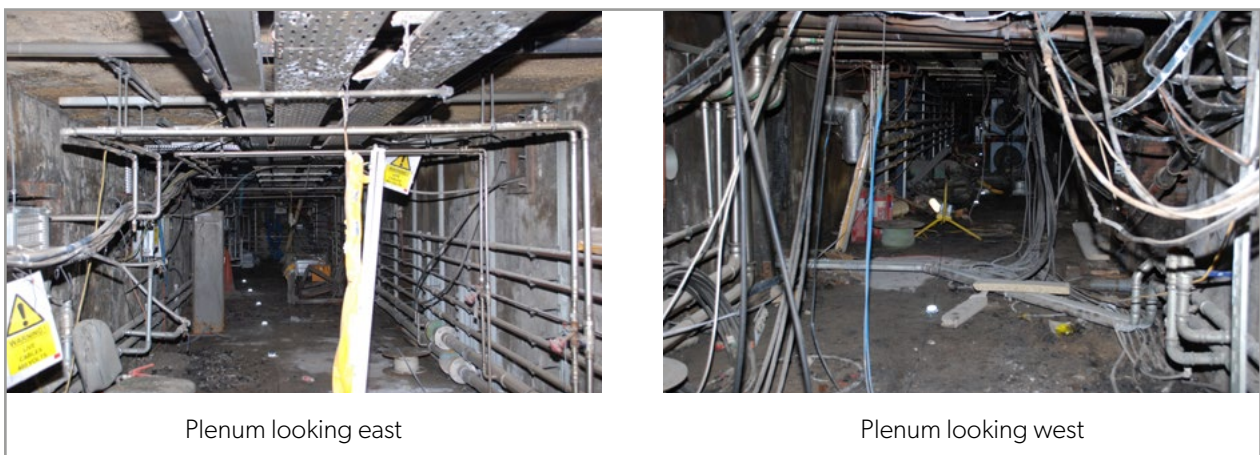
Figure 18 – Plenum below level 2

It was observed that the plenum had been utilised to route most of the electro-mechanical services for the building, including air conditioning ducts and fans, and a vast array of electrical and data wiring. Most of the wiring was observed to be secured to metal trays fastened at ceiling level. The majority of the plenum appeared to be undamaged by fire, with fire damage noted adjacent to vertical ducts which ran from numerous locations along the length of the plenum (Figure 18).

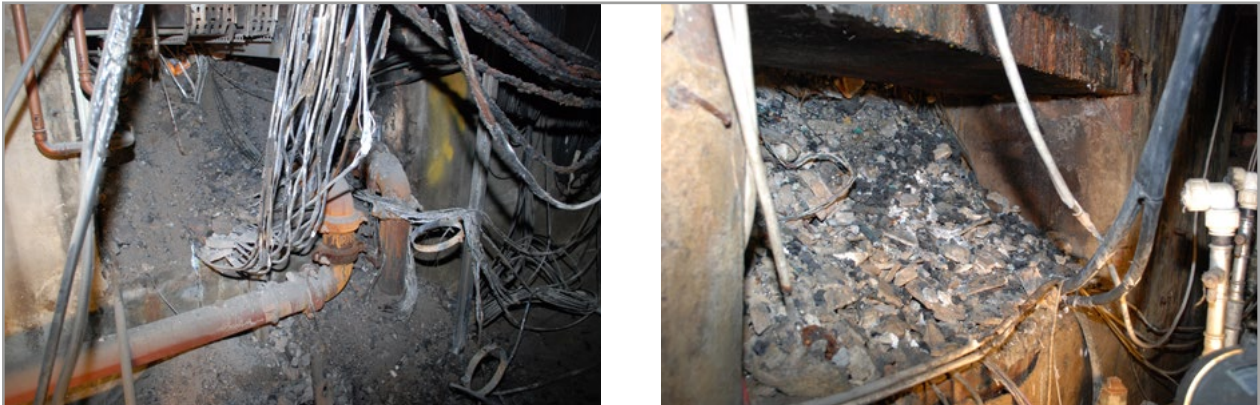
The remainder of the vertical ducts located on the north wall and to the left of the plenum entry point (leading East), were excavated from the 4th to the 7th December 2019. The ducts were observed to contain general fire debris including bricks, mortar, wood ash and general fine dust. No large pieces of wood were observed or located within the ducts. Electrical cabling entering the ducts had sustained severe fire damage, with the remaining cable forming a tangled section within the fire debris located at the bottom of the duct (Figure 19).

Figure 19 – Cables exiting vertical ducts into level 2 Plenum

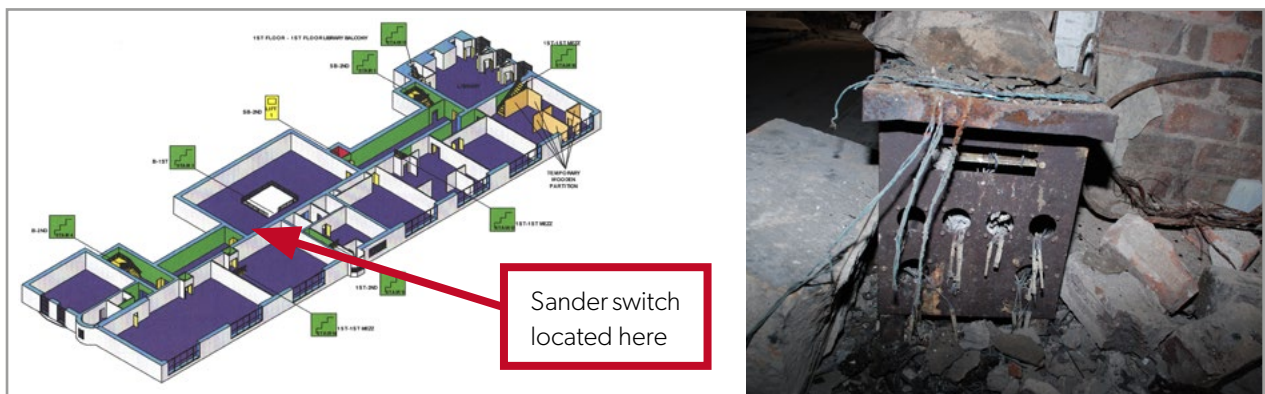
Several energised electrical supply cables were noted to be in use in a number of the vertical ducts. These supply cables served the lift, 110volt temporary site electrics and mains powered temporary site supplies. The mains powered cables supplied the contractors' offices located in the east of the building (levels 2 and 3), and an electrical control switch for a floor sander located on level 6 (Figure 20).

Figure 20 – Location of floor sander switch and the remains of one of nine 110volt site transformers

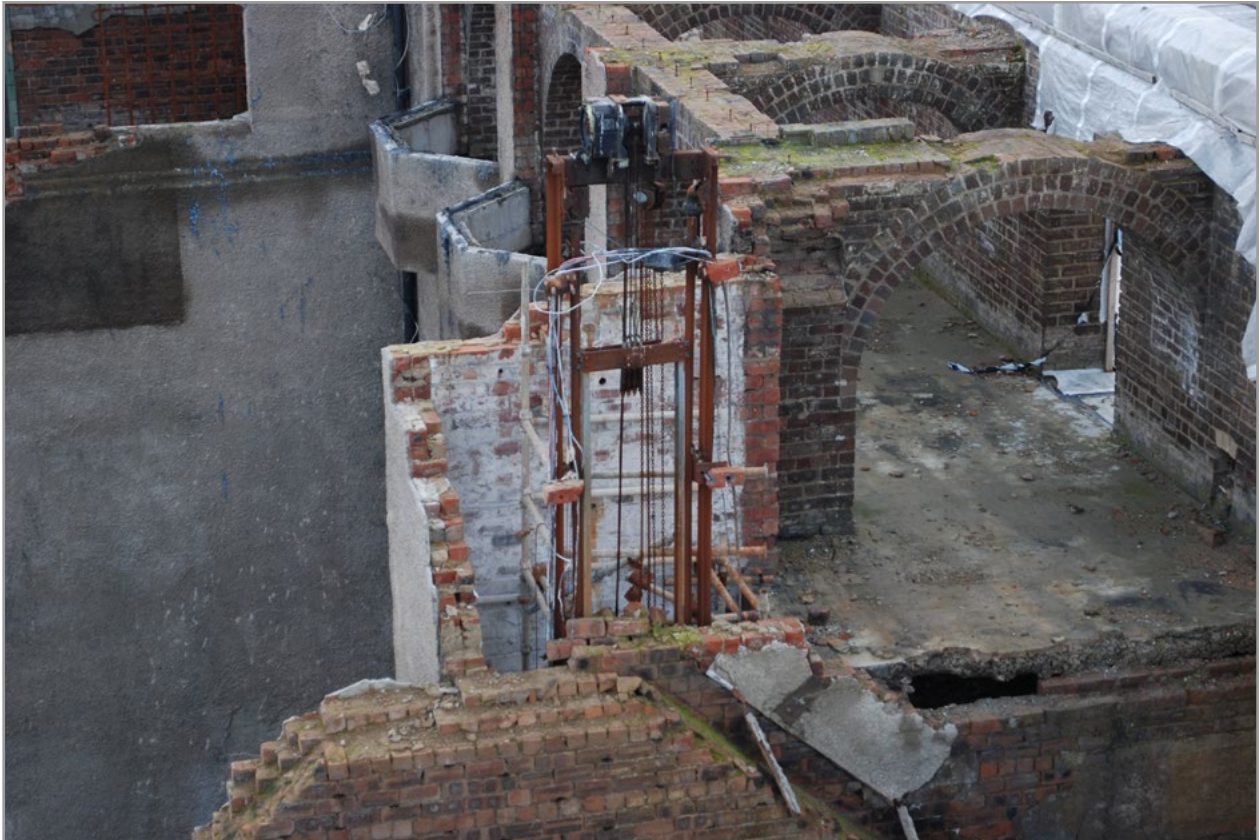
Figure 21 – Top of lift mechanism, west side

Due to the location of the lift shaft (midway along the west side of the building), both the wiring within the lift shaft and the supply cable termination at level 9 for the lift supply are not considered further as areas of origin or cause.

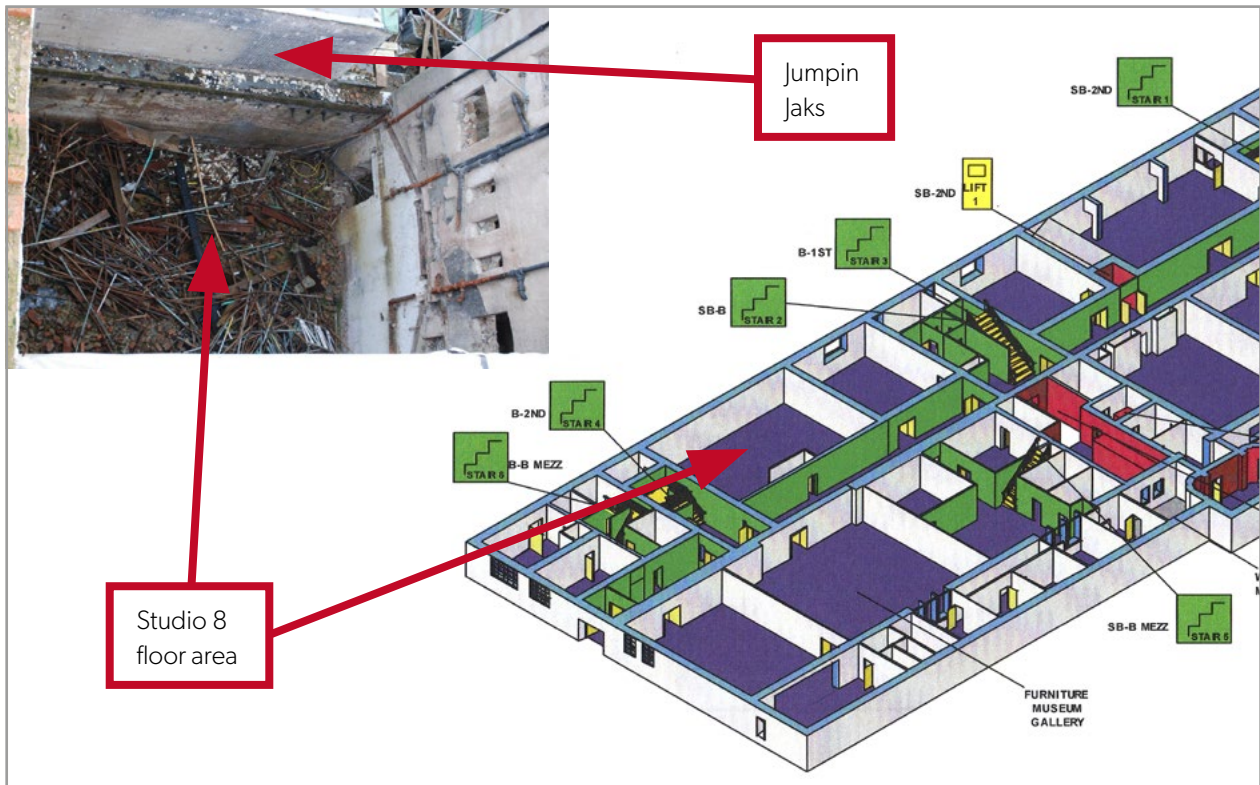
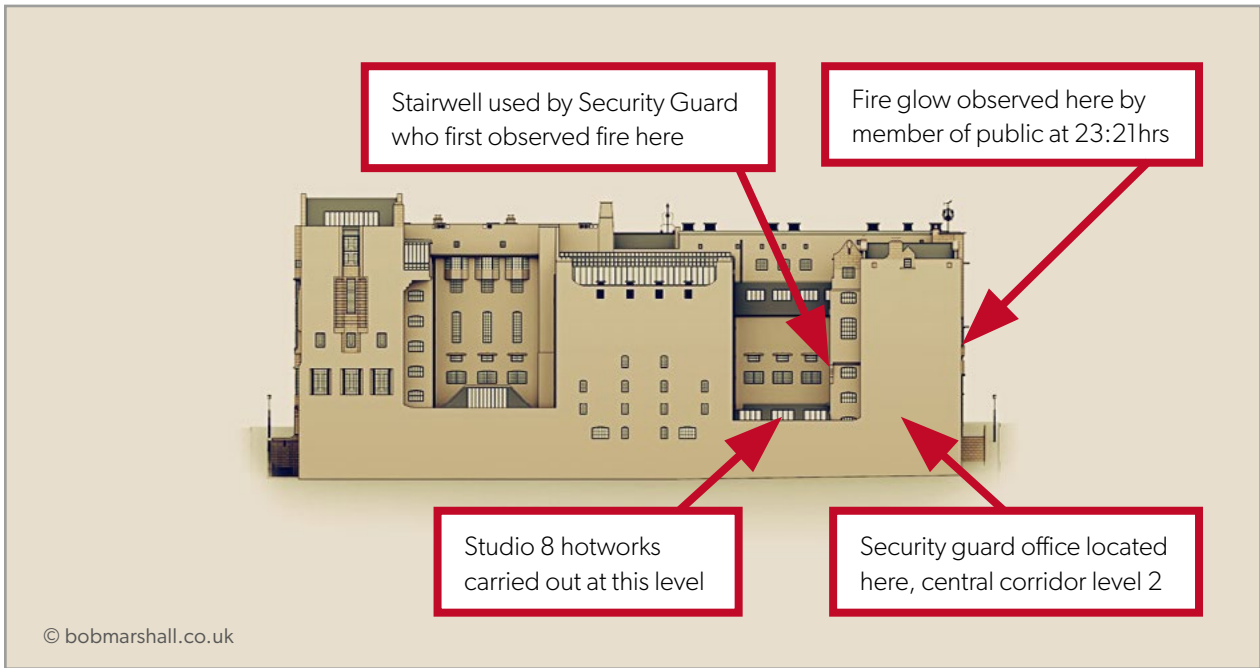
Figure 23 –View from above Studio 8, and location plan on level 2

The location of Studio 8 shown in Figure 23 and 24, was external to the main building and at a low level on the south facing elevation. There were no voids linking Studio 8 to the main building, making it highly unlikely for fire to spread unobserved from this location. Despite the Studio 8 roof, and the rear elevation being obscured by the adjoining buildings (Jumpin Jaks Nightclub and the O2 ABC), had fire started here, smoke and flames would have been visible much earlier in the day from surrounding buildings. Studio 8 is also close to the location of the security guards' desk. The security guard did not encounter signs of fire until he reached level 4 as he ascended the staircase to investigate noises that he heard around 23:10hrs.

Figure 24 – Rear, South facing elevation

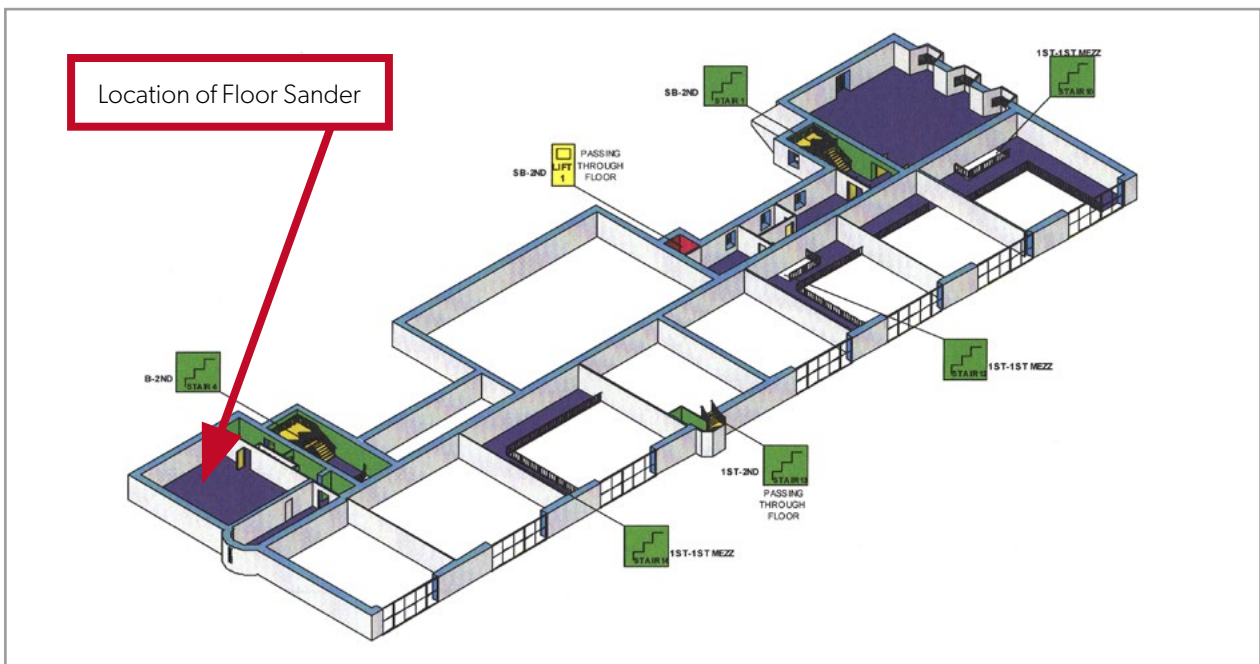
Figure 25 – Location of Floor Sander level 8, east side

3. Floor sanding was known to have taken place on the days leading up to the fire, at level 8 on the east side of the building at the location shown in Figure 25. Accidental ignition through chemical reaction inducing spontaneous combustion has been considered, as has electrical fault within the floor sander itself.
