SCOTTISH
FIRE AND RESCUE SERVICE

FIRE INVESTIGATION REPORT

Premises:	Mackintosh Building, 167 Renfrew Street, Glasgow				
Post Code:	G3 6PQ				
Occupier:	Glasgow School of Art				
Day of Call:	Friday	Date of Call:	23/05/14	Time of Call:	12:27
Incident No:	21735141	No. of Calls:	37	Grid Reference:	258133, 666052
Appliances first Mobilised	T01A1 Rescue Pump (RP) (Cowcaddens), T01A2 (RP) (Cowcaddens), T04A1 (RP) (Yorkhill)				
Incident Commander (First Attendance):	Watch Commander Stockton				
Other Appliances attending:	T02D1 Arial Rescue Pump (ARP) T02A2 (RP) (Maryhill), M04A1 Support Pump (Milngavie), M04L1 Forward Control Unit (FCU) (Milngavie), V05A2 (RP) (Calton), VO4D1 (ARP) V04A2 (RP) (Polmadie), V01A1 (RP) (Govan), V04A2 (RP) (Polmadie), V05A1 (RP) (Calton), M01K1 Major Incident Unit (MIU) (Clydebank), T02D1 (ARP) (Maryhill), T06D1 (ARP) (Springburn), 554 Fire Investigation Unit (FIU) (Livingston)				
Incident Commander (Overall):	Assistant Chief Officer Goodhew.

FI-WH-GC-006-14 – 21735141 - MACKINTOSH BUILDING, 167 RENFREW STREET, GLASGOW, G3 6PQ (REDACTED)

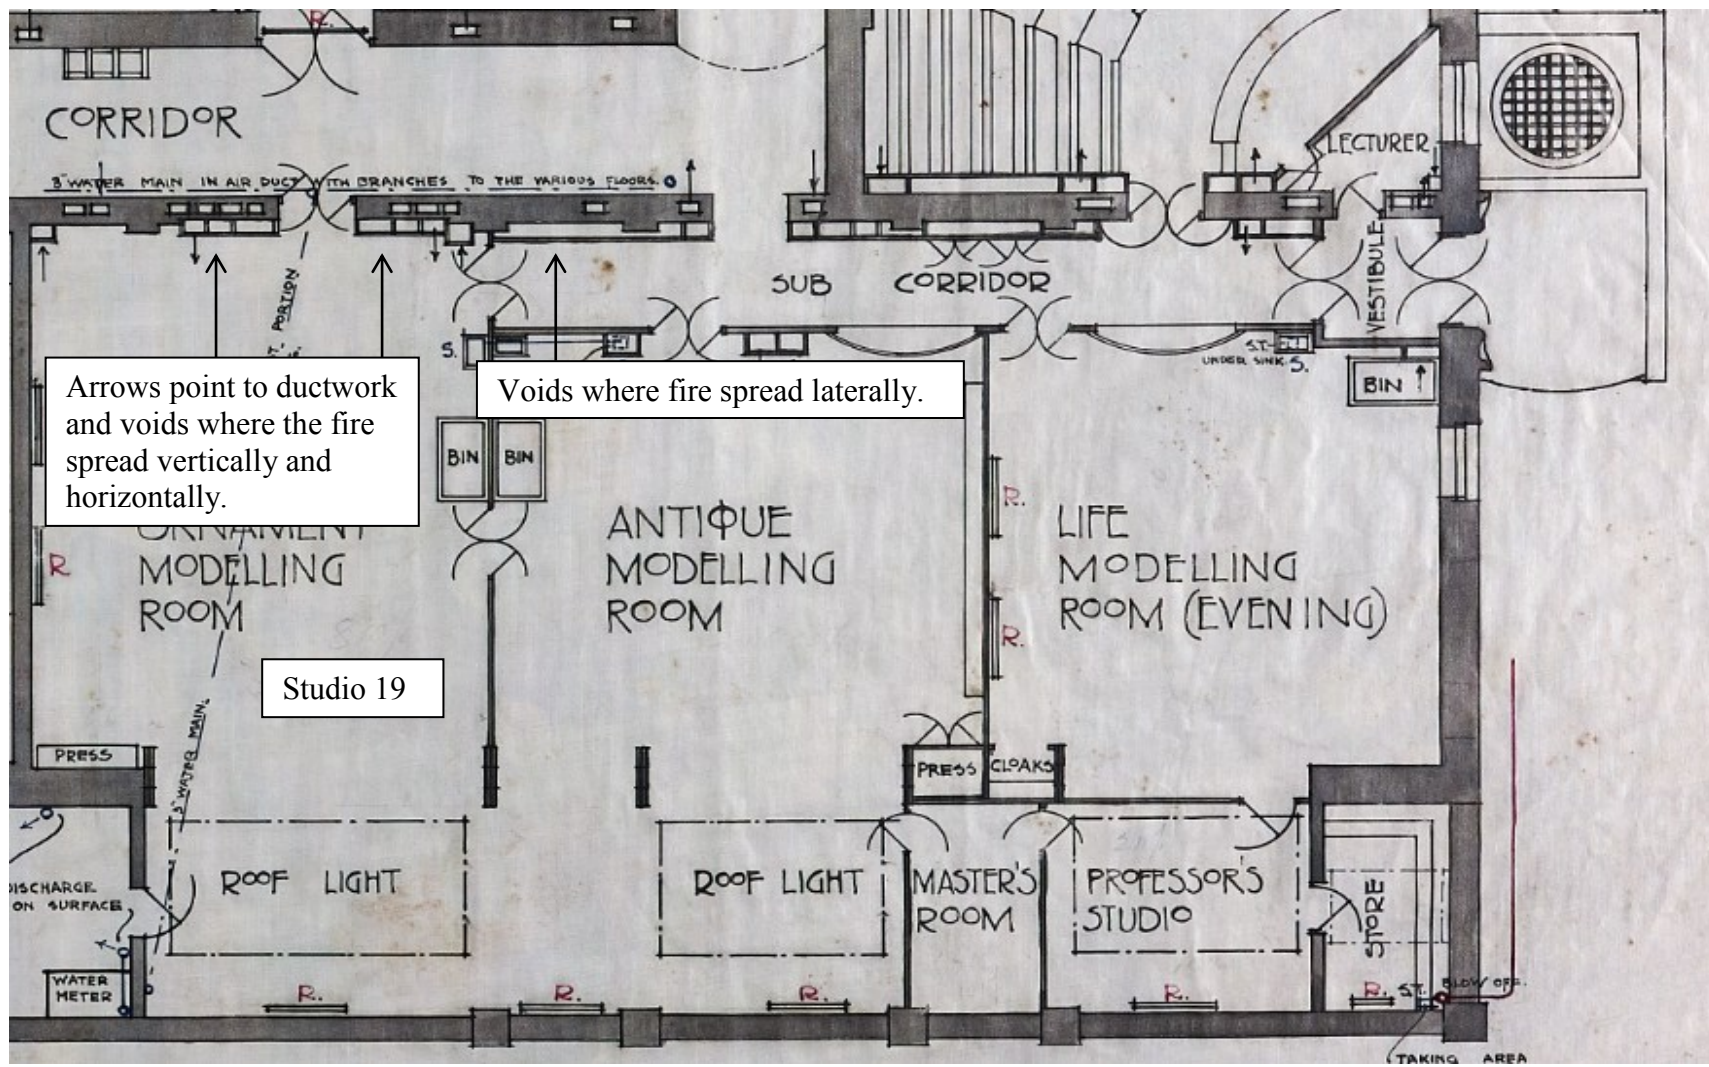
DRAWING NUMBER 1.

A major contributory factor for the fire spreading throughout the building was the number of timber lined voids and obsolete ventilation ducts running both vertically and horizontally throughout the building. The vertical ventilation ducts consisted of both brick lined, located within the walls and timber ducts mounted on the wall surface. The brick lined ducts were formed within the structure of the walls. Horizontal ducts were timber and in some instances sheet metal. See plan drawing Numbers 1, 2 and 3 showing architect plans.

1910 ARCHITECT DRAWING OF BASEMENT SHOWING HEATING AND VENTILATING DUCTWORK.

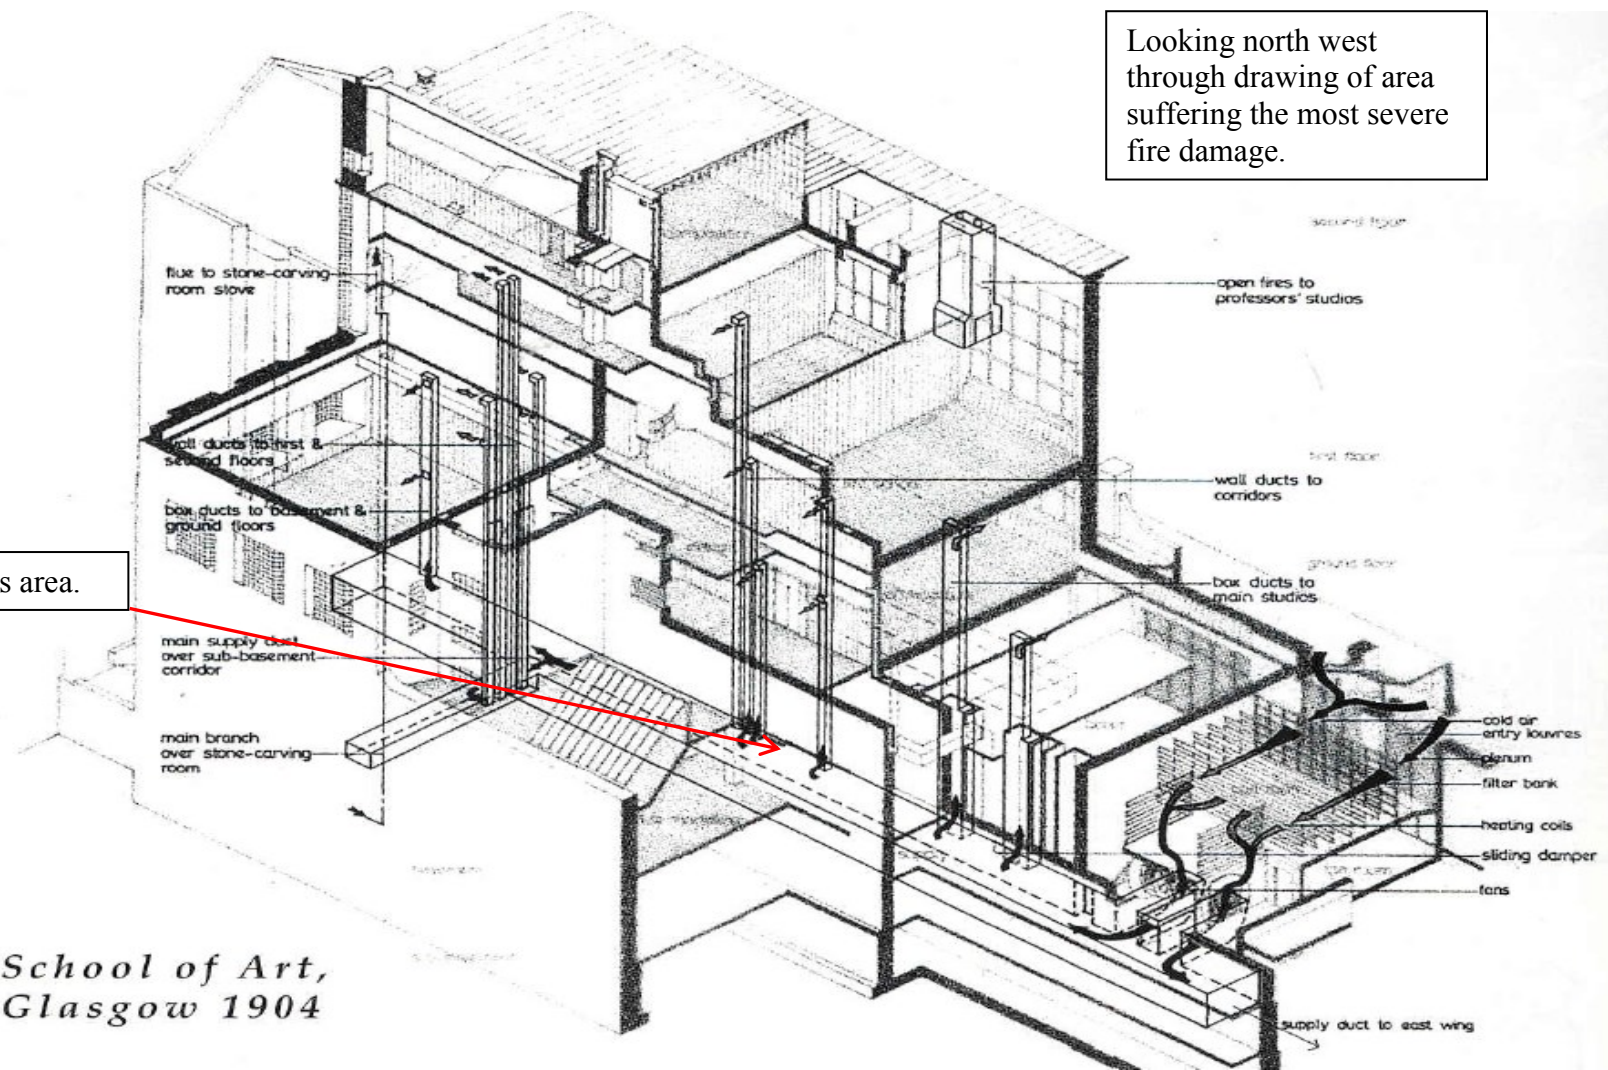
DRAWING NUMBER 3

Looking north west through drawing of area suffering the most severe fire damage.

Fire originated in this area.

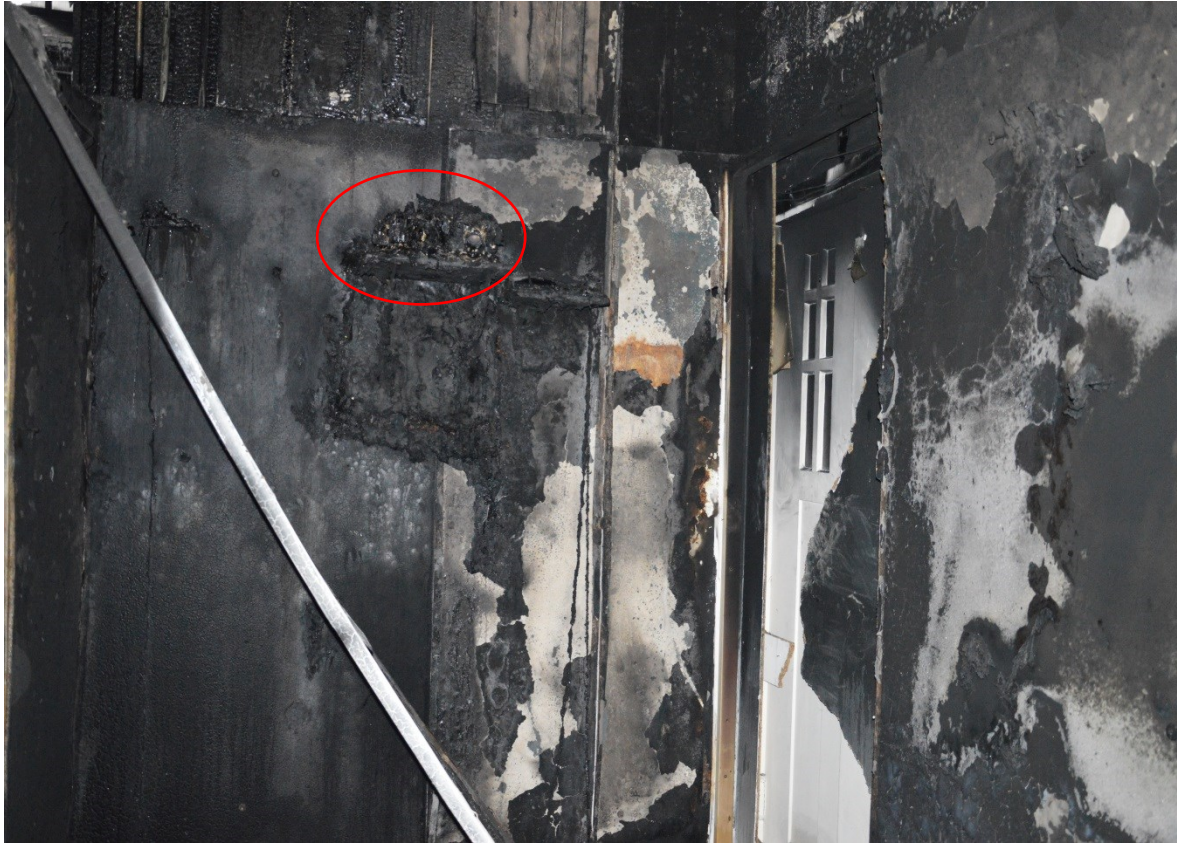
The fire originated in the vicinity of the projector which was located in the student display area of studio 19 which was in the basement in the west side of the building. **See photos 4, 5, 6 and 7.**

As the fire grew in size flames impinged onto the expanded foam panels positioned behind the projector. These foam panels were installed as part of the students work and were attached to the walls in the display area. Fire would have spread laterally around the foam lined room as well as vertically towards ceiling level. Flames would have travelled up the wall directly behind where the projector was positioned.

Photo 4. Within studio 19, the student display area, south wall, projector circled

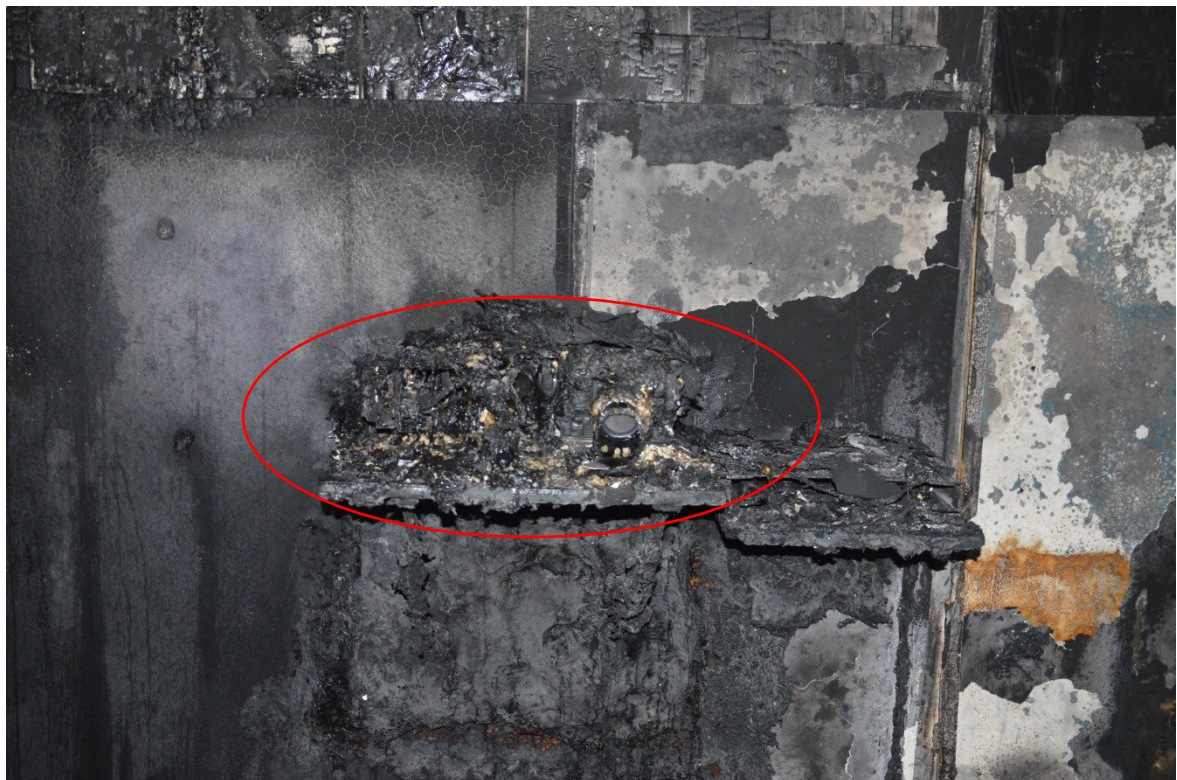
Due to the level of destruction of the projector, it's not possible to state for certain exactly what caused the flammable gases to ignite. Consideration was given to the hot bulb cracking and either the filament within igniting the gases or the electric spark created by the filament breaking would be a sufficient ignition source but the bulb is unlikely to fracture just because cooler flammable gases are passing over it.

Therefore, indirect ignition from an electrical spark is the most likely cause for the flammable gases igniting.

In conclusion, this fire originated within the projector and was caused by flammable gases used as a propellant in the expanding foam canister being drawn into the projector and igniting, most probably by energised electrical components.

Photo 5. Close up view of remain of projector.

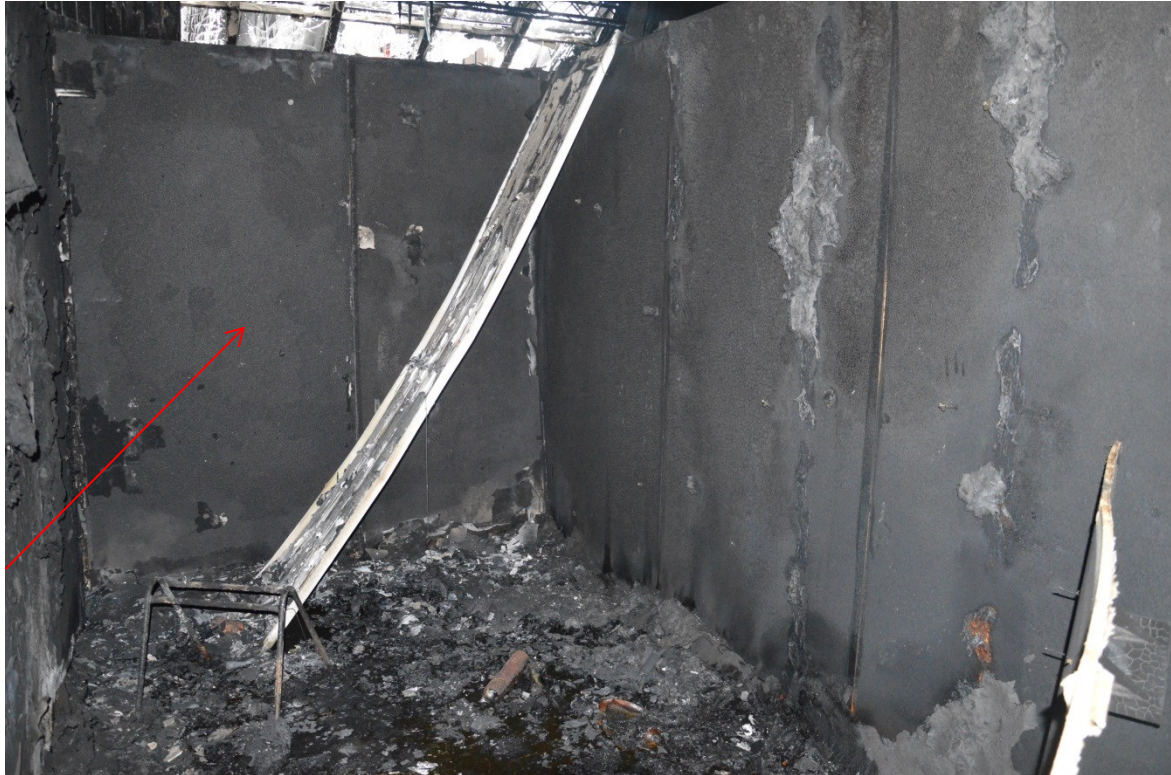
Photo 6. North wall of student display area. Projected image appeared on this wall.

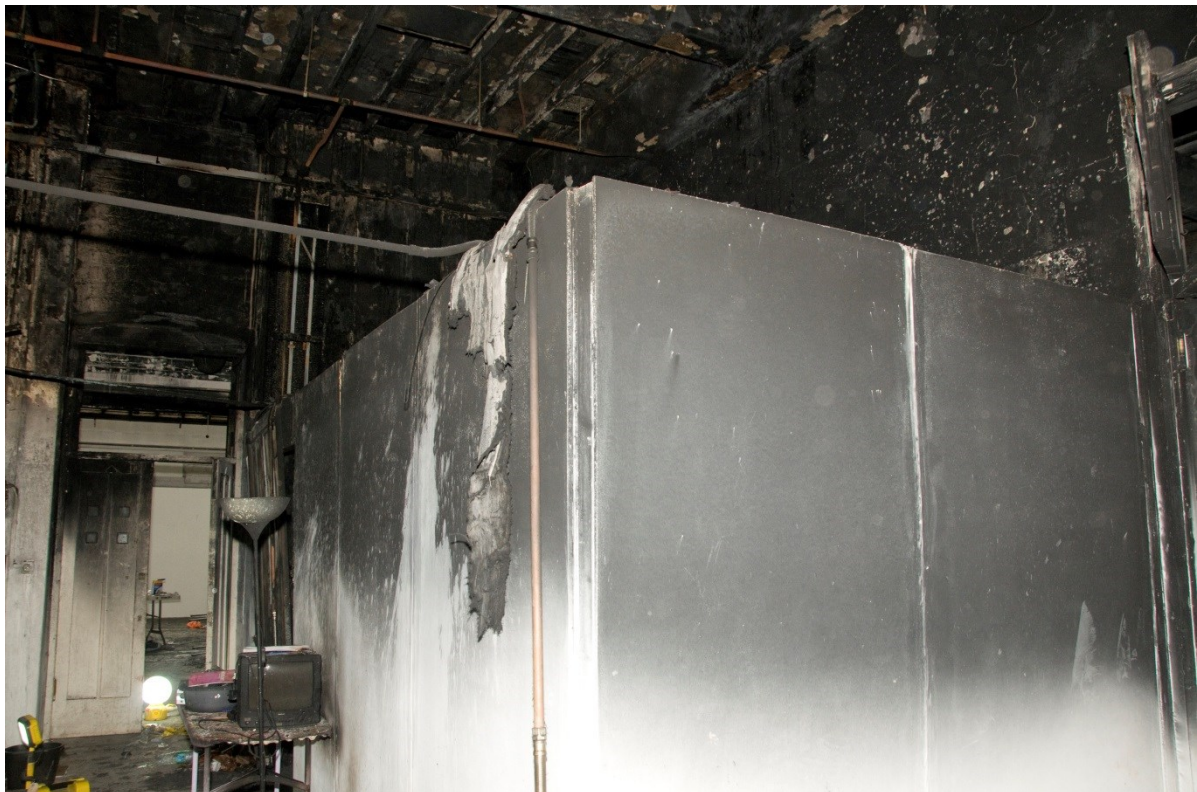
Photo 7. External image of student display area. Looking south.

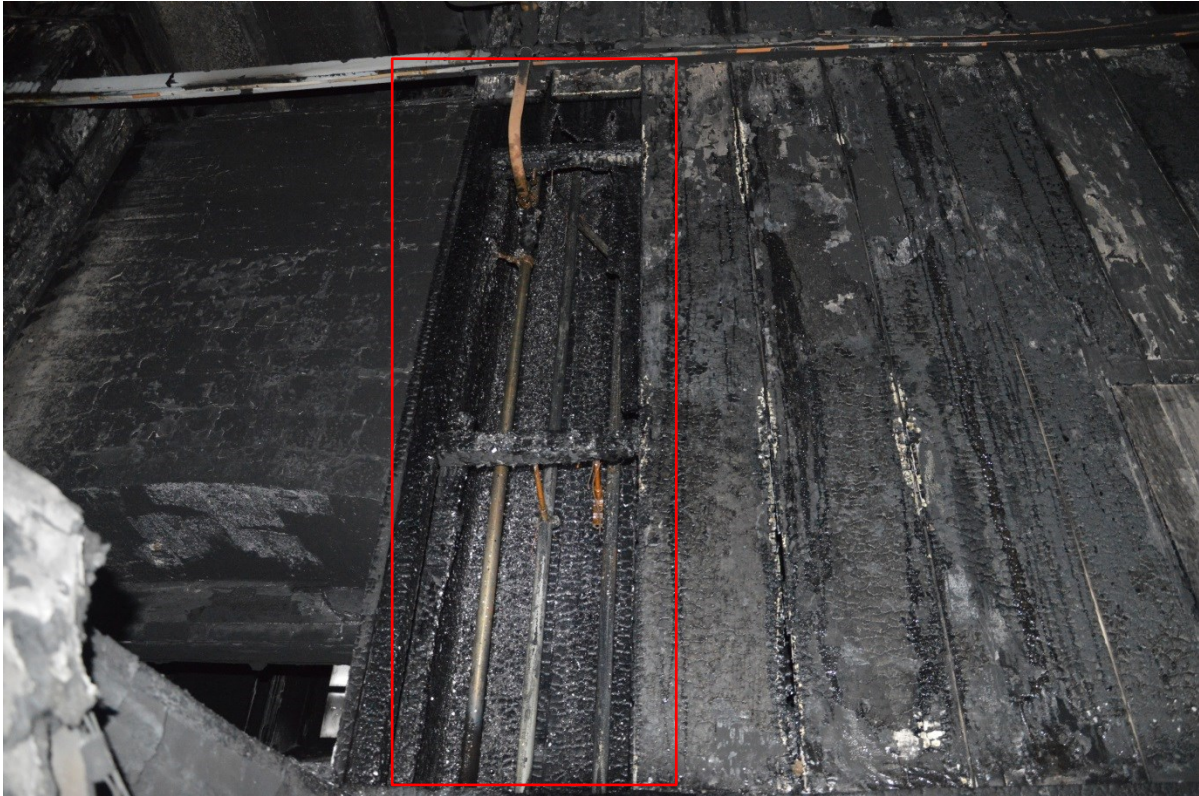
This wall area was lined with timber panels – Canadian redwood pine, which formed the outer covering of a vertical service void. An area slightly to the left of the projector had some panels removed allowing access for ongoing maintenance **See photo 8.** This void ran the entire height of the building to roof level. **See photo 9.** This timber lined void acted like a chimney and allowed flames, hot gases and smoke to travel vertically.

Photo 8. Area above and slightly to left of where projector was located. Note missing void panels highlighted within red rectangle

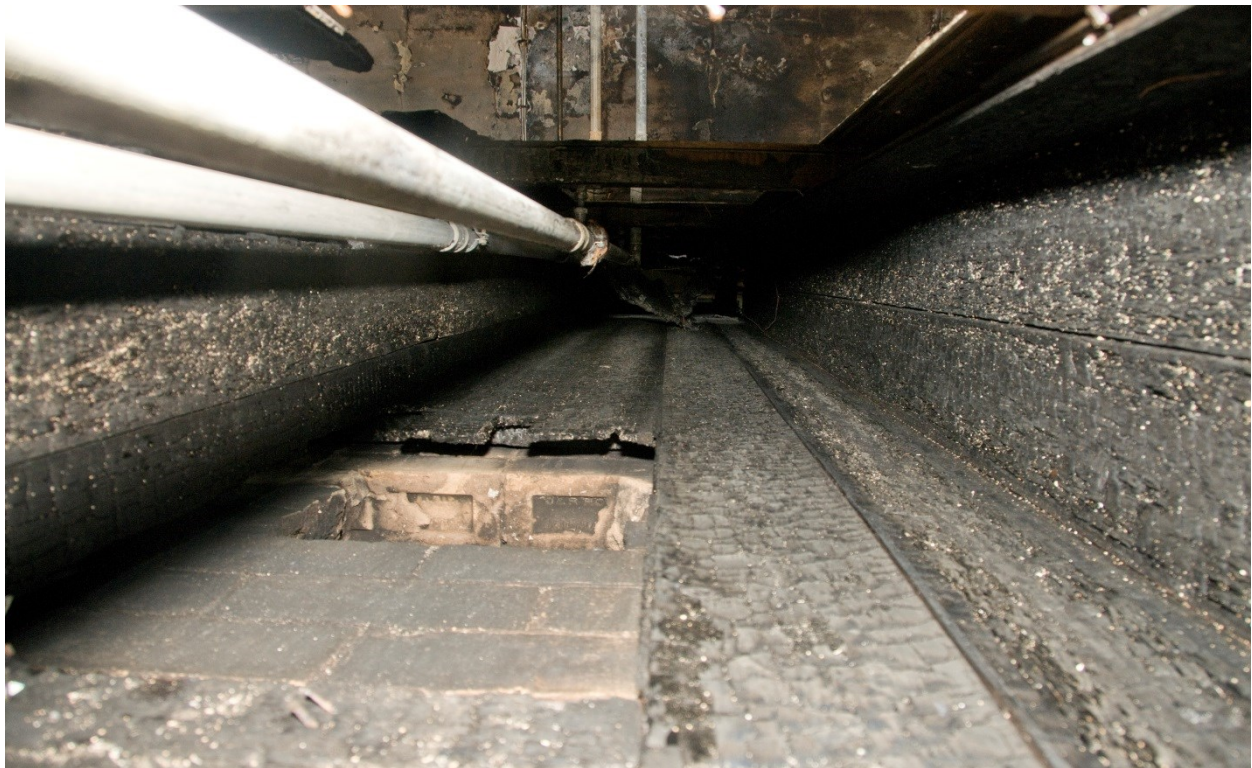
Photo 9. Void running from basement studio 19 to roof

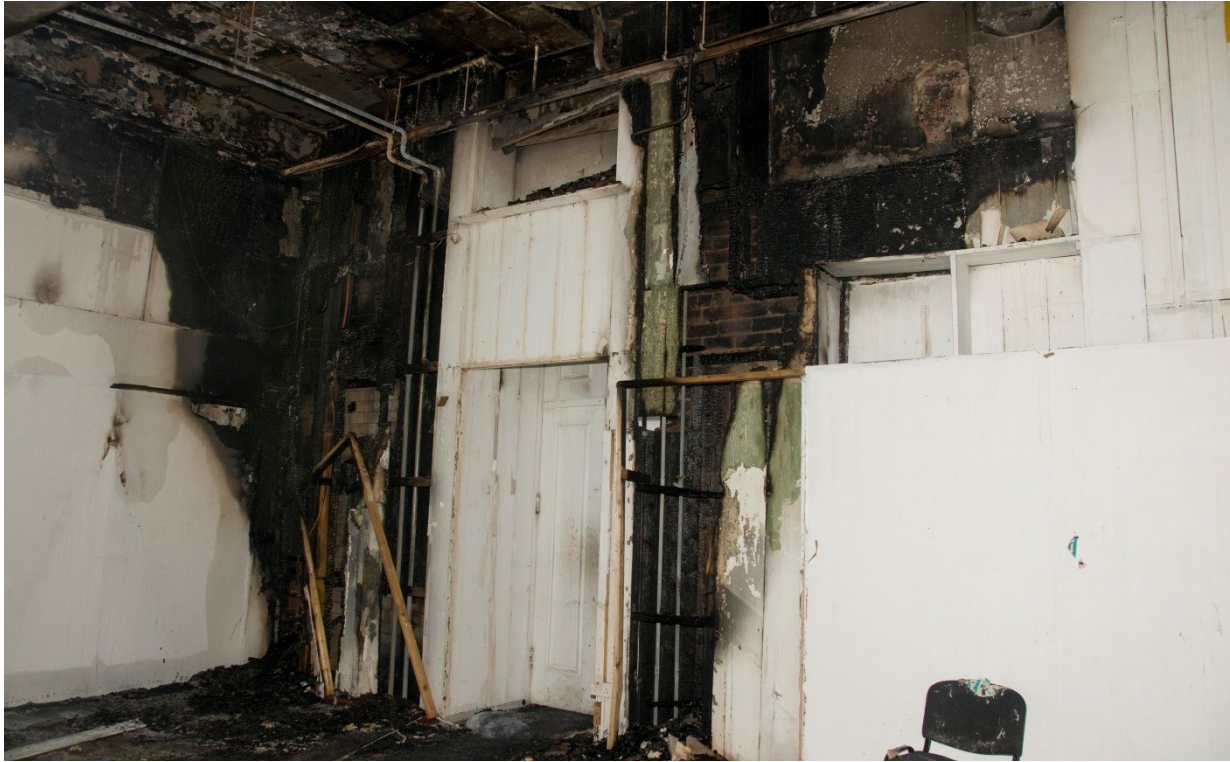
Flames then travelled through these voids in to studio 31 on the ground floor, directly above studio 19. Fire spread vertically either side of the doorway and also horizontally behind the timber panelling in a westerly direction in studio 31. **See photos 10, 11 and 12.** At least four voids run vertically through studio 31 and these allowed unchecked fire spread to areas above as well as on the same level.

Photo 10. Studio 31 Ground floor. Fire spread vertically via voids either side of door. Note V pattern. Less damage in this area as fire spread to floor above at wall/ceiling junction.

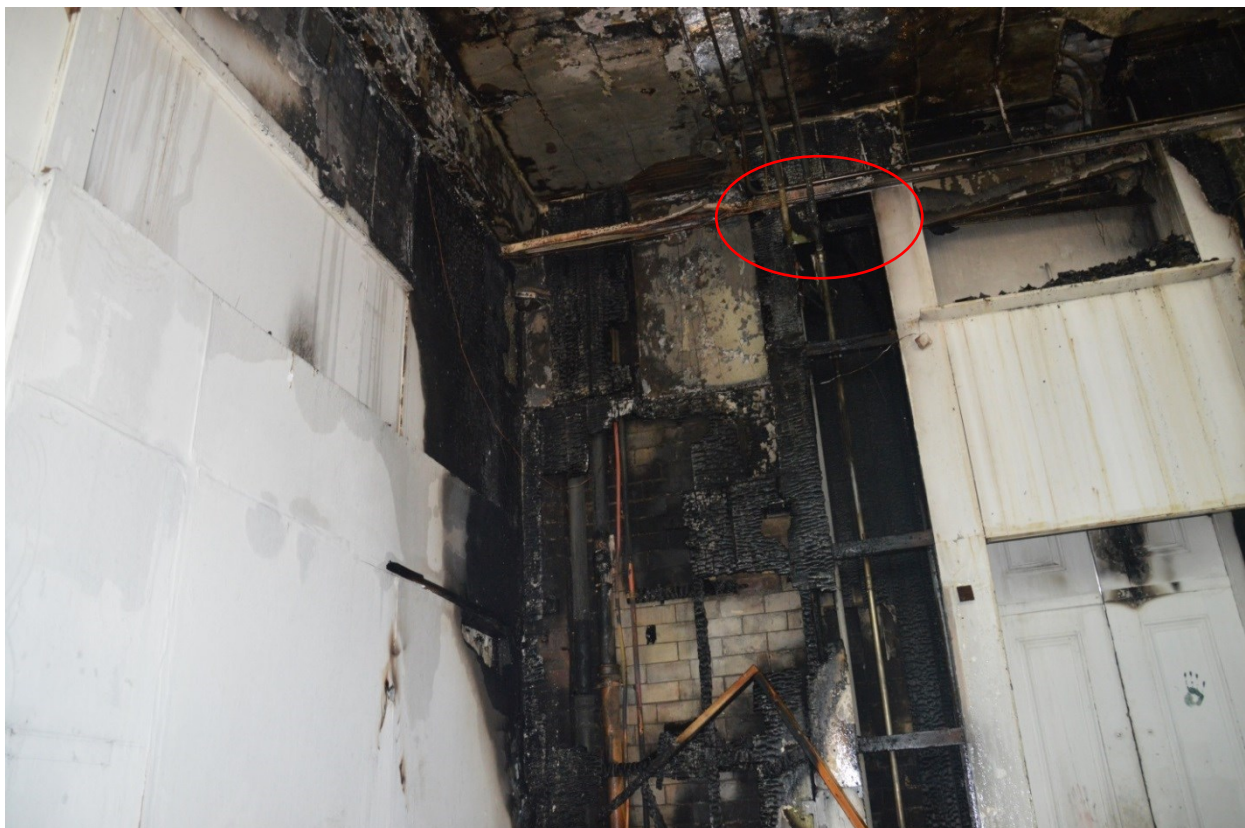
Photo 11. Studio 31 Ground floor. To left of door, fire spread to first floor via void area circled.

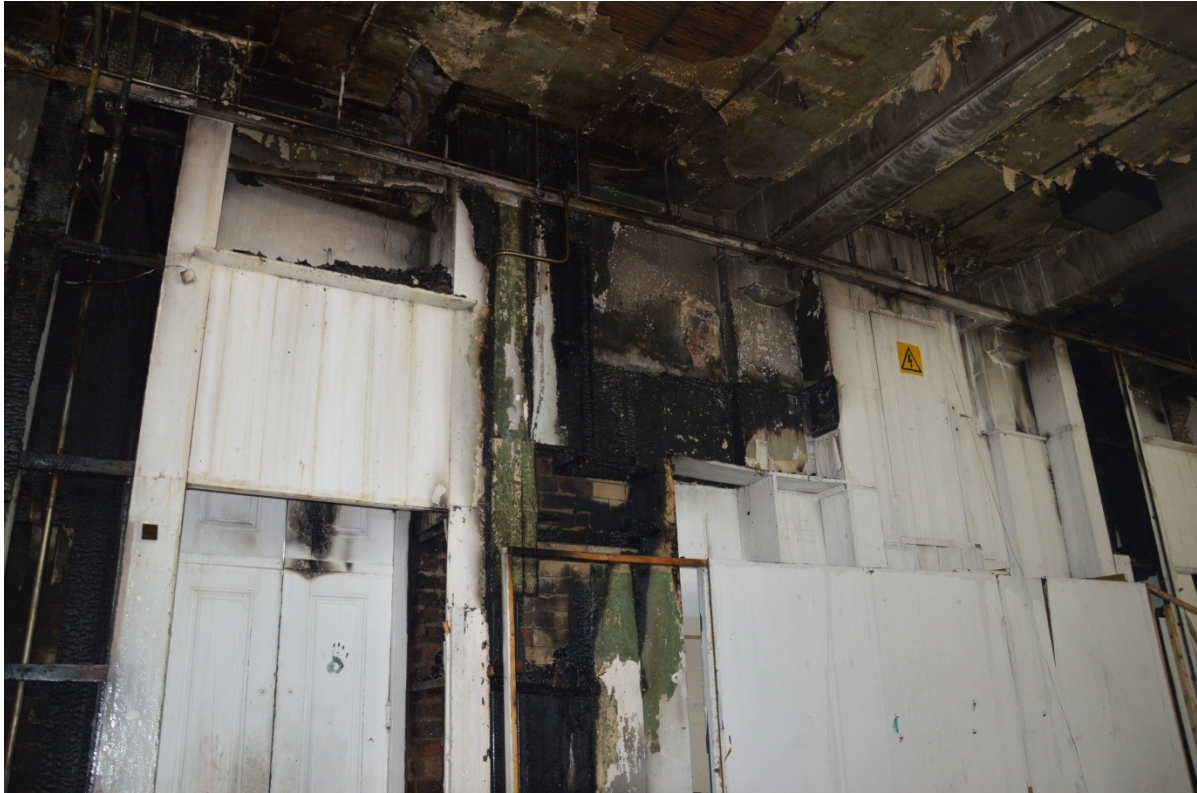
Photo 12. Studio 31 Ground floor. To right of door fire spread up vertical void

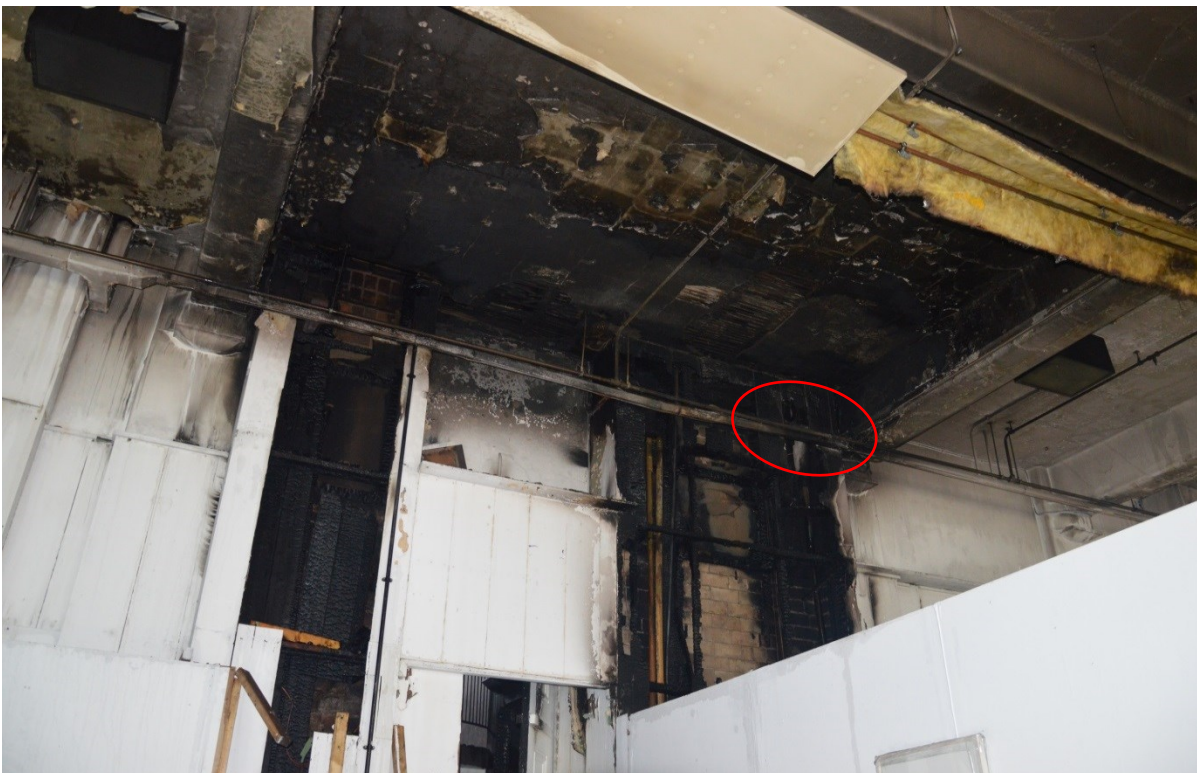
One of these voids allowed lateral access to studio 32 at ceiling level. **See photo 13.**

Photo 13. Ground floor studio 31 west side. Fire spread up each vertical void. Suspect fire spread to these voids horizontally from the left. Circled area horizontal void leads to studio 32.

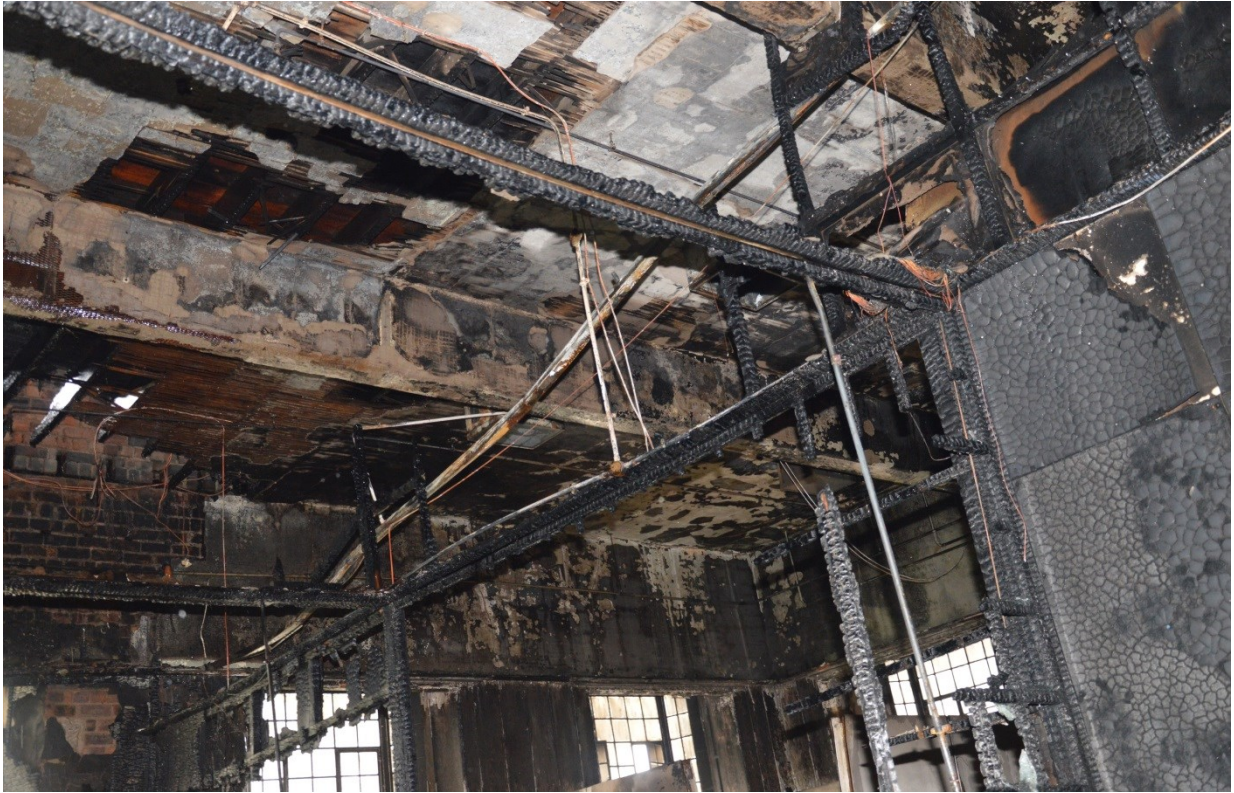
From studio 32 fire spread through voids to the Mackintosh library above. **See photo 14.**

Photo 14. Ground Floor Studio 32 looking south west.

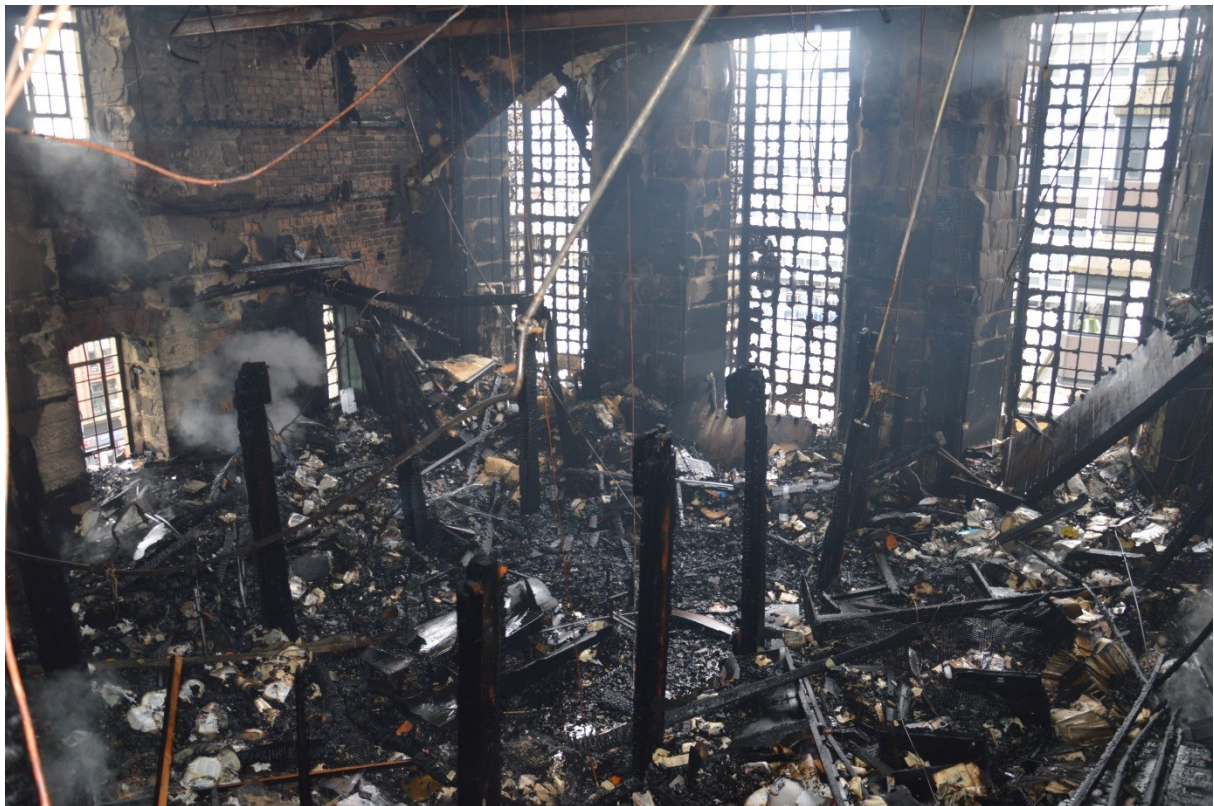
The construction, layout, and high fire loading which included timber furniture, panelling and books meant the room contents became totally involved in fire. **See photo 15.** From the library fire spread vertically via voids to the library storage space above and then into studio 58 via these same voids. **See photo 16.**

Photo 15. First floor Mackintosh Library, looking south west.

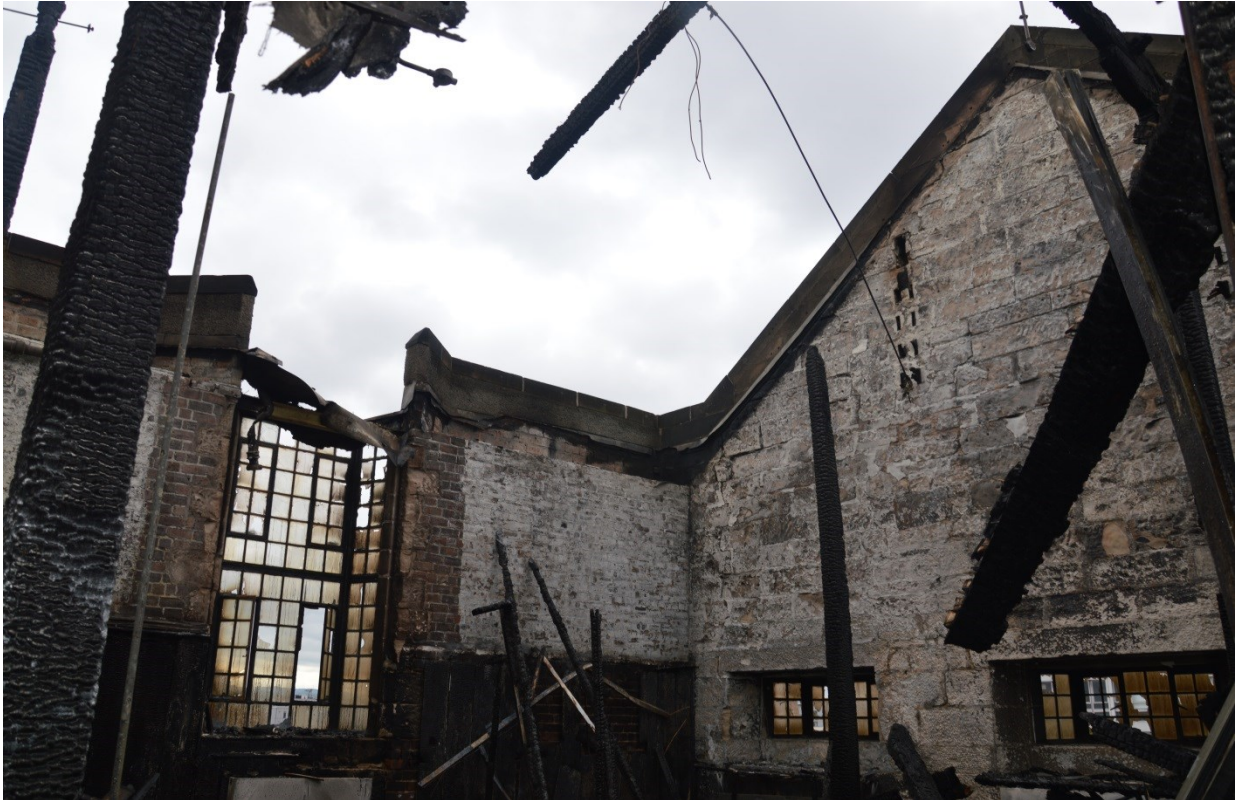
Photo 16. 2nd floor Studio 58 looking south

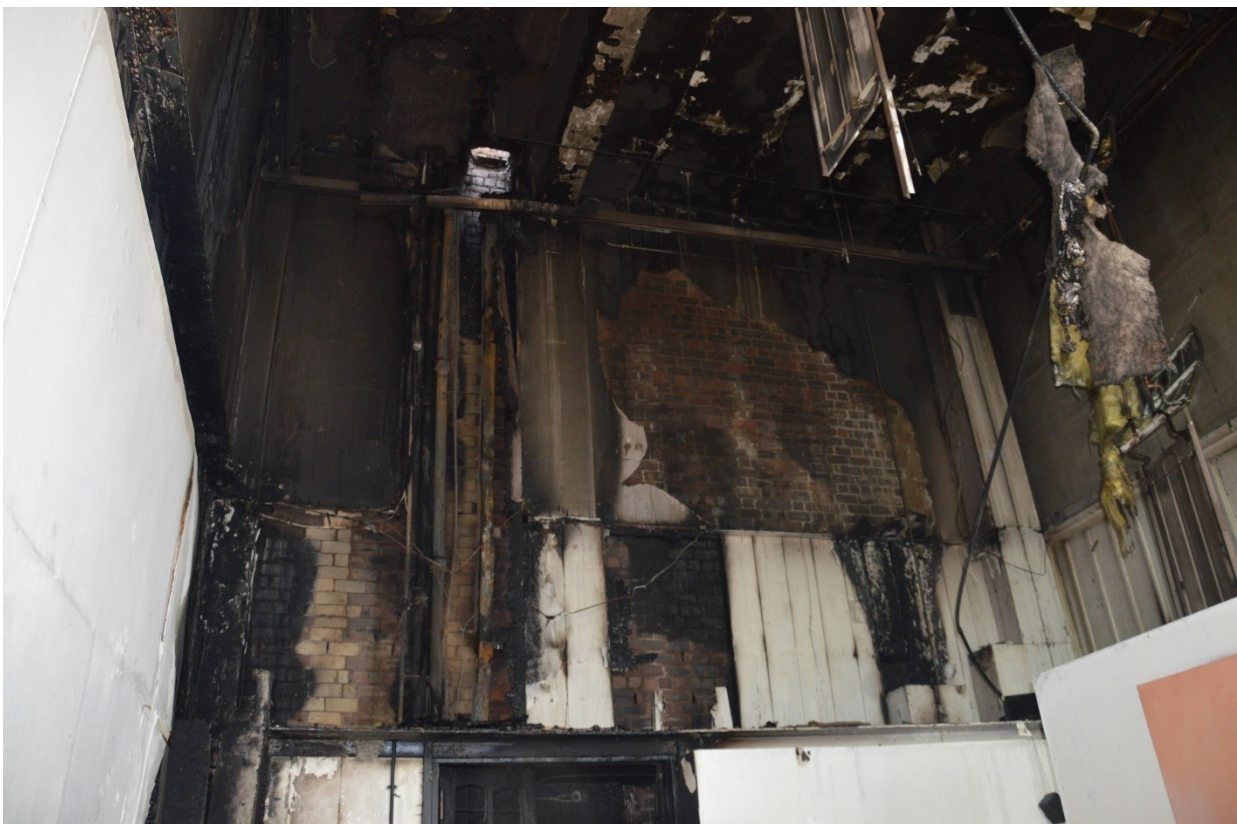
Returning to the ground floor within studio 31, fire then spread via all four vertical voids to the first floor studios above, 43, 44 and 45. It achieved this by breaking through timber panelling which covered the voids, allowing access into the corridor outside the studios. An example of fire spread via the voids in studio 44 on the first floor to the second floor above is shown in **photo 17.**

Photo 17. First floor studio 44. Looking south, fire spread up vertical voids to 2nd floor

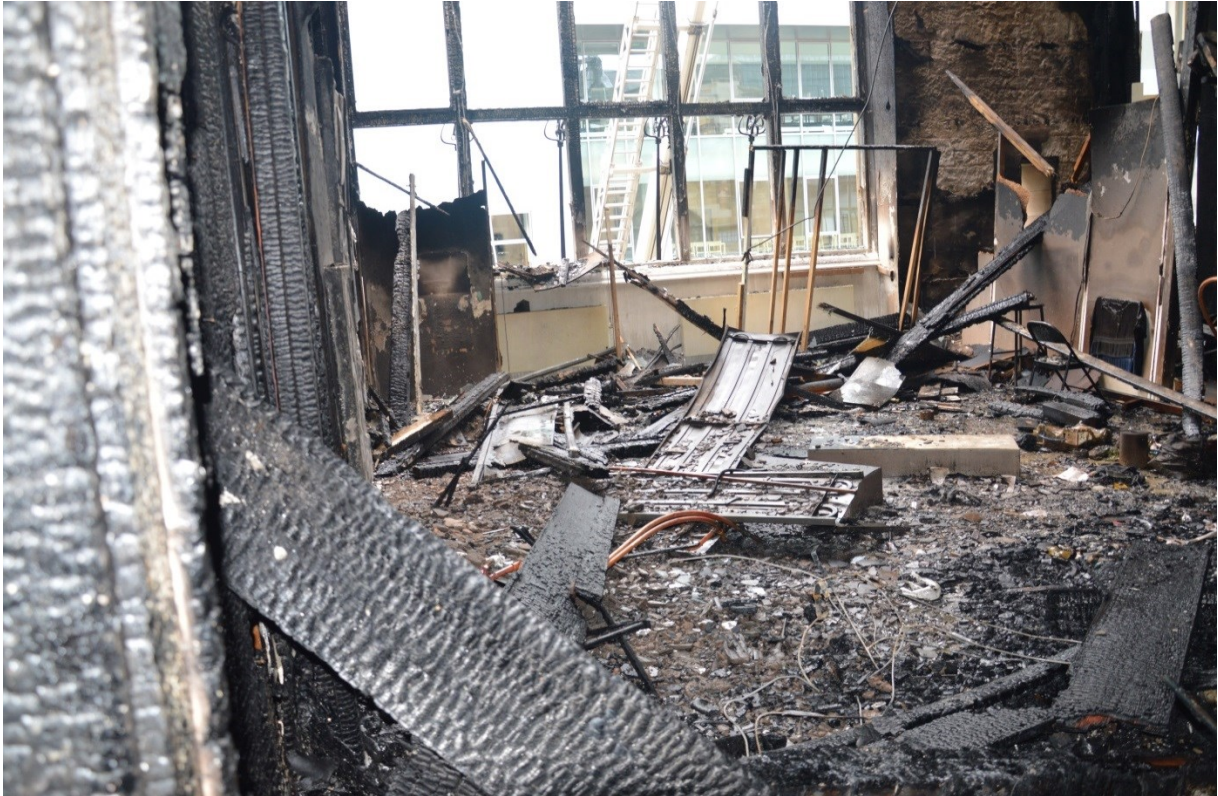
Flames then travelled up the walls to ceiling level, traversed across the ceiling and exited at window level. The inrush of oxygen via the broken windows intensified the fire. **See photo 18.**

Photo 18. First floor studio 45, looking north onto Renfrew Street

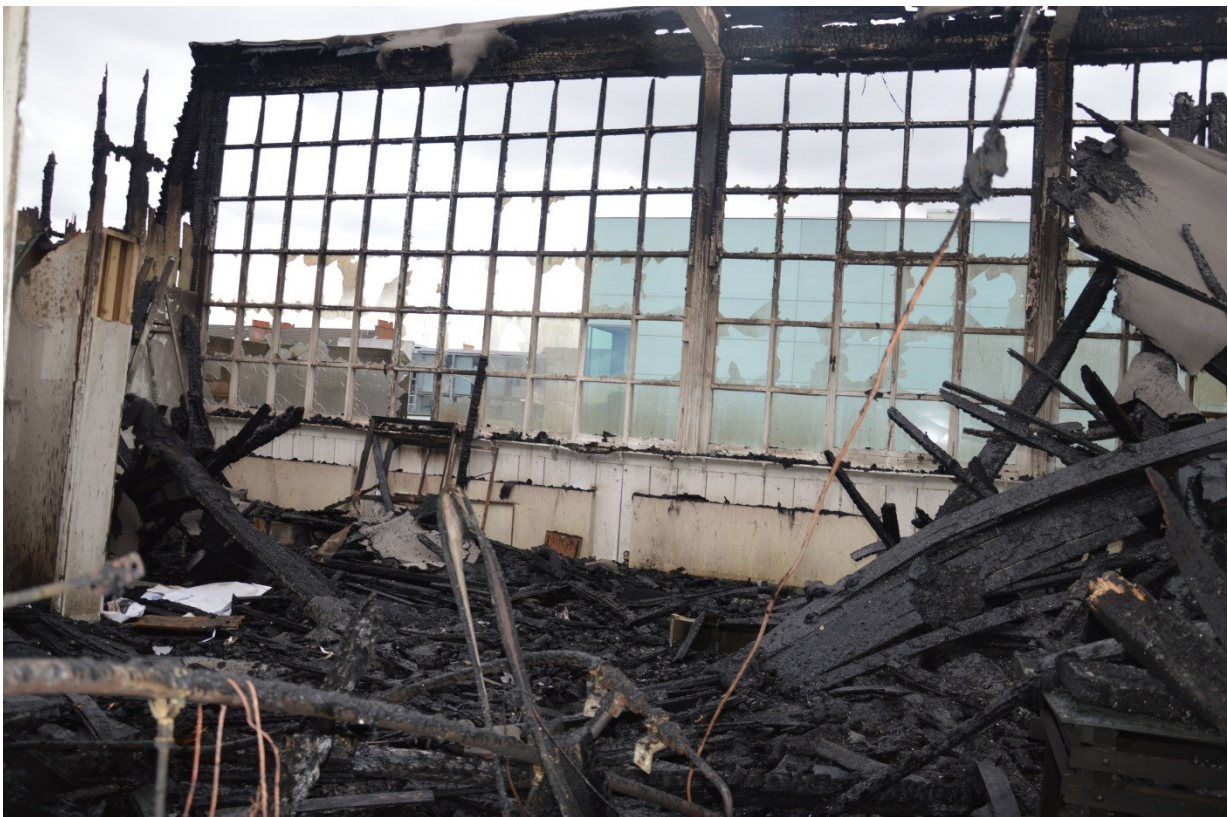
On the second floor fire spread laterally from the professor studios to studio 57 **see photo 19.** From here, fire also spread into studio 58. In effect, studio 58 was being attacked on two fronts by fire spread from below and from the same floor.

Photo 19. 2nd floor Studio 57 looking north

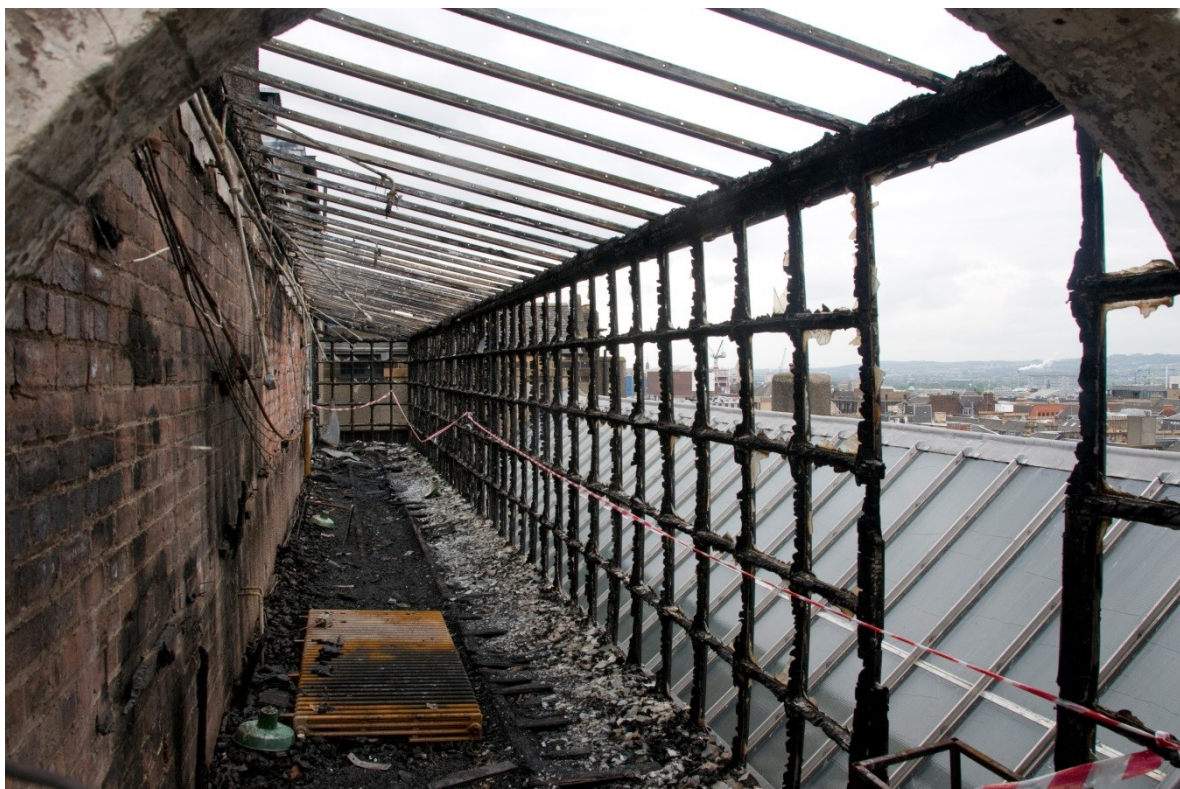
Photo 20 shows the area known as the Hen Run, fire spread to this area from the professor studios which were located on the other side of the wall on the left of the image.

Photo 20. 2nd floor Hen run south elevation, looking east.

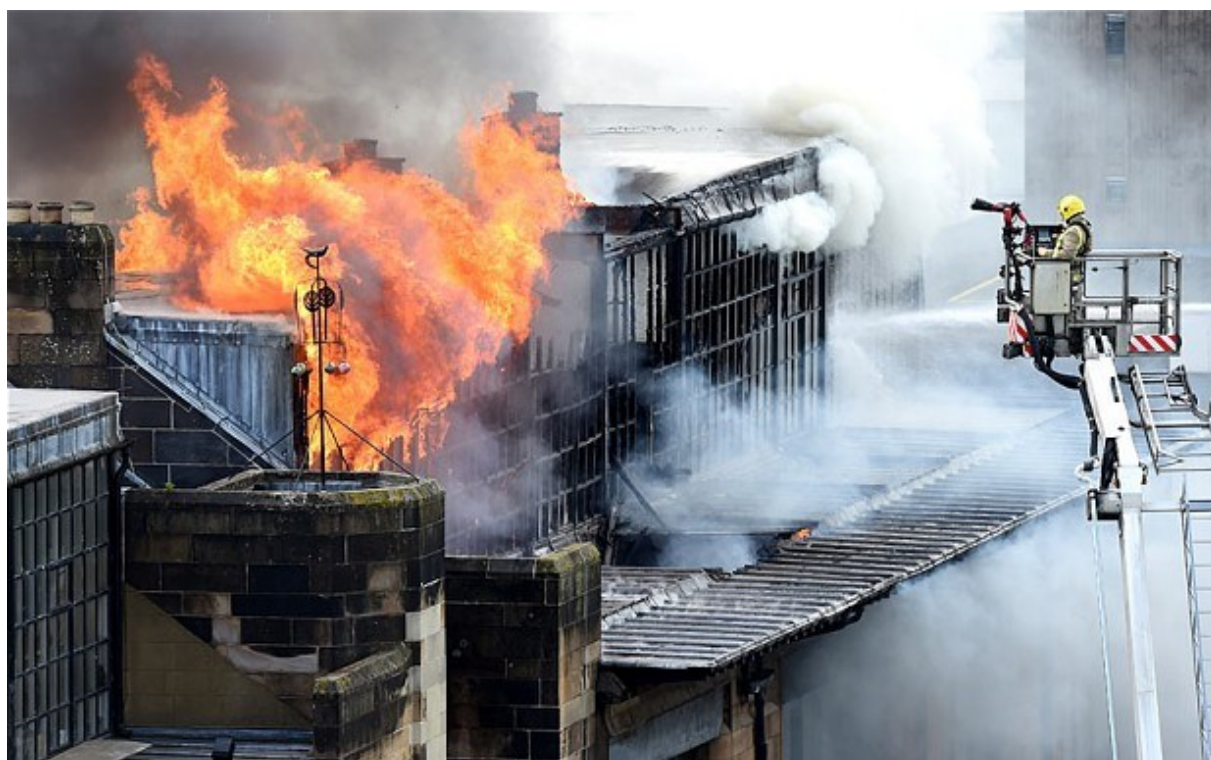
The studios on the north side of the building overlooking Renfrew Street were constructed of timber, glass and lead lined roofs. Once these failed the inrush of oxygen intensified the fire affecting the second floor. **See photos 21 and 22.**

Photo 21. Professor Studios on 2nd floor north elevation totally involved in fire. Image courtesy of Craig Watson SNS Group.
