SCOTTISH
FIRE AND RESCUE SERVICE

FIRE INVESTIGATION REPORT

Premises:	Mackintosh Building, 167 Renfrew Street, Glasgow				
Post Code:	G3 6PQ				
Occupier:	Glasgow School of Art				
Day of Call:	Friday	Date of Call:	23/05/14	Time of Call:	12:27
Incident No:	21735141	No. of Calls:	37	Grid Reference:	258133, 666052
Appliances first Mobilised	T01A1 Rescue Pump (RP) (Cowcaddens), T01A2 (RP) (Cowcaddens), T04A1 (RP) (Yorkhill)				
Incident Commander (First Attendance):	Watch Commander Stockton				
Other Appliances attending:	T02D1 Arial Rescue Pump (ARP) T02A2 (RP) (Maryhill), M04A1 Support Pump (Milngavie), M04L1 Forward Control Unit (FCU) (Milngavie), V05A2 (RP) (Calton), VO4D1 (ARP) V04A2 (RP) (Polmadie), V01A1 (RP) (Govan), V04A2 (RP) (Polmadie), V05A1 (RP) (Calton), M01K1 Major Incident Unit (MIU) (Clydebank), T02D1 (ARP) (Maryhill), T06D1 (ARP) (Springburn), 554 Fire Investigation Unit (FIU) (Livingston)				
Incident Commander (Overall):	Assistant Chief Officer Goodhew.

FI-WH-GC-006-14 – 21735141 - MACKINTOSH BUILDING, 167 RENFREW STREET, GLASGOW, G3 6PQ (REDACTED)

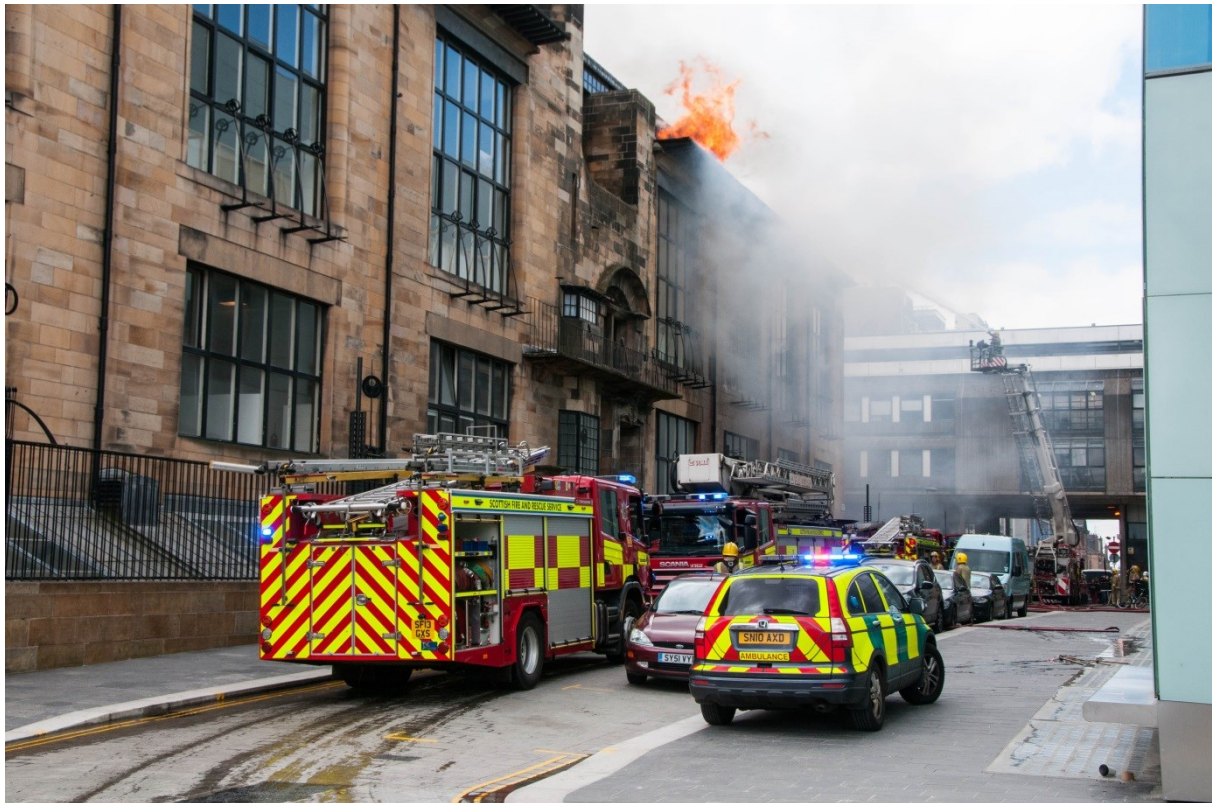
Photo 22. North elevation

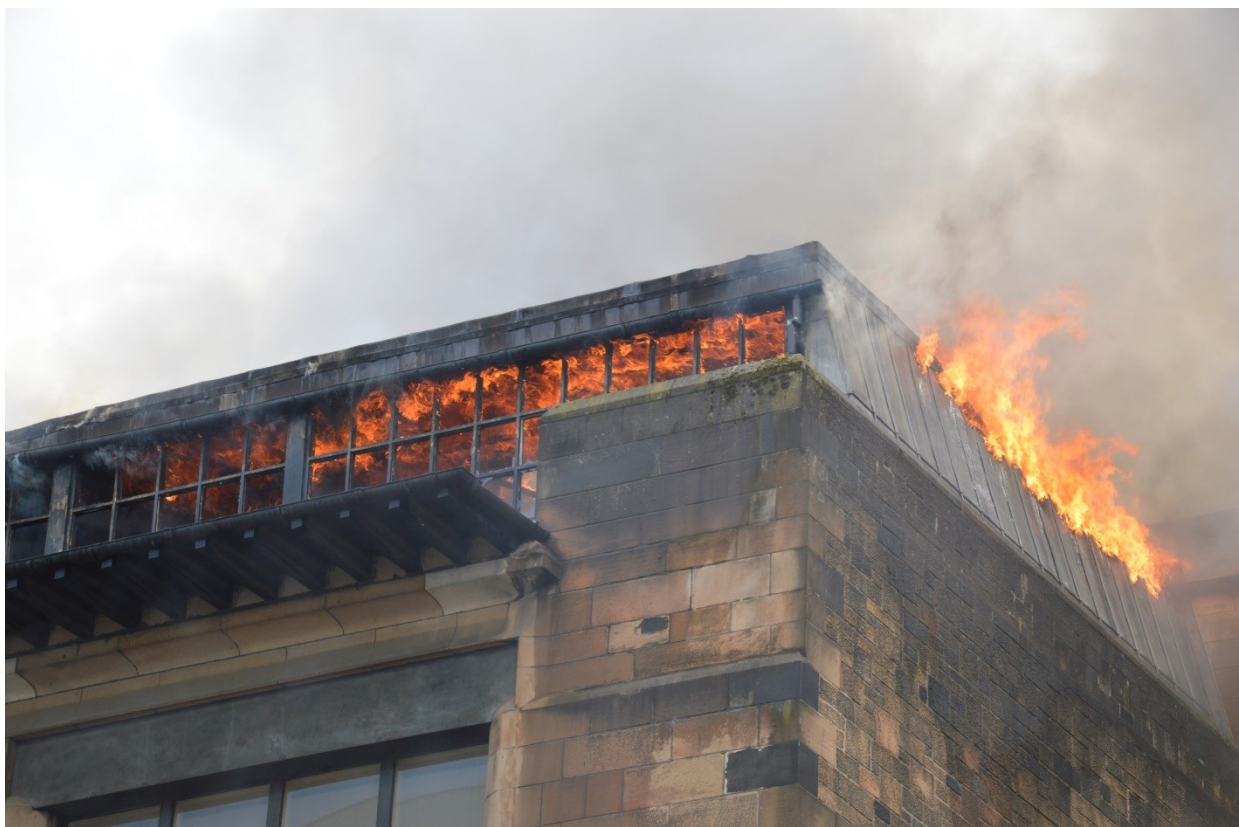
Photo 23 shows fire consuming studio 57 on the north east side of the building and **photo 24** shows firefighting operations on the north side of the building.

Photo 23. 2nd Floor north west elevation, studio 57

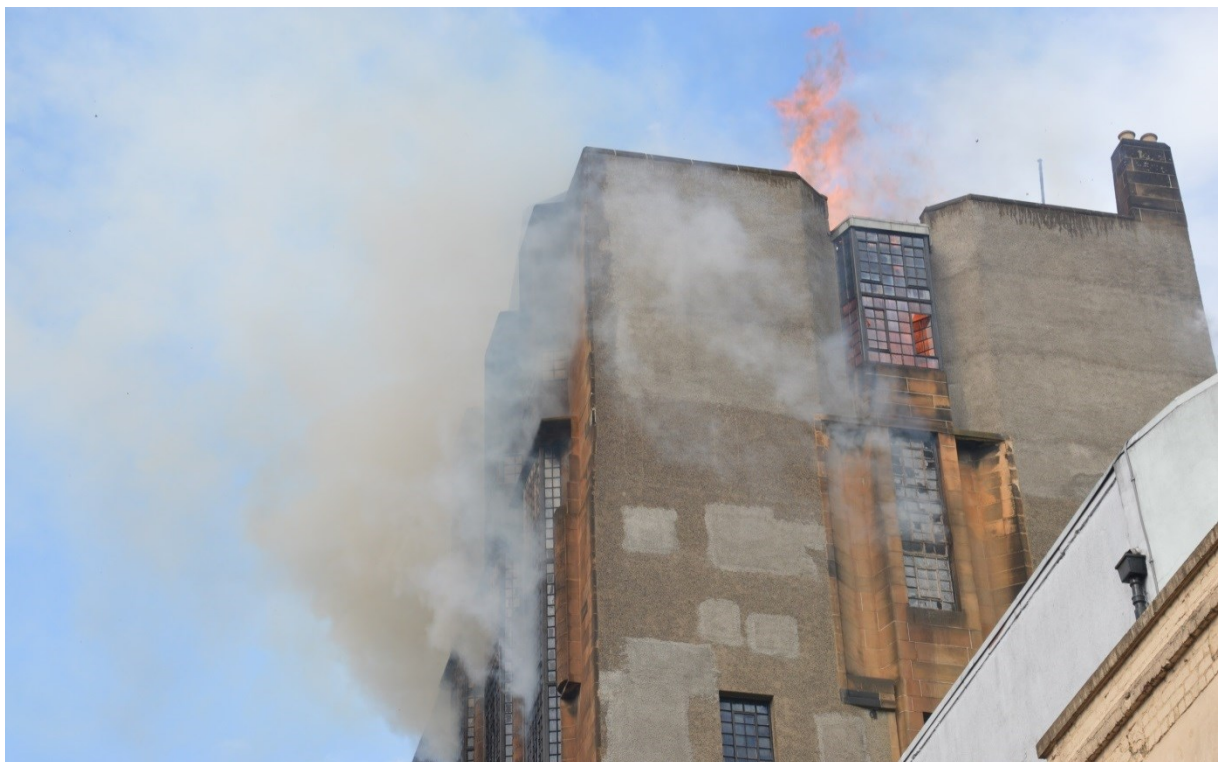
Fire spreading within the library and up to studio 58 south can be seen in **photo 25.**

Photo 25. South west corner of building. Library and studio 58 above.

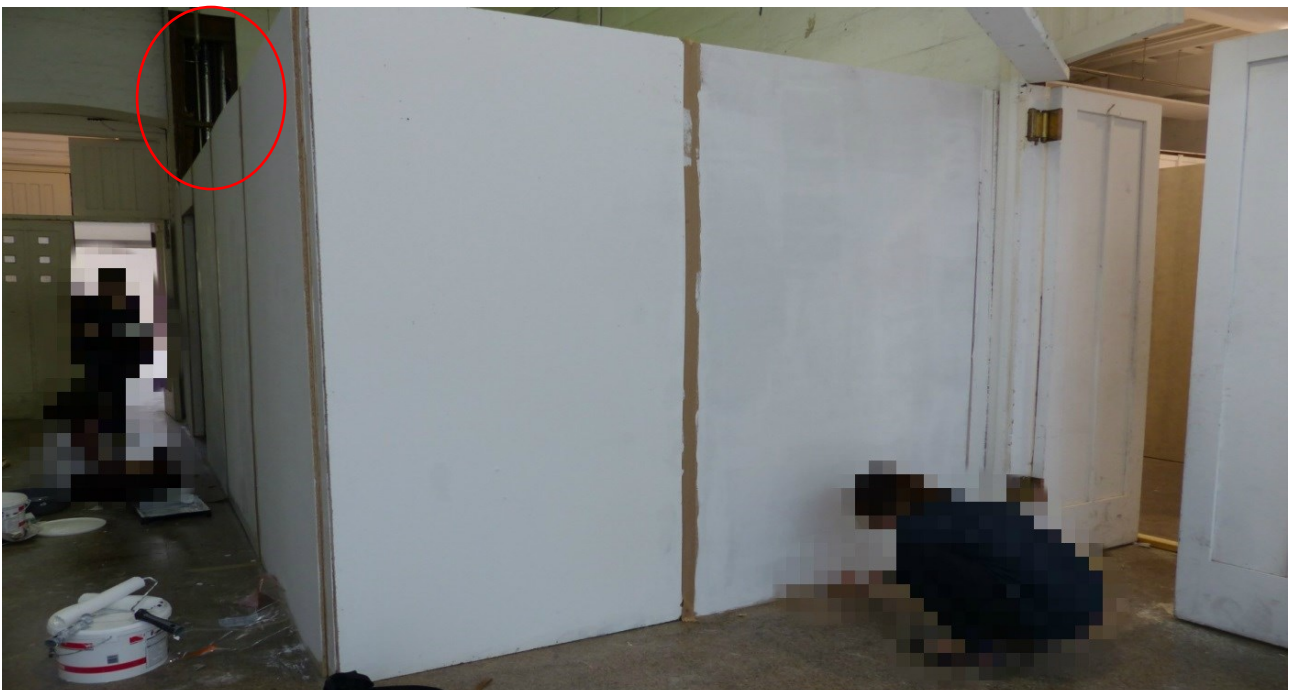
Photo 27. Exterior image of the student display area within studio 19. This was taken two to three days prior to the fire. Note the area circled is the pipe void with panels removed. Image courtesy of Police Scotland.
