SCOTTISH  
FIRE AND RESCUE SERVICE

# Fire Investigation Report

The Glasgow School of Art

15 June 2018

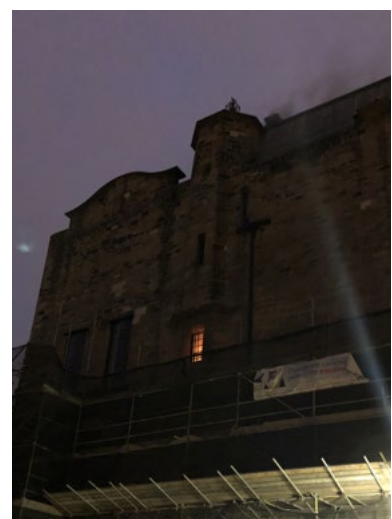
Figure 3 – Dalhousie Street east elevation

Around this timeframe (approximately 23:21hrs) a second member of the public, walking north up Dalhousie Street, observed a glow in a window aperture on the east elevation and took this photograph with a mobile telephone. In the photograph shown below in Figure 3, the glow of fire can be observed, as well as smoke issuing from the top of the building.

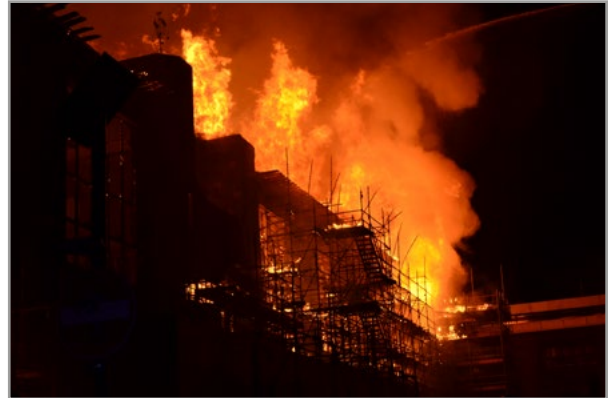
Figure 6 – Northwest corner

At 01:44hrs, DCO (**redacted**) assumed the role of IC. An “Informative” message was sent to JOC stating that PS were evacuating commercial properties on Sauchiehall Street and domestic properties on Dalhousie Street due to significant risk of collapse of the scaffolding enclosing the building and collapse of the Mackintosh Building itself (Figure 6 above).

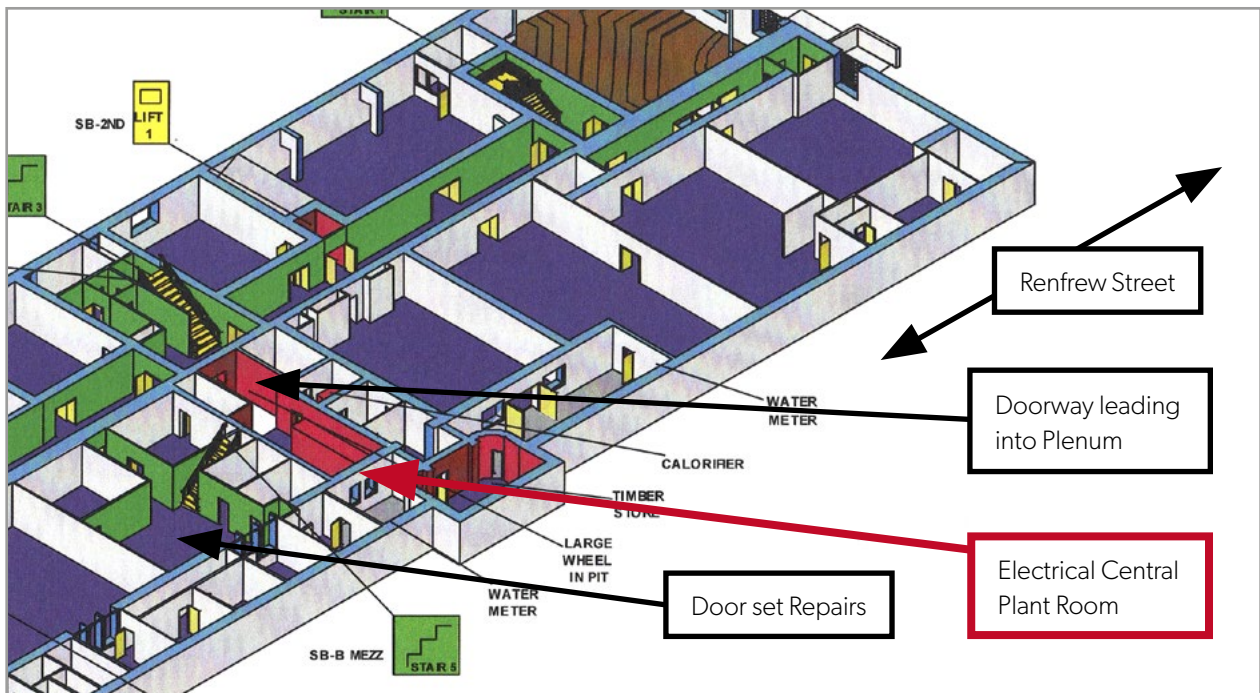
Figure 22 – Central plantroom level 2

The investigation considered seven theories that could support an electrical source as the cause of ignition.

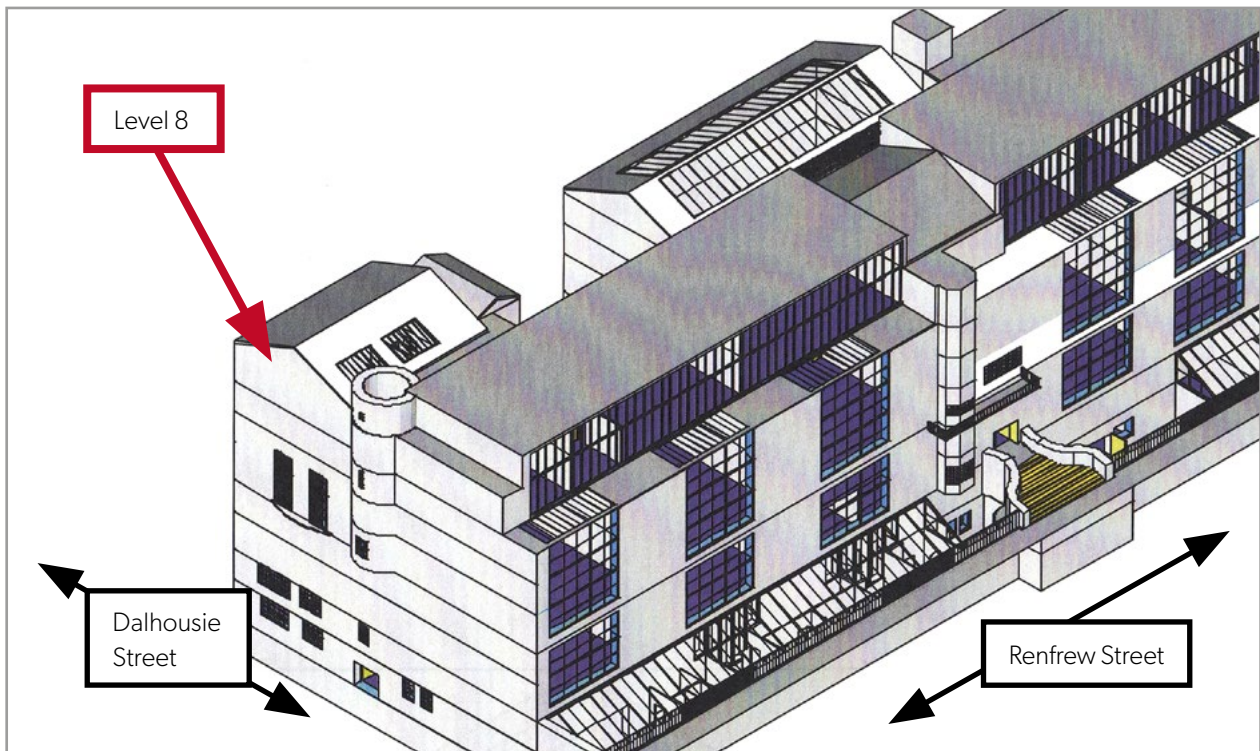
Figure 26 – Level 8, high level and prominent on the skyline from a southerly location

3. Floor sanding was known to have taken place on the days leading up to the fire, at level 8 on the east side of the building at the location shown in Figure 25. Accidental ignition through chemical reaction inducing spontaneous combustion has been considered, as has electrical fault within the floor sander itself.

The sander was located within the fire debris at level 2, but extensive damage prevented any detailed analysis. The surface finish of the floor being sanded and the resulting sanded material within the sander containment bag is unknown. If the sanded material within the sander collection bag came in to contact with a heat source (such as the sander motor) there may have been enough energy to ignite the material. Furthermore, a spark from a floor nail entering the bag during operation could have sustained a slow smouldering fire within.
