SCOTTISH
FIRE AND RESCUE SERVICE

FIRE INVESTIGATION REPORT

Premises:	Mackintosh Building, 167 Renfrew Street, Glasgow				
Post Code:	G3 6PQ				
Occupier:	Glasgow School of Art				
Day of Call:	Friday	Date of Call:	23/05/14	Time of Call:	12:27
Incident No:	21735141	No. of Calls:	37	Grid Reference:	258133, 666052
Appliances first Mobilised	T01A1 Rescue Pump (RP) (Cowcaddens), T01A2 (RP) (Cowcaddens), T04A1 (RP) (Yorkhill)				
Incident Commander (First Attendance):	Watch Commander Stockton				
Other Appliances attending:	T02D1 Arial Rescue Pump (ARP) T02A2 (RP) (Maryhill), M04A1 Support Pump (Milngavie), M04L1 Forward Control Unit (FCU) (Milngavie), V05A2 (RP) (Calton), VO4D1 (ARP) V04A2 (RP) (Polmadie), V01A1 (RP) (Govan), V04A2 (RP) (Polmadie), V05A1 (RP) (Calton), M01K1 Major Incident Unit (MIU) (Clydebank), T02D1 (ARP) (Maryhill), T06D1 (ARP) (Springburn), 554 Fire Investigation Unit (FIU) (Livingston)				
Incident Commander (Overall):	Assistant Chief Officer Goodhew.

FI-WH-GC-006-14 – 21735141 - MACKINTOSH BUILDING, 167 RENFREW STREET, GLASGOW, G3 6PQ (REDACTED)

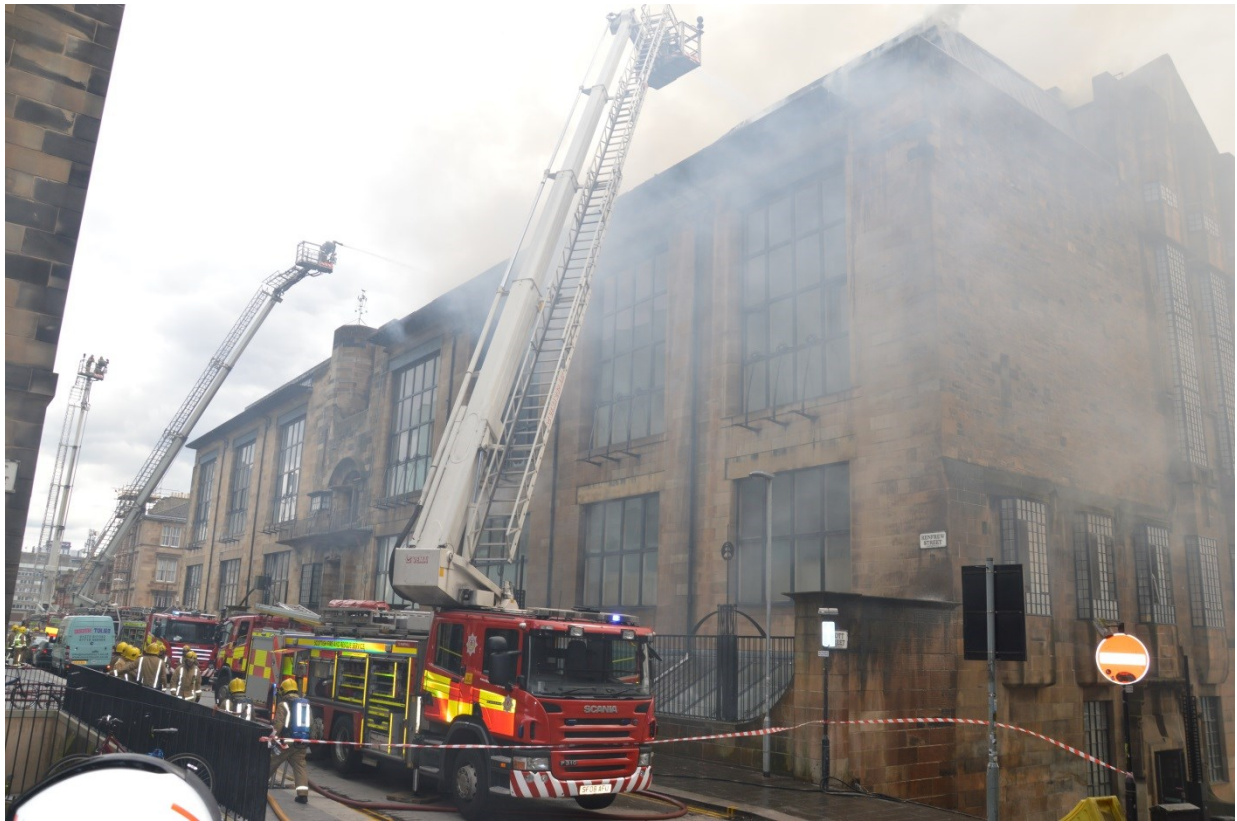
Photo 23 shows fire consuming studio 57 on the north east side of the building and **photo 24** shows firefighting operations on the north side of the building.

Photo 24. Aerial Rescue Pumps at work on north side of building

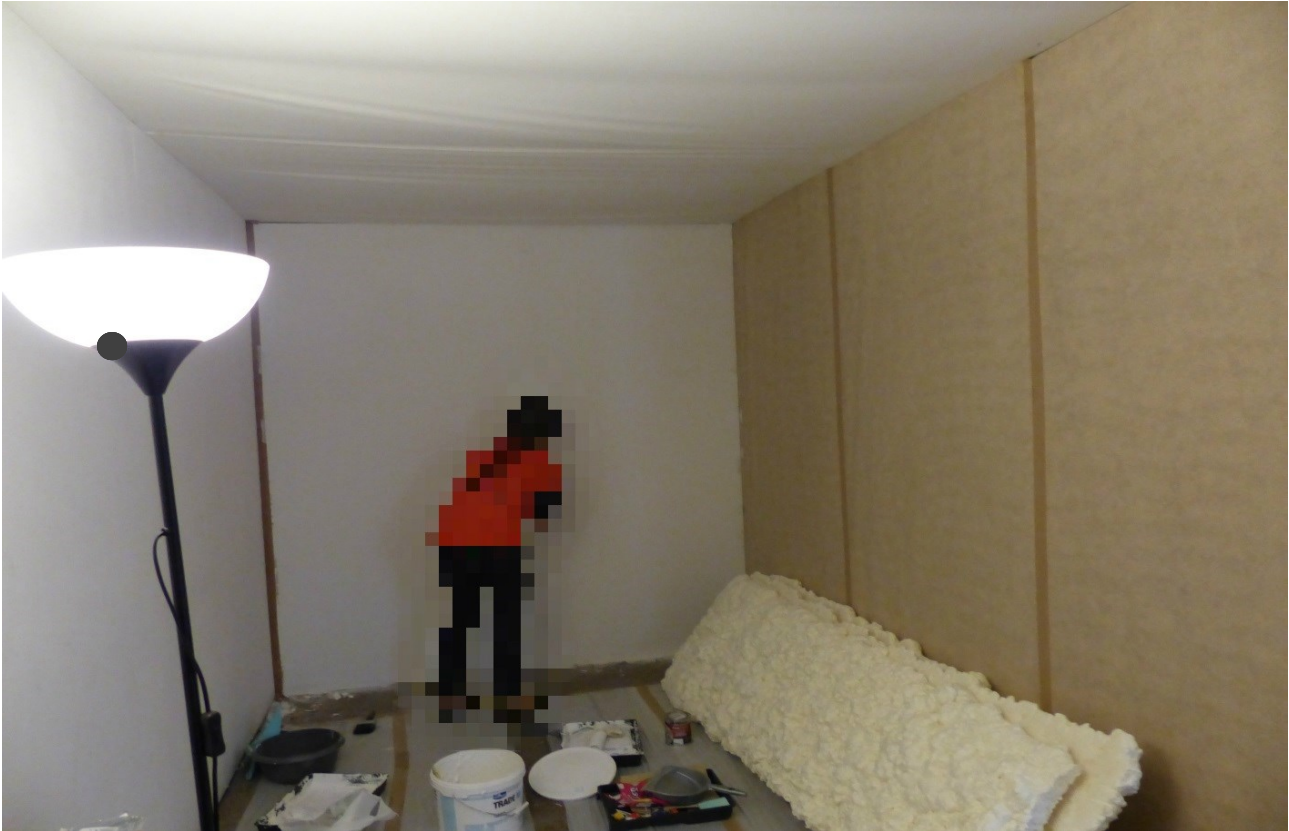
From the beginning of the week students had been working in their areas preparing their work. Some areas were purely used as exhibiting space where other areas were part of the exhibit, for example material applied to the walls. **See photo 26.**

Photo 26. Interior image of student display area prior to foam panels being located on walls. Image courtesy of Police Scotland.

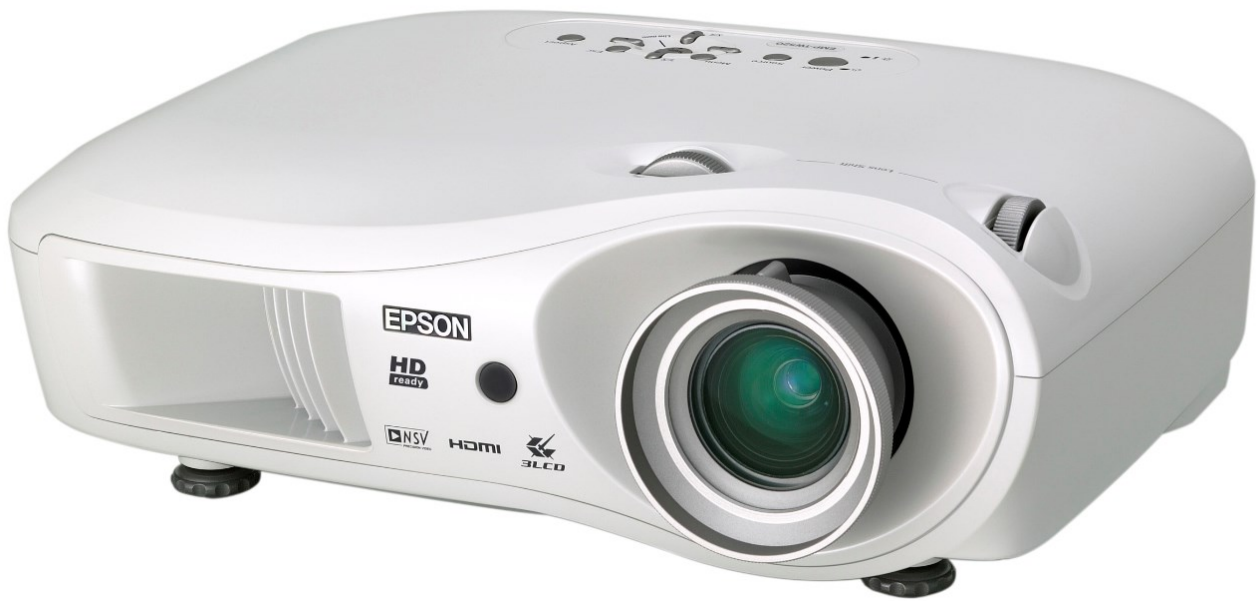
The projector was an Epson EMP-TW680. **See photo 28.** Purchased by the school in 2008. While operating it consumed 240 watts and its lamp source contained a 170 watt ultra-high energy (UHE) bulb.

There was no record of recall of the projector due to faults or defect. No previous records or reports were found of this type of projector being responsible for a fire. We could find no evidence to suggest that a fault occurred within this product which caused the ignition of the flammable gases.

Therefore, indirect ignition from an electrical spark is the most likely cause for the flammable gases igniting.

Photo 28. Catalogue image of projector Epson EMP-TW680. Courtesy of google image.

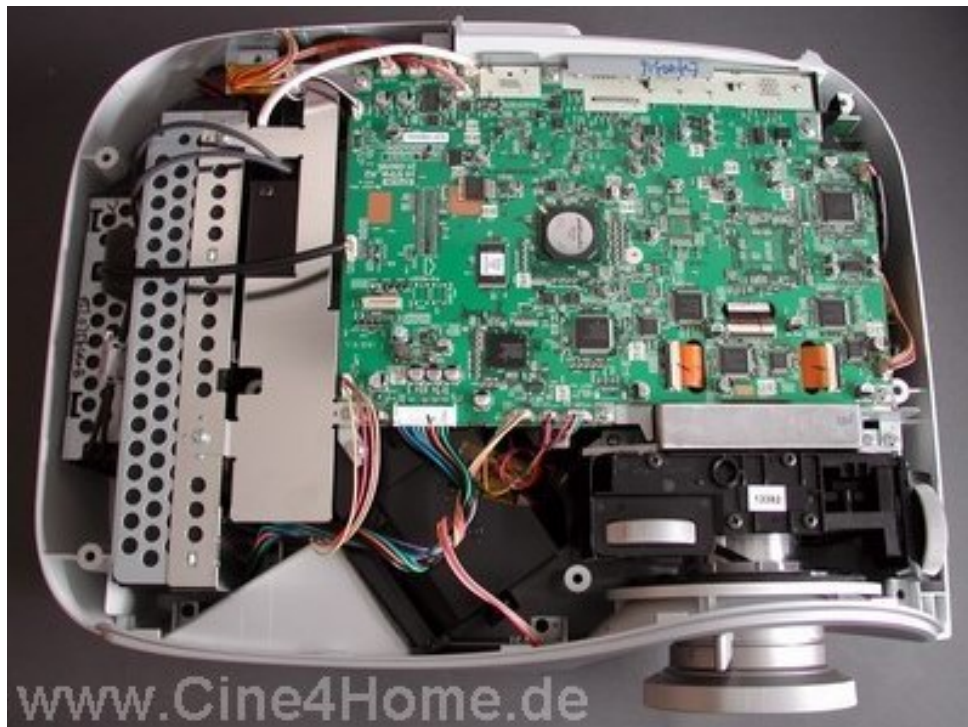
Photo 29. Top cover removed. Image courtesy of www.cine4home.com

Photo's 29-31 are internal images of a similar Epson model, the TW 600. Layout of components is the same only the specifications vary slightly. The purpose of the photos is to show the internal construction.

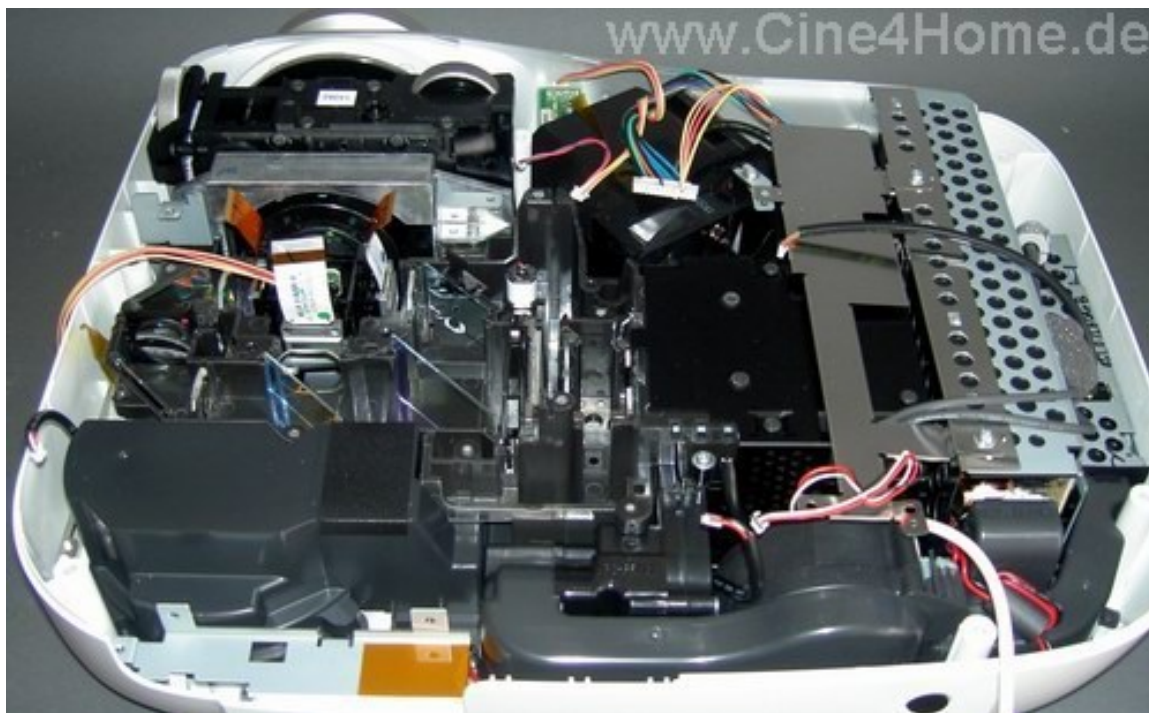
Photo 30. Image with cover removed. Printed circuit board removed. Image courtesy of www.cine4home.com

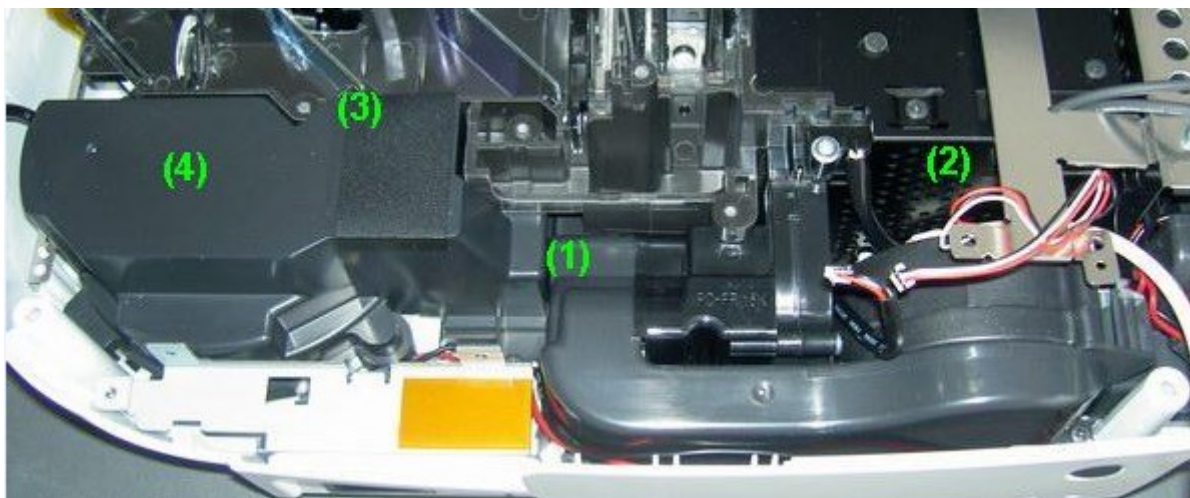
Photo 31. Air intake. Back of projector. Image courtesy of www.cine4home.com

The necessary cooling air is sucked in from the bottom of the machine (1), and the majority is passed directly over to the lamp (2). The remaining part is led towards the optical path (3) where a second fan continues to distribute the air further (4). The "used" air is finally exhausted completely on the front right on the front of the machine, next to the optics.
