# The Mackintosh Building

SOBC Addendum Report

Appendix A  
Architectural & Technical Report

June 2025

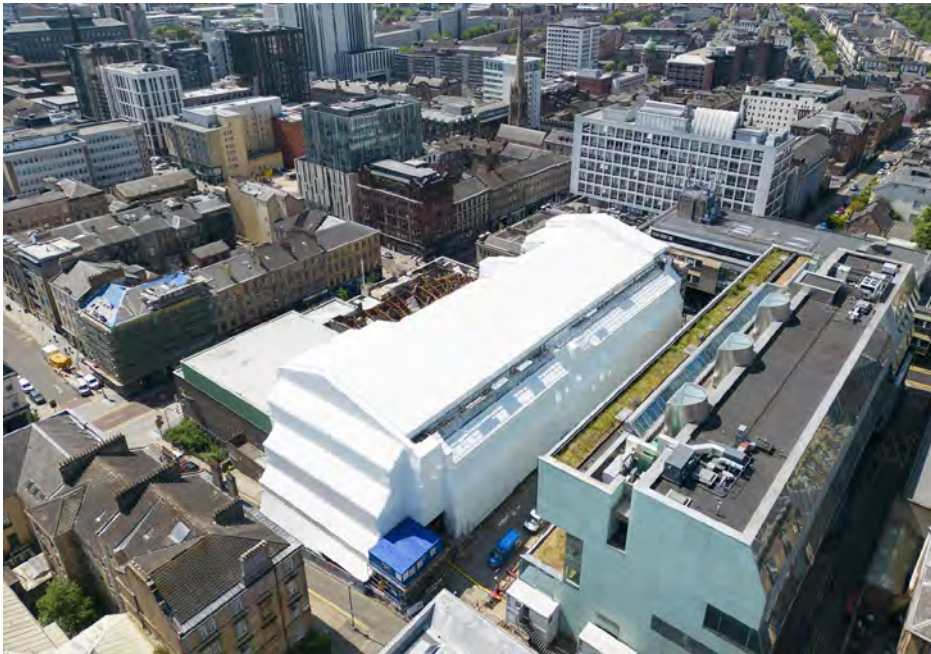
In 2024 the building was shrouded in scaffold. The wrap was removed from the walls in April 2025

5. Erection of temporary weather protection – roof and wrap to facilitate drying out.
6. Trials of various spalled stone consolidation specifications.
7. Initial materials testing to inform outline scope of repairs.

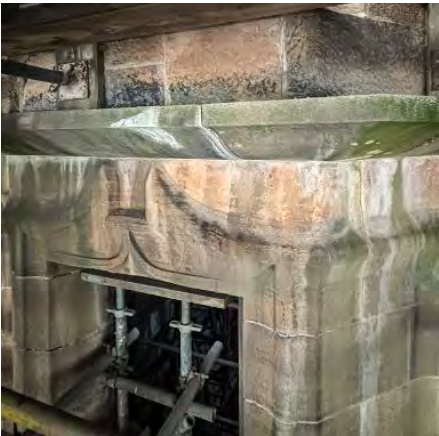
Stone at window head on East elevation

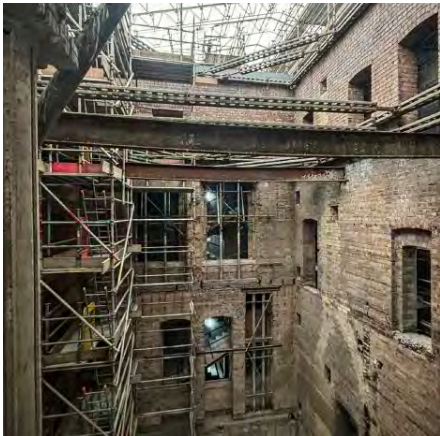
West and North Brick walls to Mackintosh Room

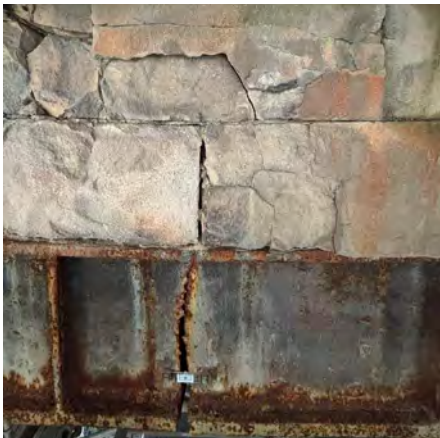
Cast iron window lintel at Ground Floor Studio

The stone walls on the north elevation are in poor condition particularly between basement and ground level and require replacement with new stone. The reveals to the large window openings are damaged and need to be replaced. The cast iron beams over the windows and the stone aprons above the windows need to be taken down, with stone set aside for potential re-use where possible. The stone at the north-east corner where Dalhousie Street meets Renfrew Street needs to be taken down and rebuilt, using as much salvaged stone as possible. The east wall to the studios has some extensive cracks that will need to be either taken down and rebuilt or repaired.

2. Shoring works:
  - Shoring scaffold installed to east and west gable and northern façade.
  - Propping to cracked cast iron lintels on external facades.

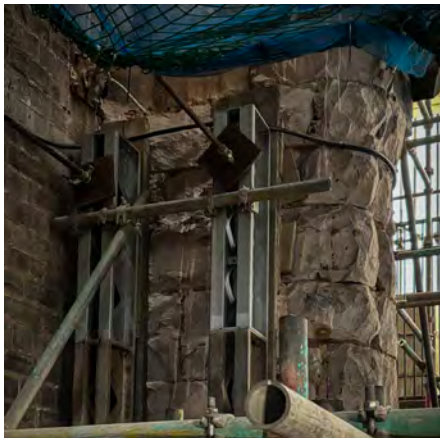
Damaged stonework at North Elevation Basement

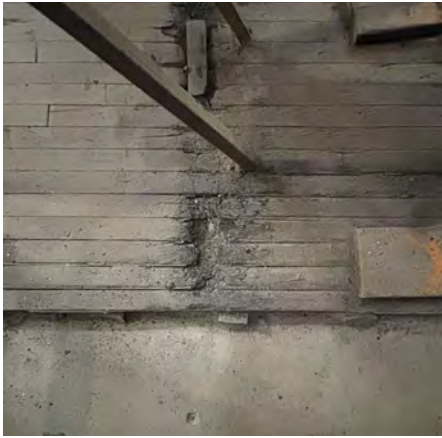
Surviving timber strip flooring at Basement

There is a small area of surviving timber floorboarding on battens in the basement. All doors and timber linings have perished. Some metal window frames survived but are warped and will require replacement.

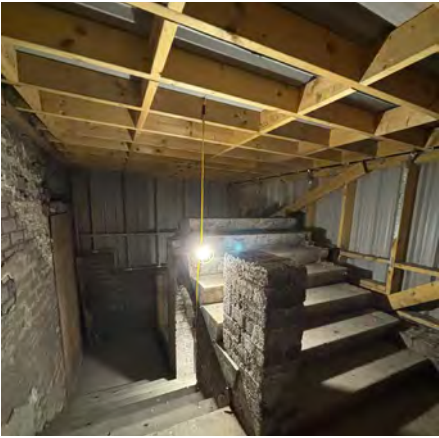
Top of East Stair

The East Stair largely survives from basement level up to second floor level with the exception of the last flight at the top of the stair which has been removed. The stair requires extensive repairs. The concrete treads and landings are cracked and require repair and some replacement. Approximately a third of the landings need to be replaced. Some of the 'Glasgow Marble' plaster has survived but is cracked and de-bonded from the brickwork walls. All windows need to be replaced. Some of the decorative tilework has survived.

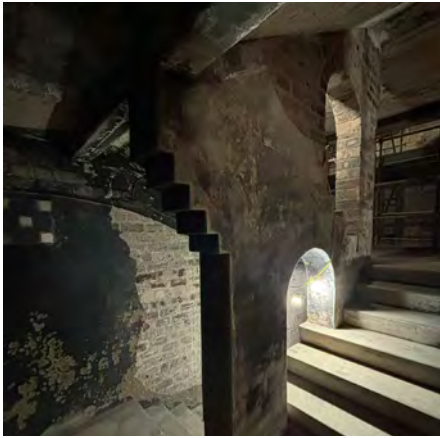
East Stairwell - surviving tiling and plaster

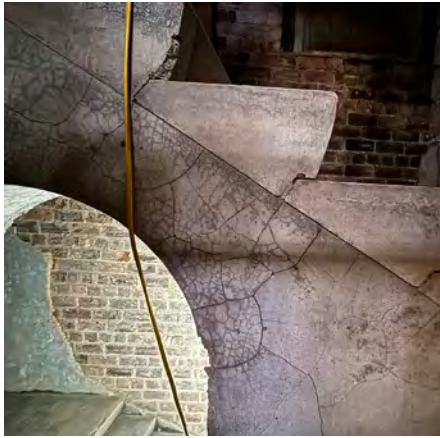
East Stairwell - concrete treads and plaster

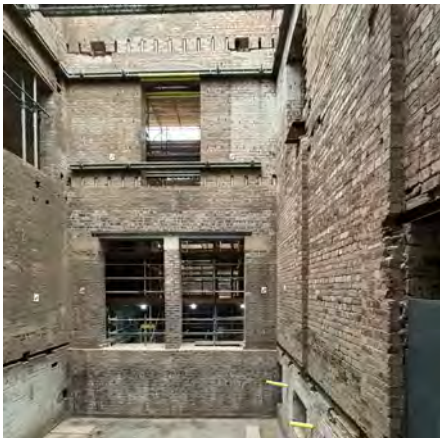
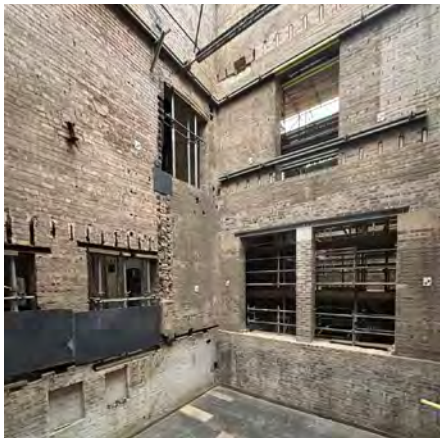
Corridor spine wall from main entrance

The brick walls to the southern side and cross walls largely survive from Basement Level up to Second Floor slab level. The main corridor spine wall extends to 7 or 8 brick courses above Second Floor slab level. The brickwork requires extensive local repairs to cracks, lintels and arches over openings. Some of the brick piers for supporting beams require to be tied back to adjacent walls.

8. Local areas of brick repairs to the spine wall (approx. 40% of length) including:
  - Stitching of main cracks
  - consolidation of flues
  - Rebuilding of central pier and reinstatement of lintels in main entrance

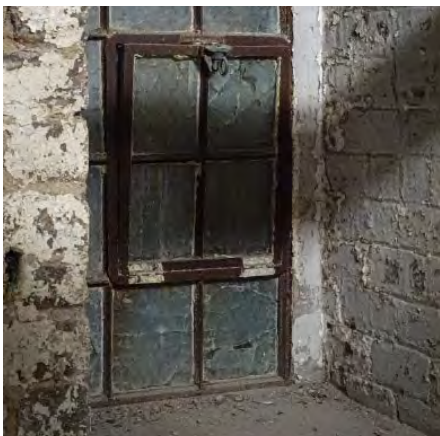
Surviving metal framed window and glass

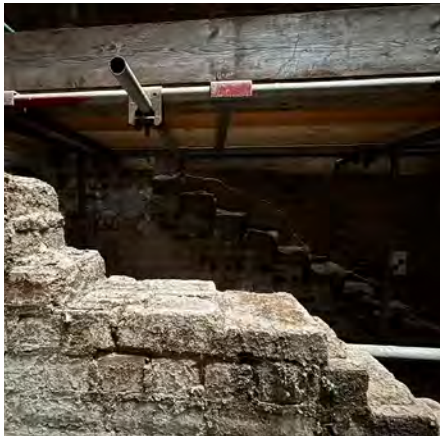
Seating for main stair from ground to basement

The central Stair has perished but seatings for the stone treads from Basement to Ground Floor Level are still visible. The timber stair from ground floor to the museum at first floor has completely perished.

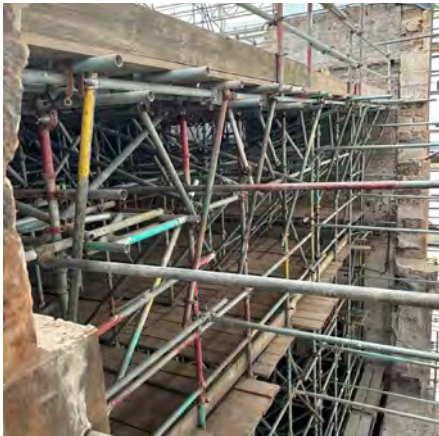
Removed west wall of library

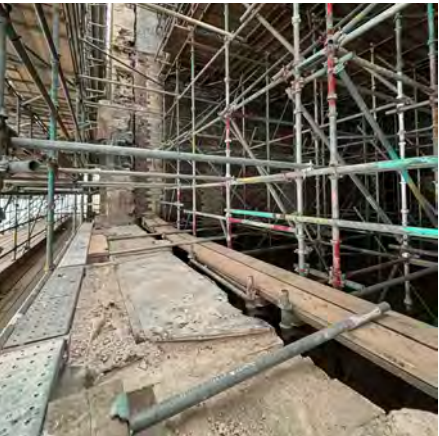
Window cill level of library

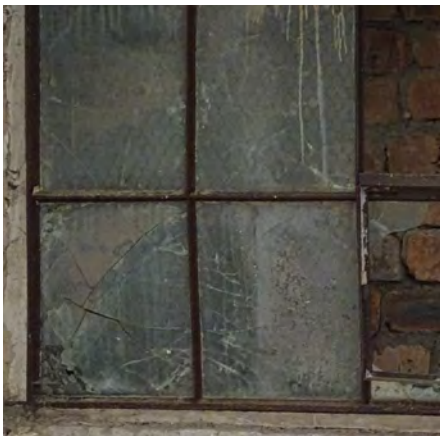
Steel framed window and glazing

Some of the metal windows survived, most were distorted by the heat, but some still have some glazing, albeit cracked or broken. A particular delight is that some of the decorative tilework at stair landings has survived.

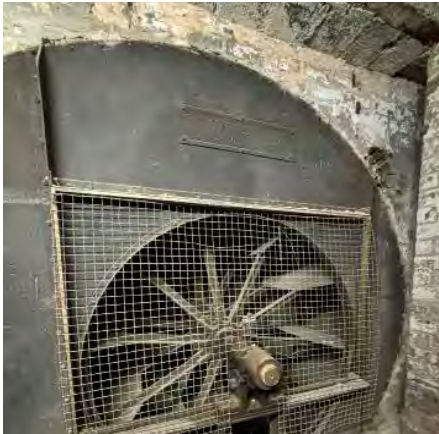
Air Fan in the Basement

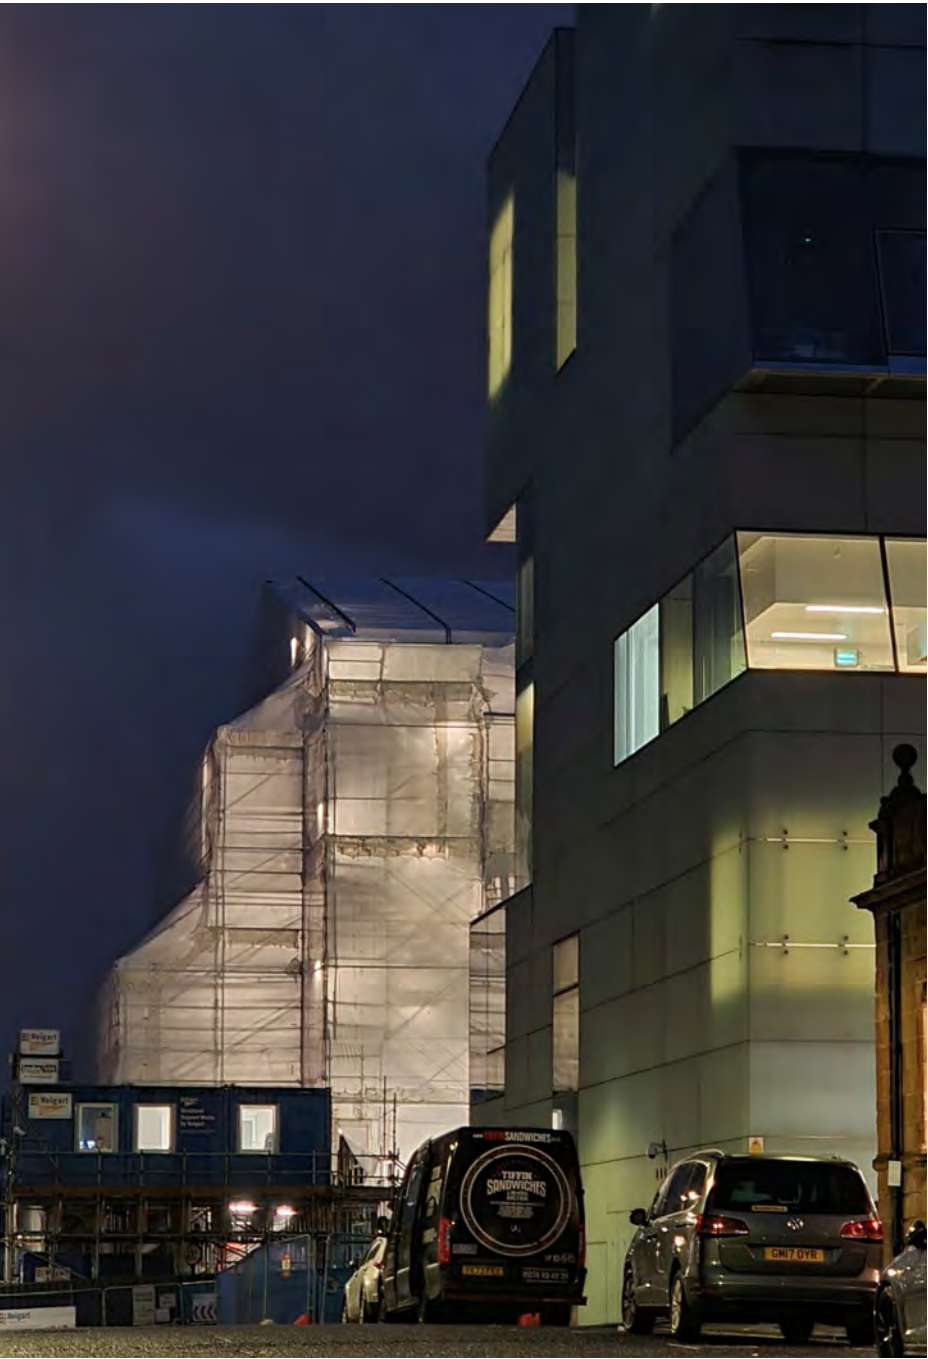
Shoring scaffold, viewed from Dalhousie Street

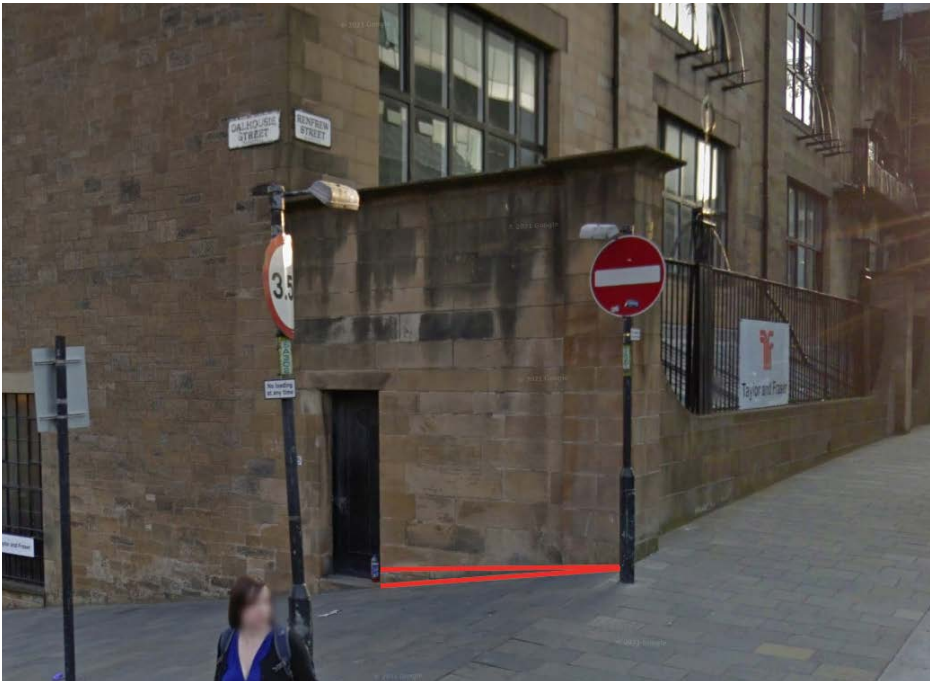
Potential location for intervention to allow level access, on Dalhousie Street

Two opportunities have been identified where, with skillful design, reasonable adjustments could be made to the building to improve access from the street while protecting the original design intent. The most inclusive and equitable solution would be the one which sees level access incorporated closest to the main entrance. The following pages contain two design exercises that test the feasibility of this.

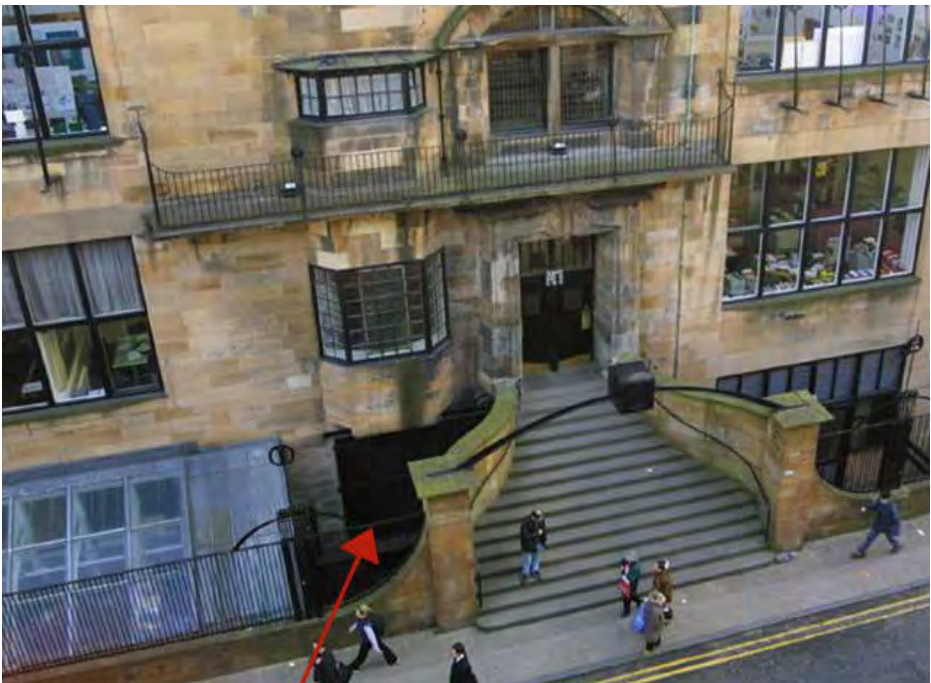
Potential location for intervention to allow level access, adjacent to the main entrance on Renfrew Street

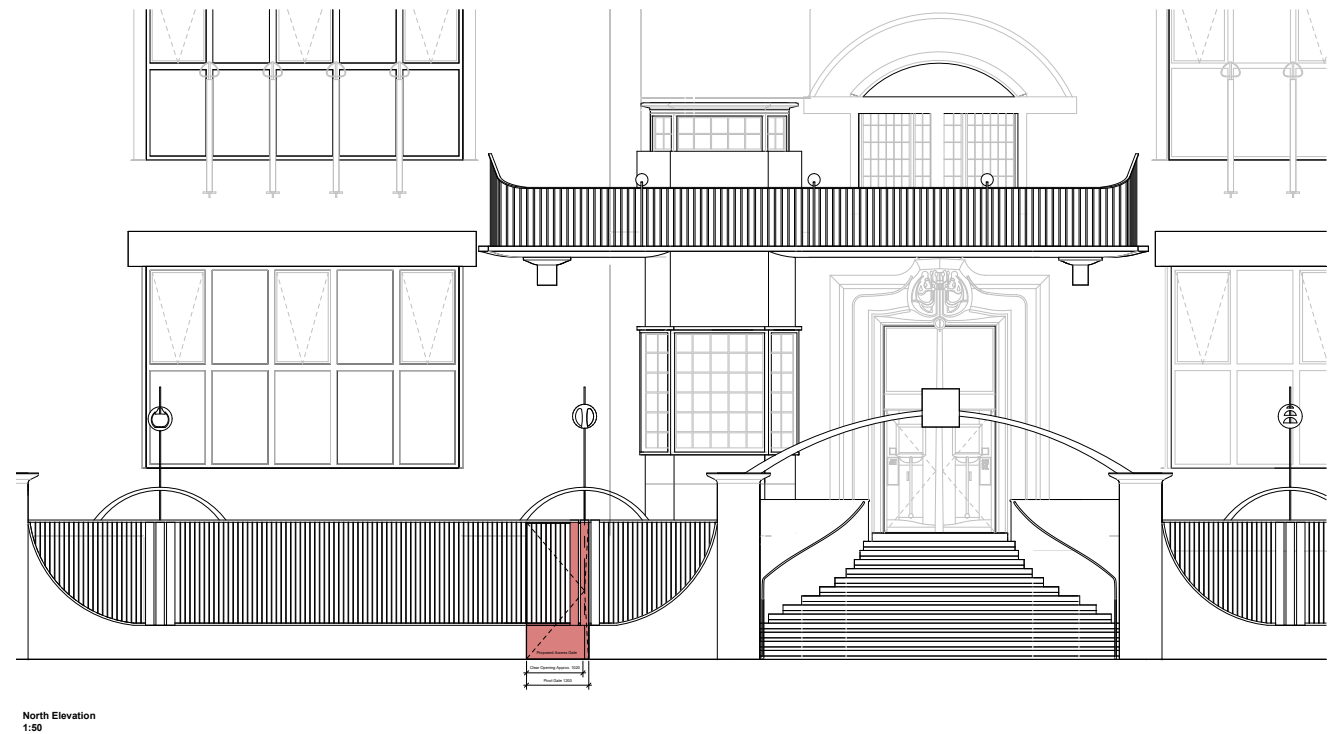
Entrance Study A

This design incorporates a discreet pivot gate within the existing railings and stone wall, ensuring a sensitive approach that preserves the original decorative metalwork. A ramp from Renfrew Street, with a gradient not exceeding 1:15, provides access to the basement mezzanine of the Mackintosh Building, leading to a platform lift. The lift offers direct access to the entrance lobby, adjacent to the main entrance doors, where the reception desk was formerly located.

Diagram showing potential location of gate, ramp and platform lift

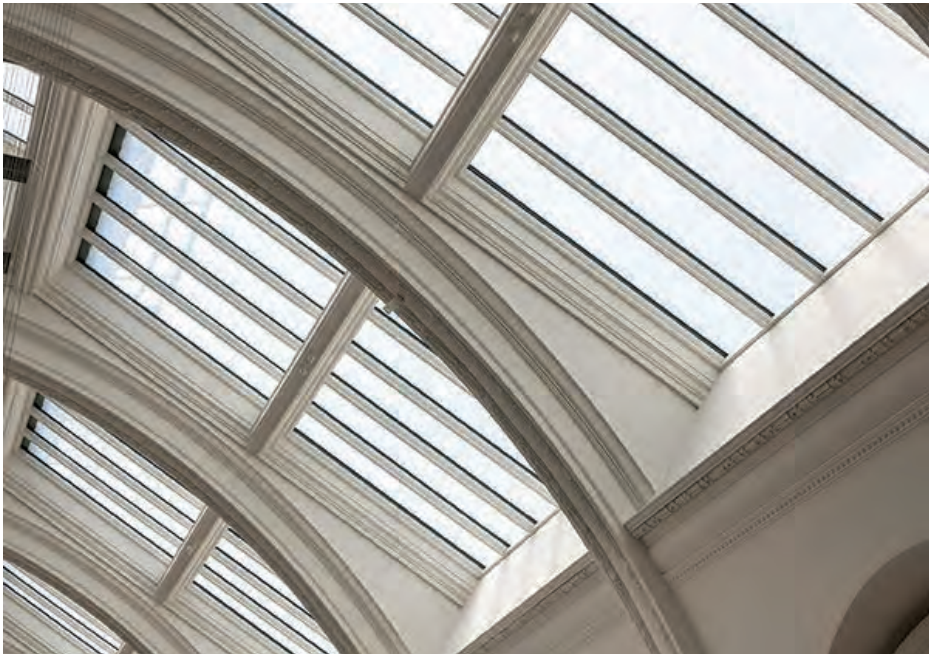
Double glazed patent glazing at the V&A Kensington

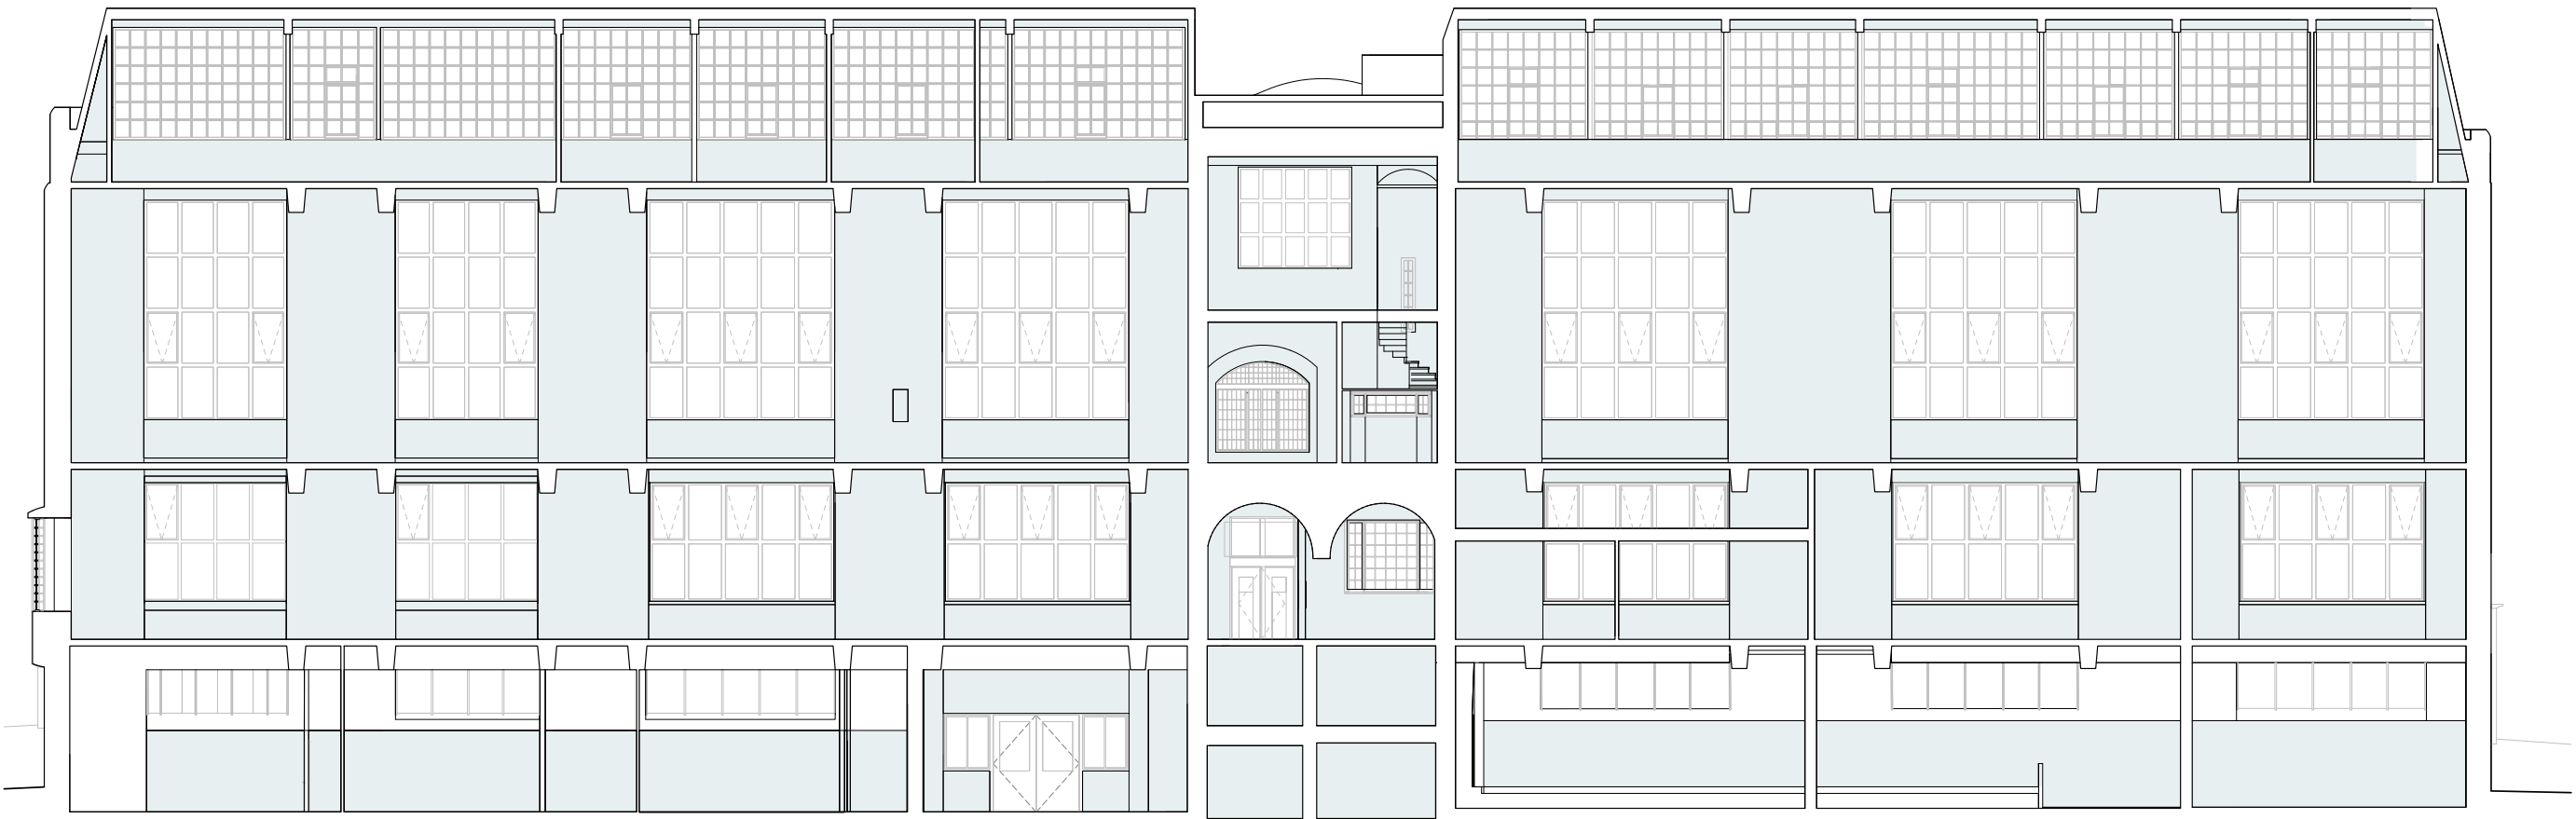
External Walls - North Elevation

Approach to Sustainability: Insulation Extents

Insulation Area: 783 m<sup>2</sup>

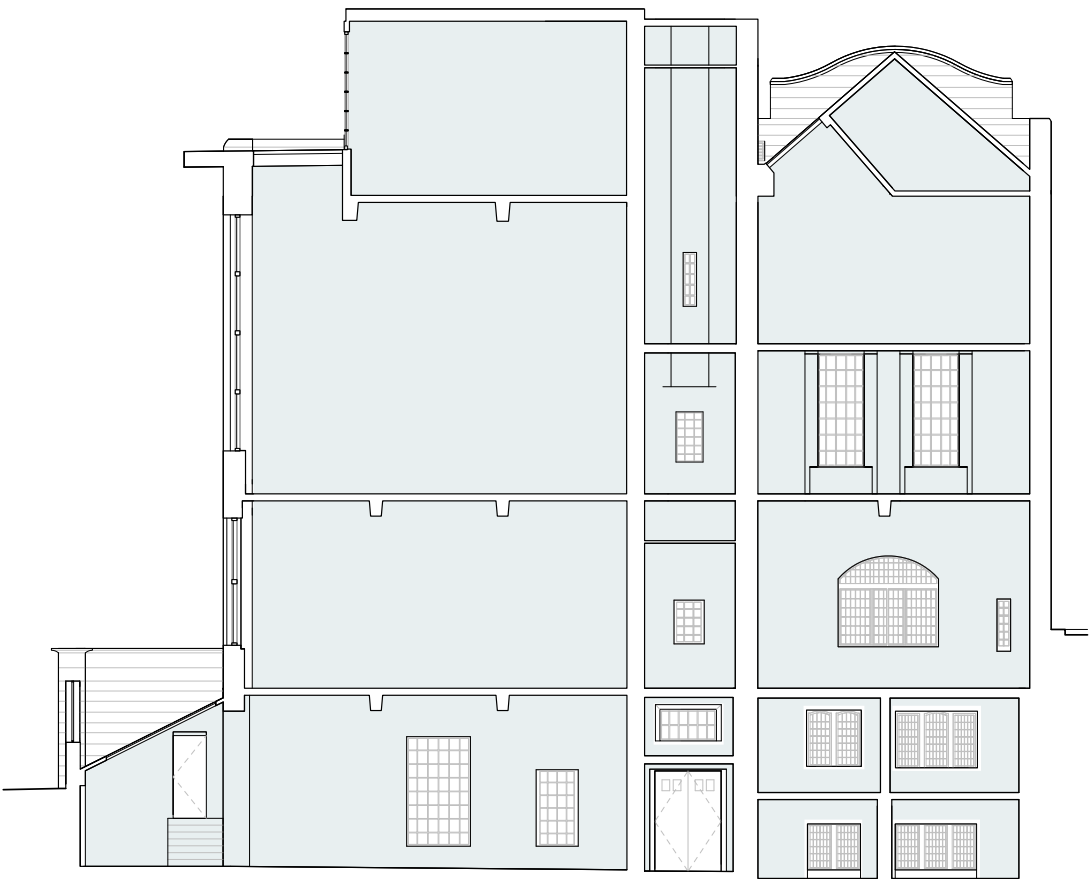
External Walls - West and East Elevations

Approach to Sustainability: Insulation Extents

Insulation Area: 432 m<sup>2</sup>

Insulation Area: 421 m<sup>2</sup>

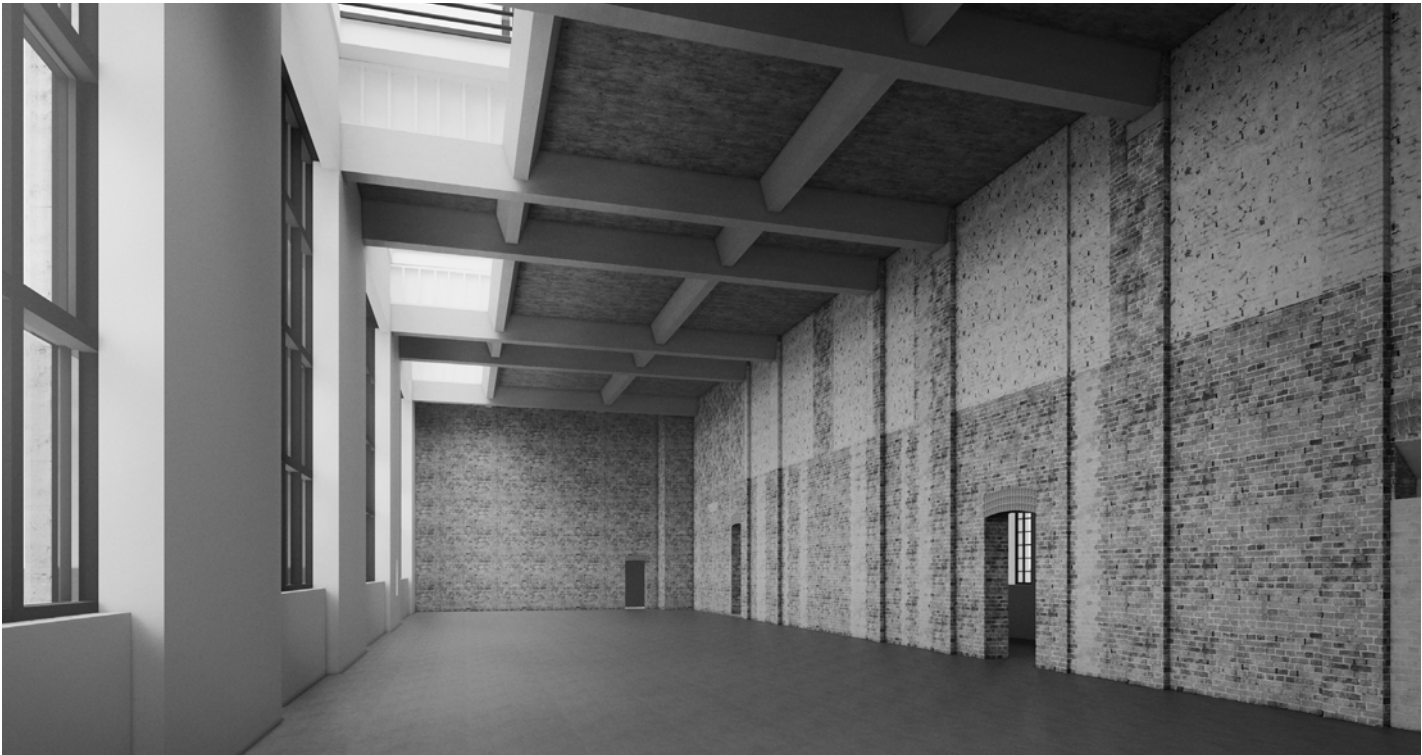
Visual Comparison - Studios (West) Looking East

First Floor studio with internal wall insulation

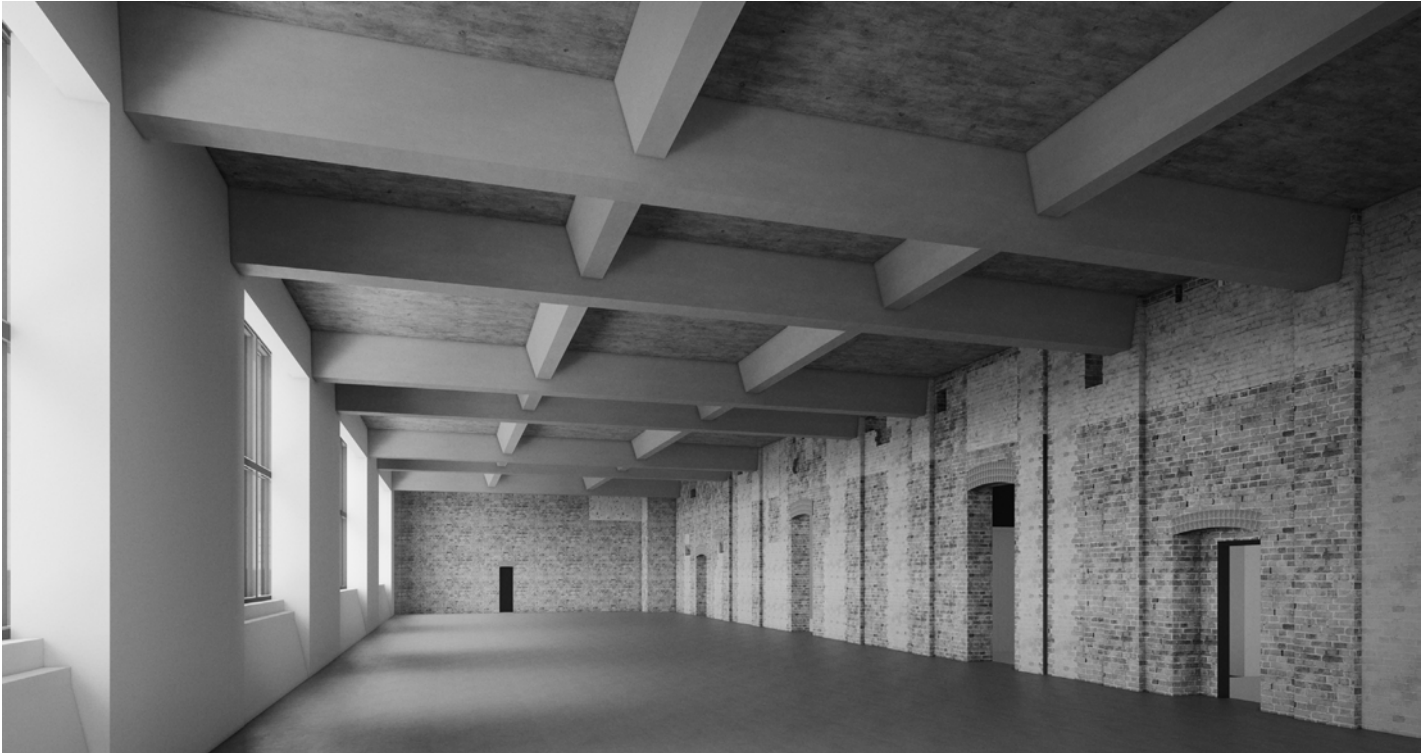
Second floor studio with internal wall insulation

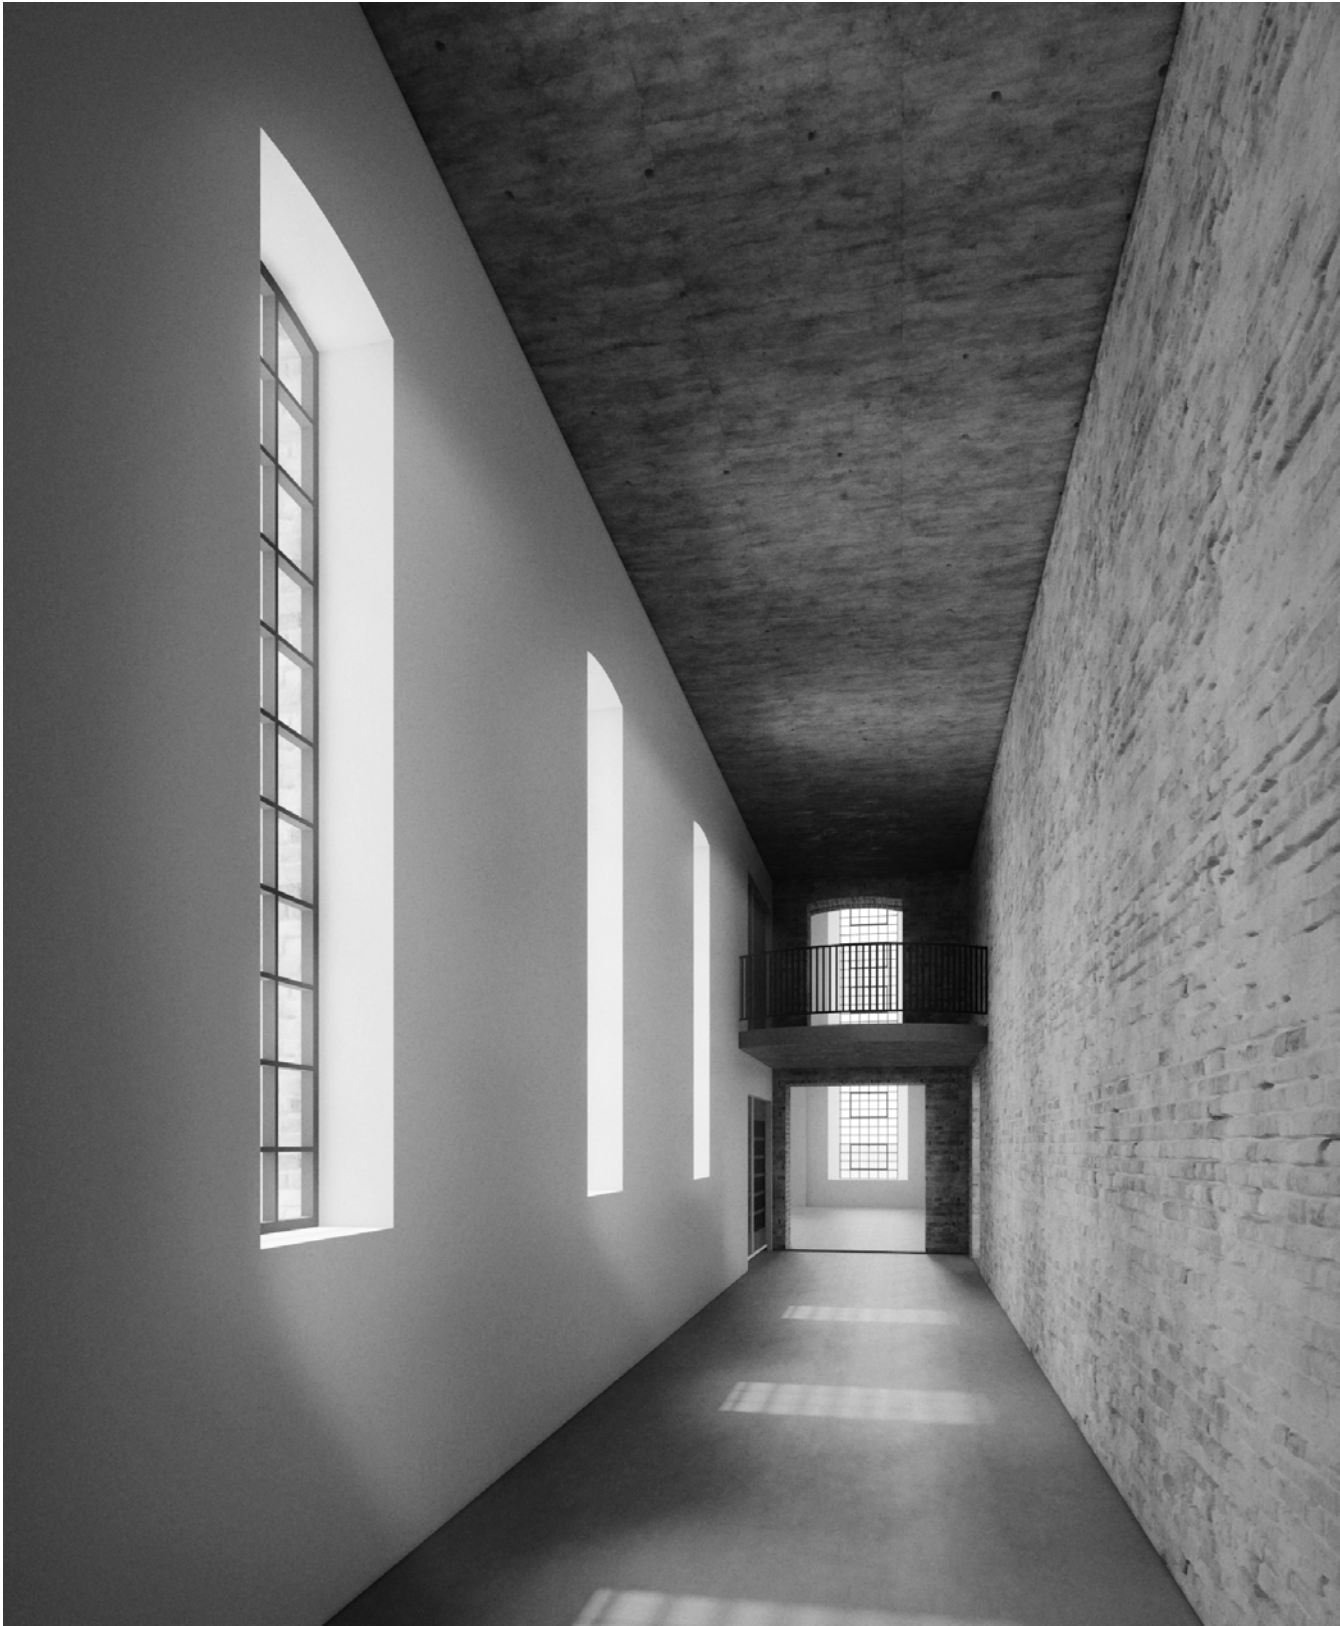
Visual with internal wall insulation before linings or furniture are installed

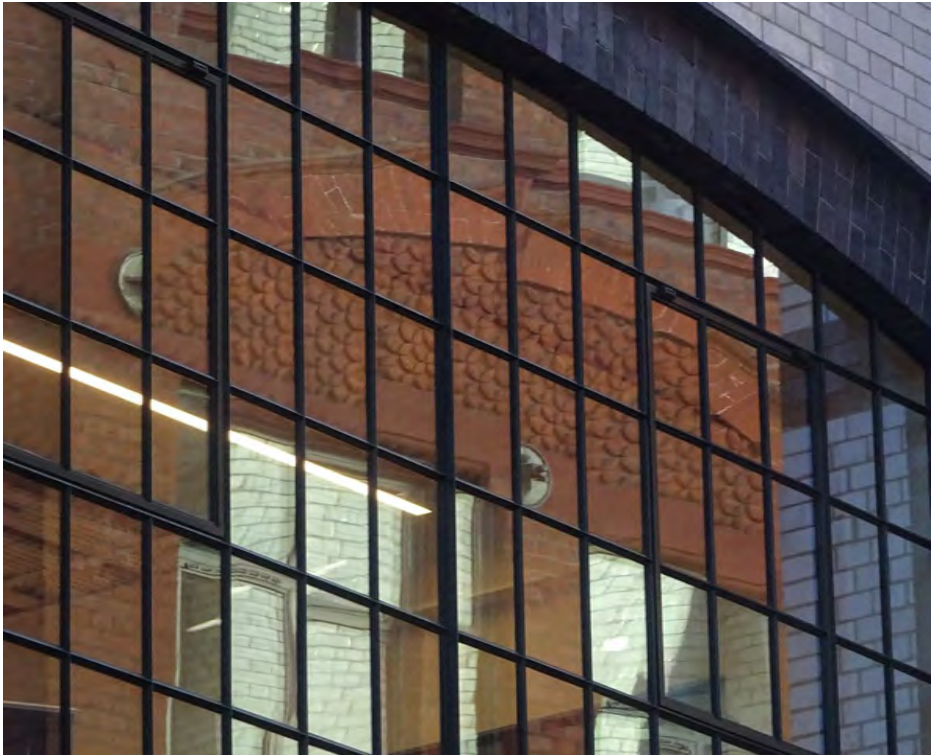
Glazing close-up

According to an article published in the RIBA Journal on 28 August 2024, the glazing; "utilises 7.7mm thick Fineo vacuum double glazing, by West Leigh, with steel frames reproducing the original profiles in a colour-matched 'Voysey bottle green'. The glazed unit achieves a u-value of 0.7 W/m2k though the glass, which reduced the building's U-value by over 50%, contributing to an EPC rating of A."

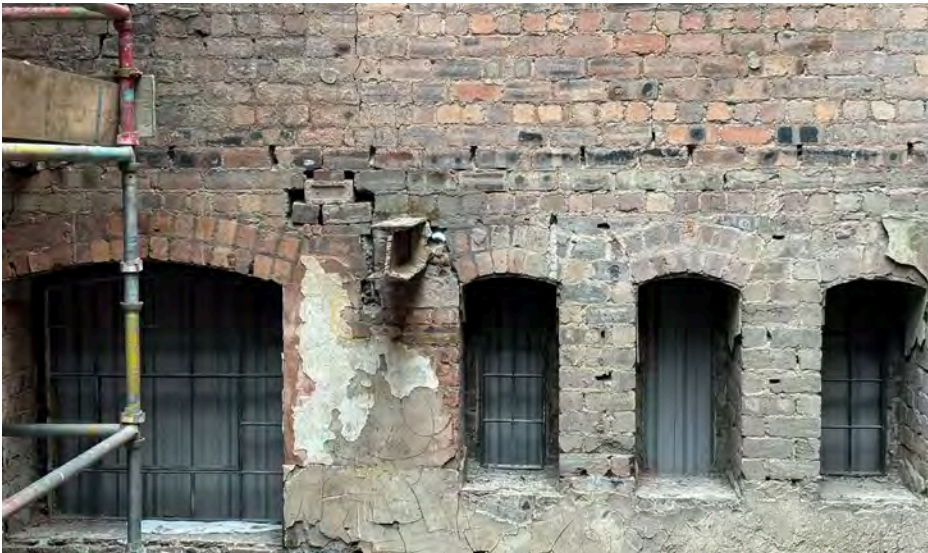
Type 5 - male cloakroom - steel framed standard

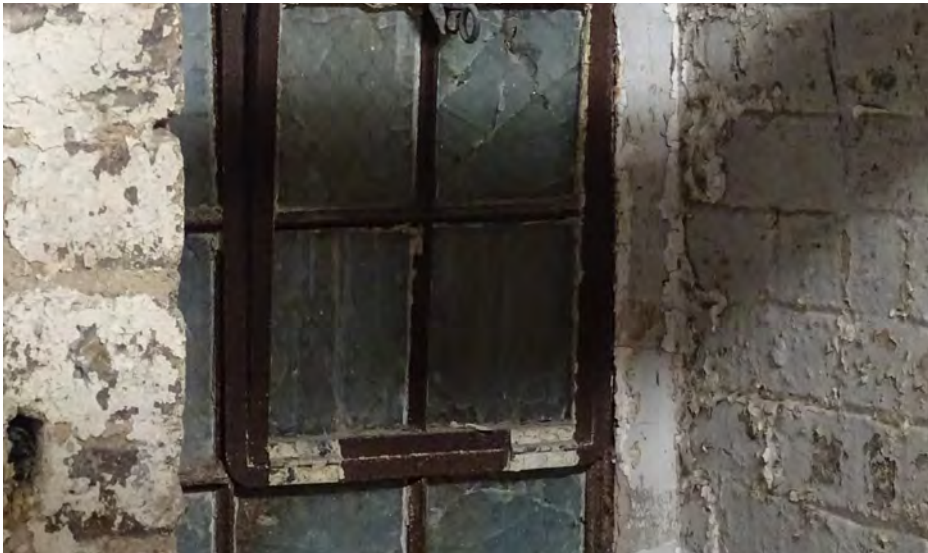
Type 5 - cleaners - basement - steel framed standard

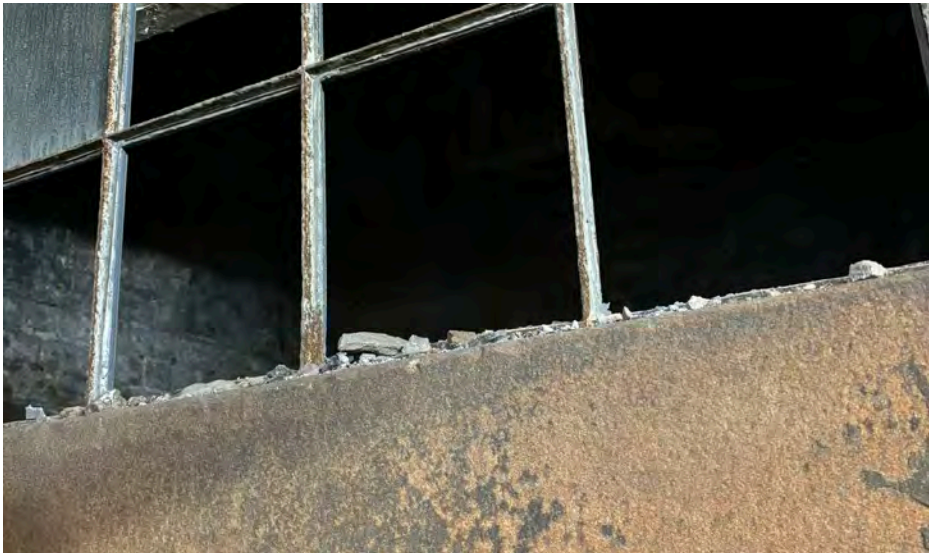
Type 5 - lavatory - sub-basement - steel framed standard

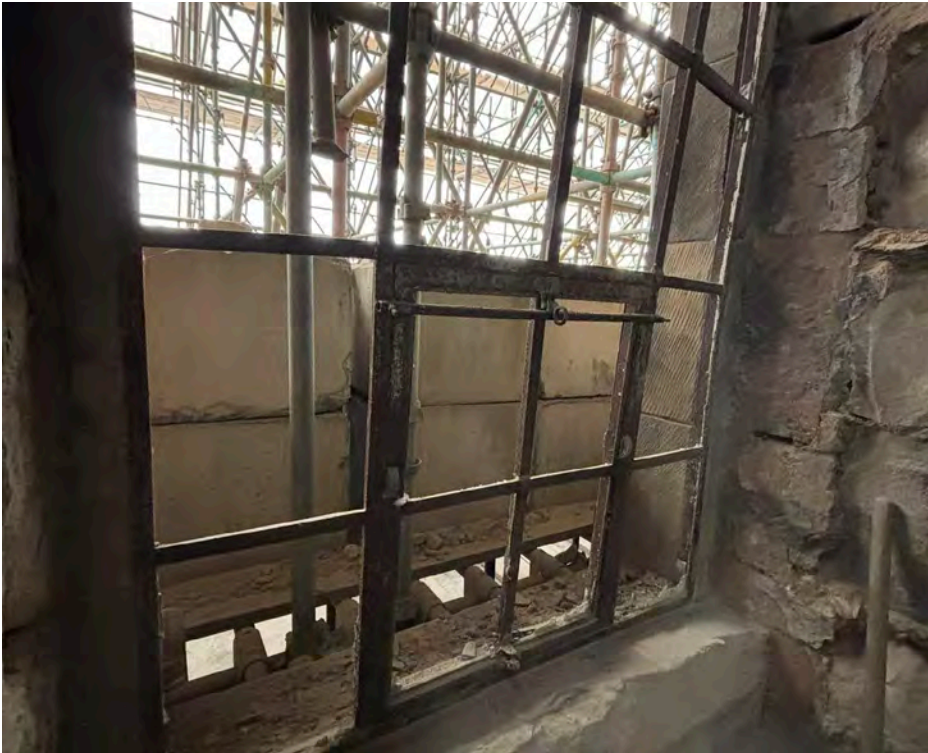
Type 5 - animal room - steel framed standard (this window was installed against Mackintosh's wishes)

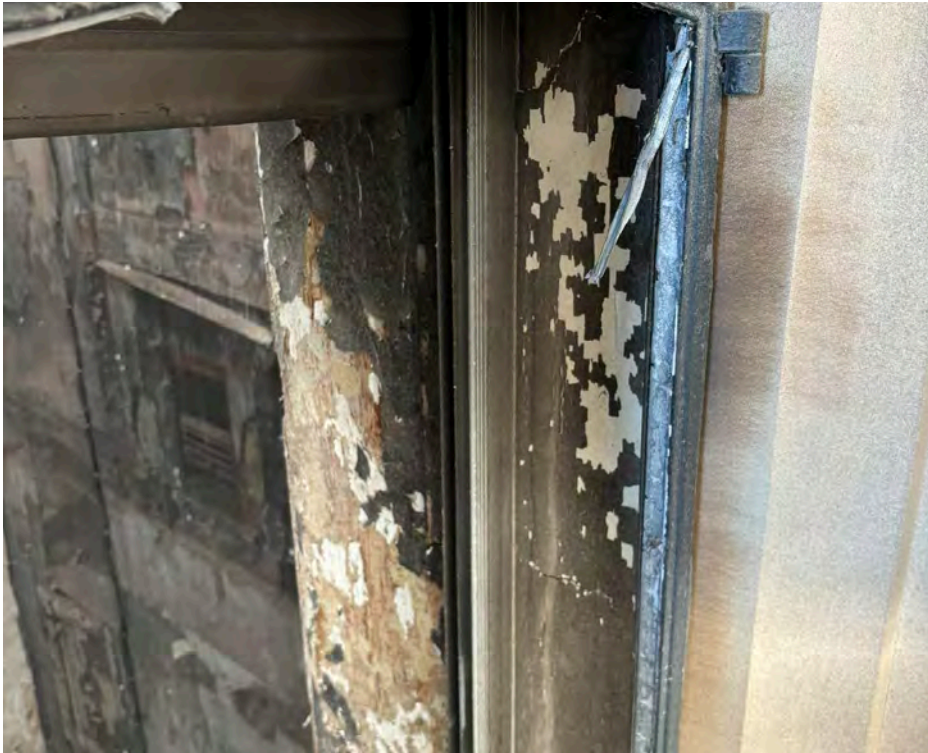
Type 1 - Caretaker's house - leaded, steel framed (image shows alter added frame of secondary glazing inside)

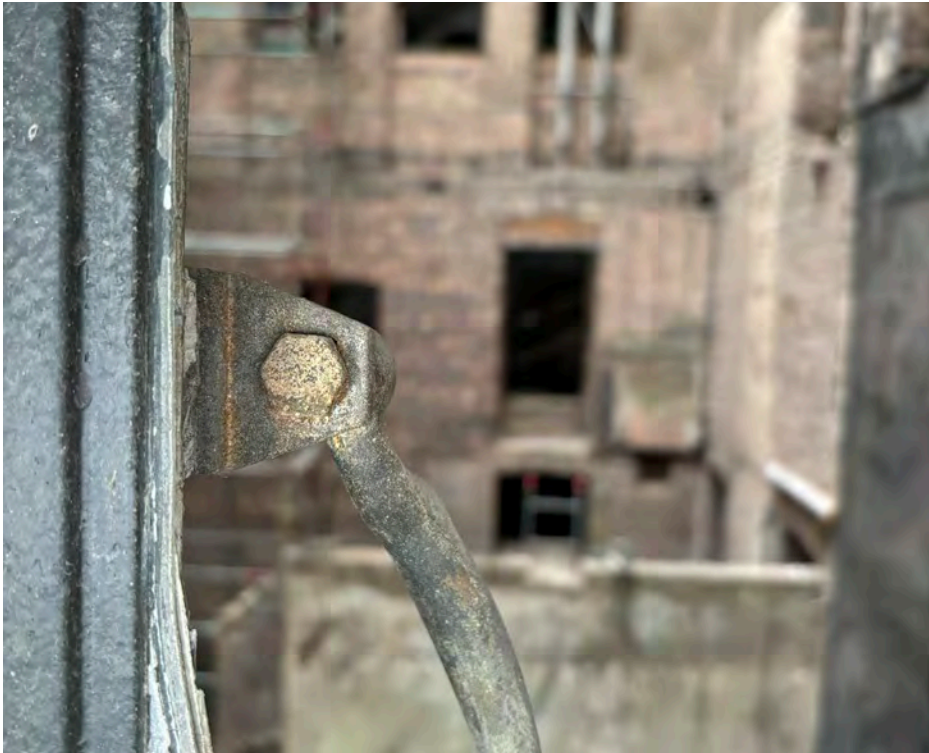
Type 1 - Caretaker's house - leaded, steel framed (handle remains)

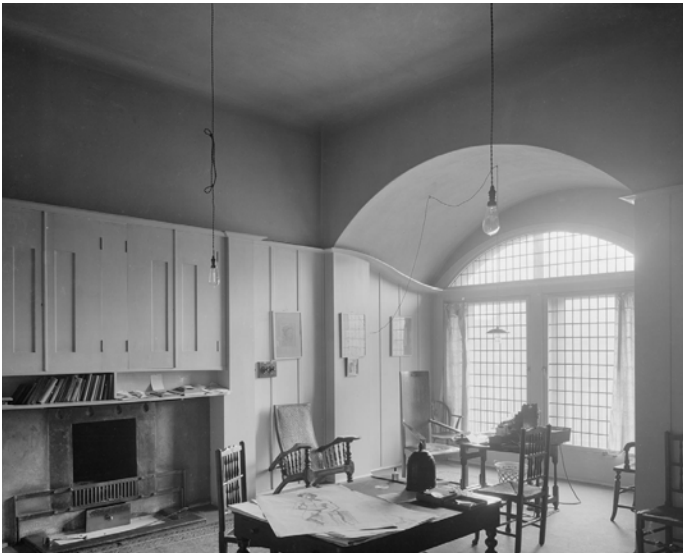
Type 2 - director's office - leaded in metal frame

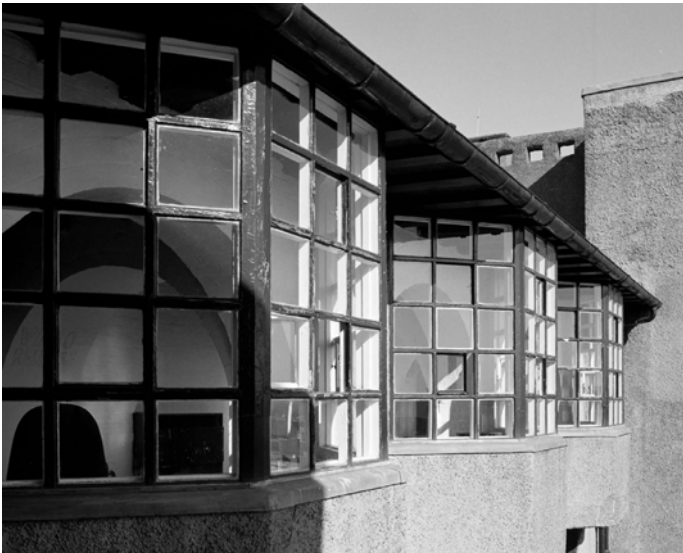
Type 4 - loggia - timber framed

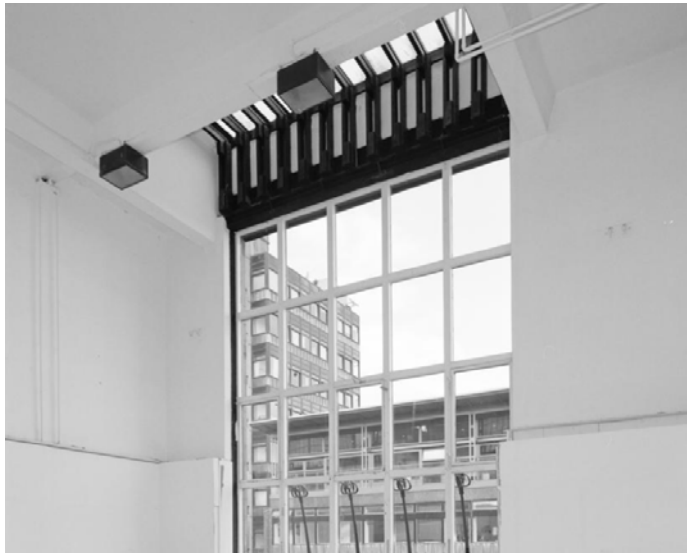
Type 1 - studio - timber framed

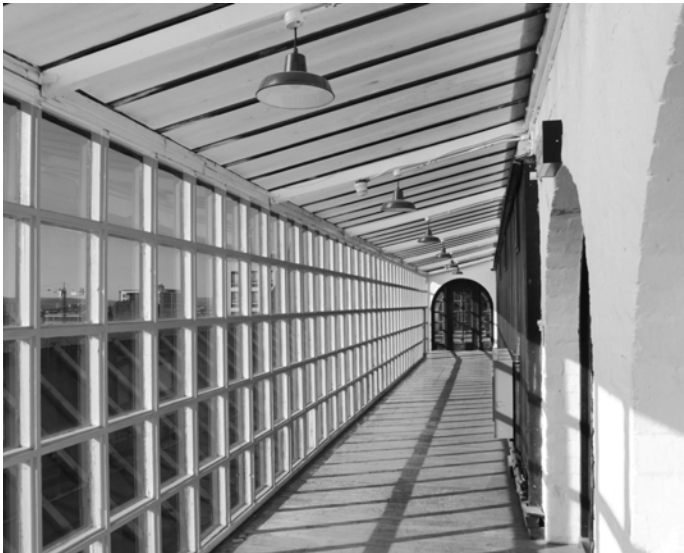
Type 4 - loggia - timber framed
