# The Mackintosh Building

SOBC Addendum Report

Appendix A  
Architectural & Technical Report

June 2025

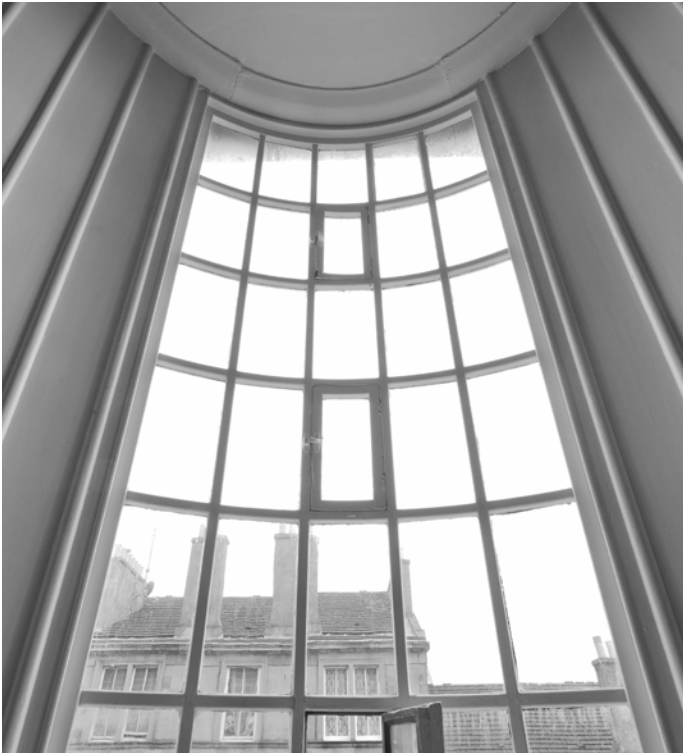
Type 4 - design room - curved timber frame

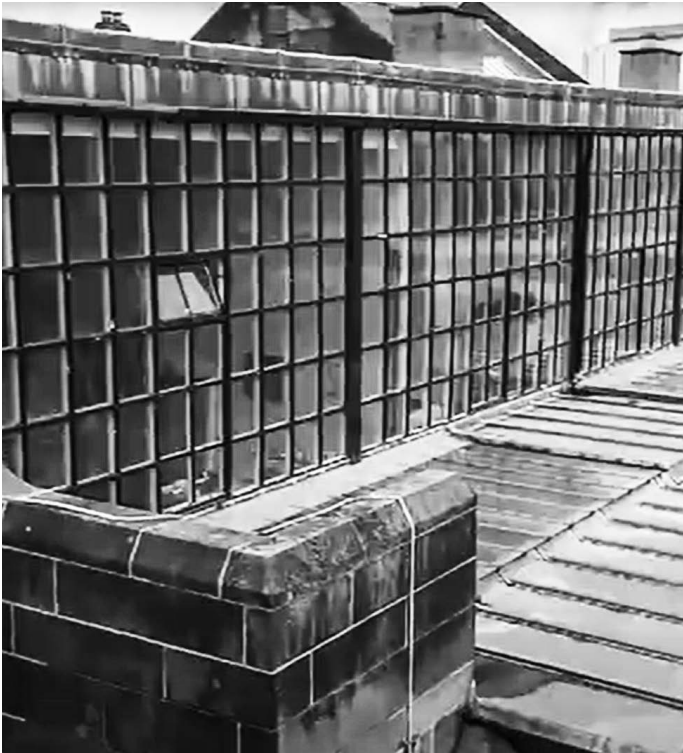
Type 3 - second floor studio - hardwood framed

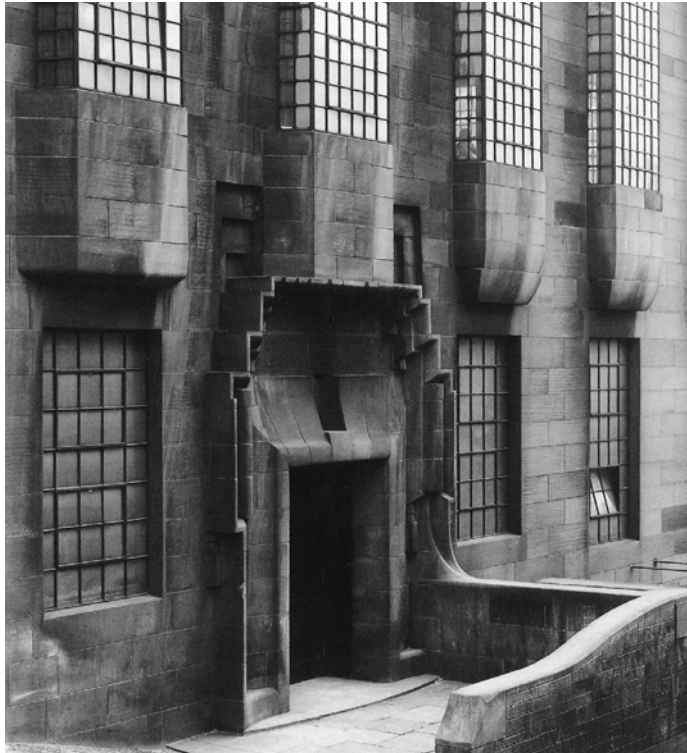
Type 5 (lower) and 6 (Upper) metal framed

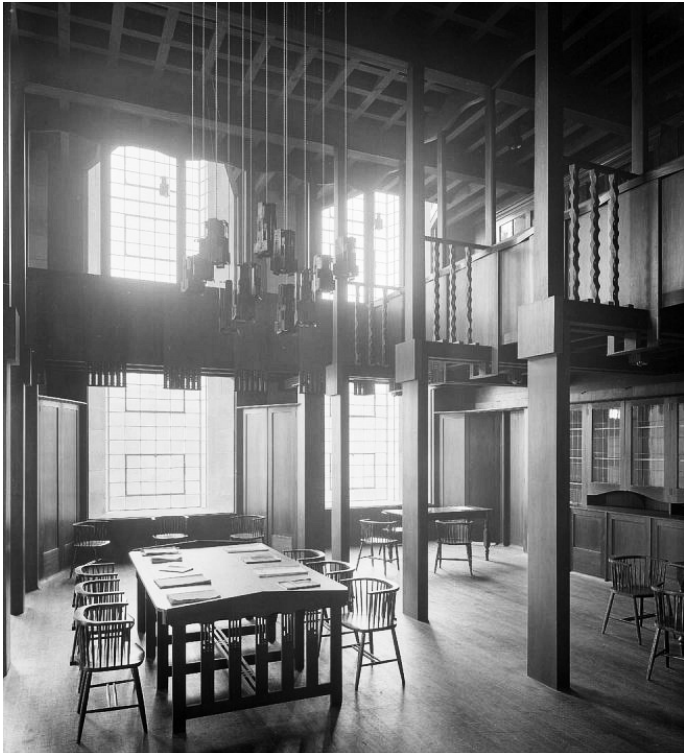
Type 6 - library - steel framed bespoke

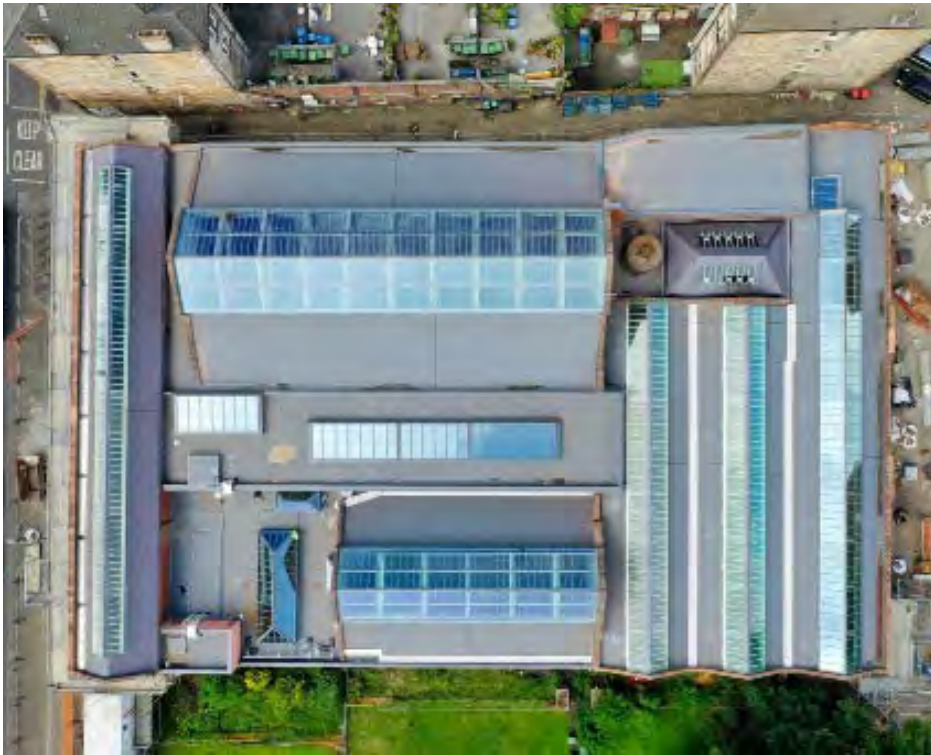
Double glazed heritage patent glazing at Govanhill Baths, Glasgow

The photographs opposite show recently completed patent glazing replacement projects where new, double glazed patent glazing has been installed on listed, historic buildings. Category B Listed Govanhill Baths in Calder Street in Glasgow has had over 800m2 of replacement patent glazing installed using a double-glazed ‘heritage’ system.

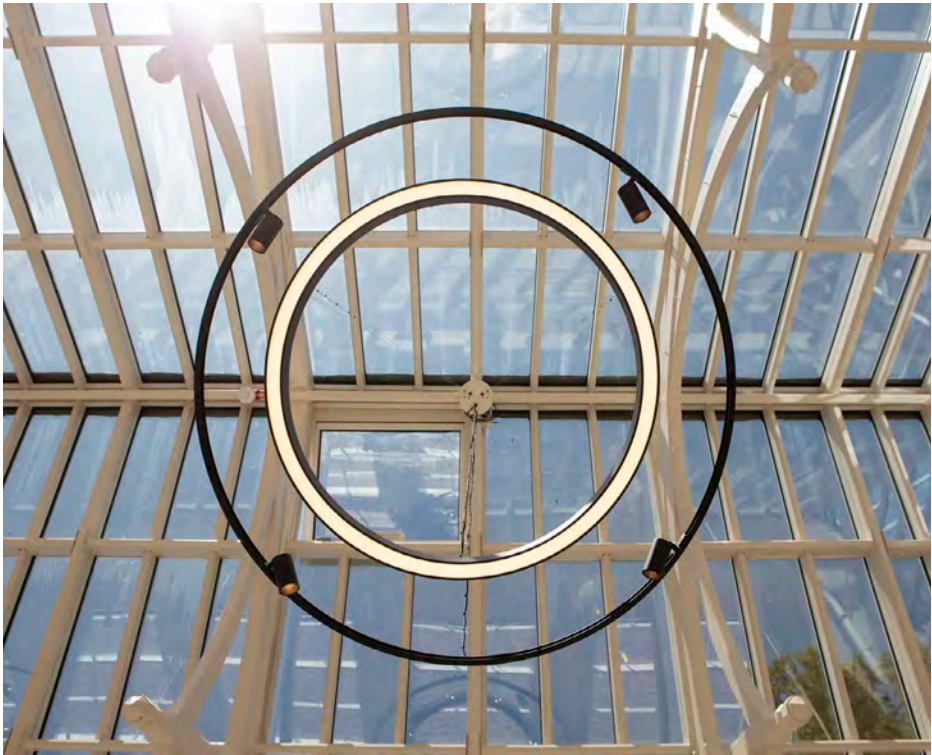
Ingestre Orangery after restoration

Ingestre Orangery, a grade 2 listed building in Staffordshire also recently successfully utilised a double glazed ‘heritage’ system of patent glazing.

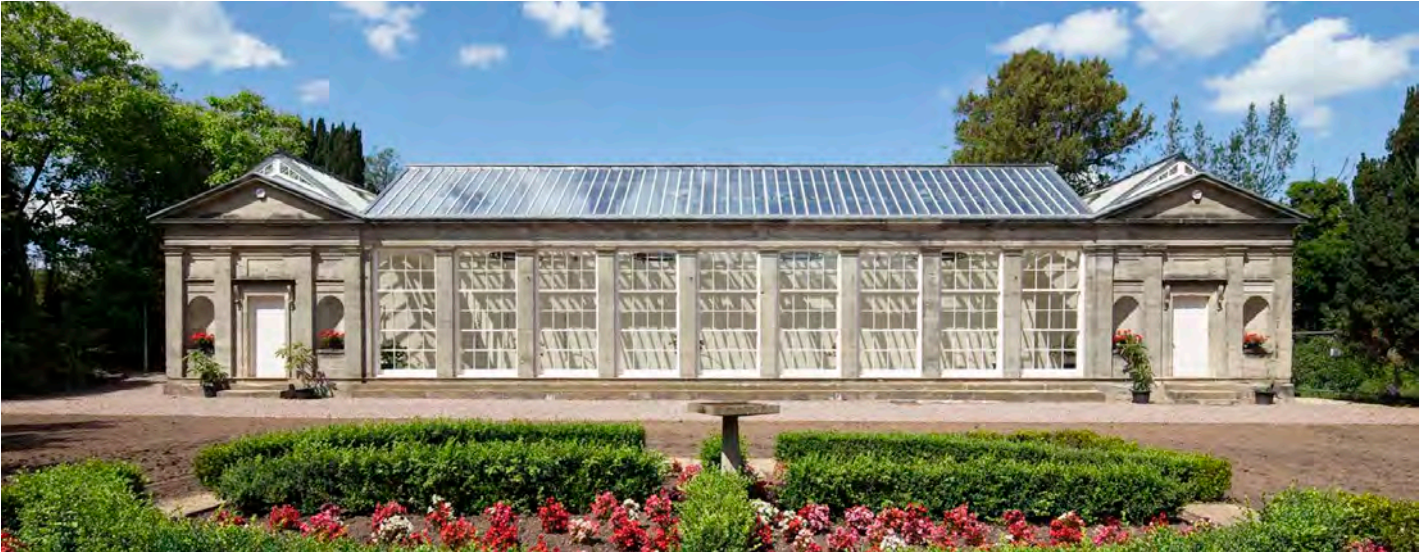
Ingestre Orangery after restoration

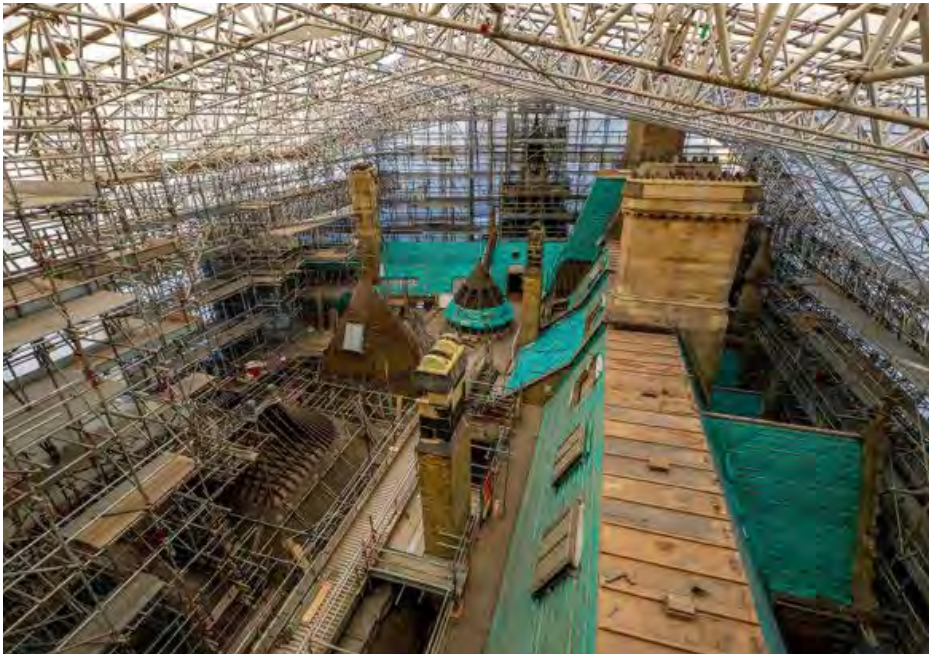
Manchester Town Hall, restoration

The project involves repairing and restoring the building external envelope and internal spaces throughout, including key historic features and highly decorative interiors. It also includes improving the building’s safety and accessibility, such as adding new lifts and welfare facilities ensuring office, ceremonial and civic accommodation fit for the 21st Century. Currently planned to complete in 2026, areas of the building are now opening to the public in phases.

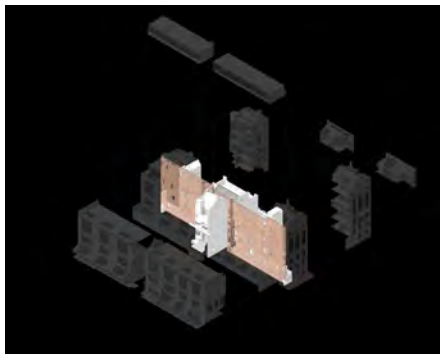
The entrance and museum, with director's rooms above, comprise the main arrival sequence

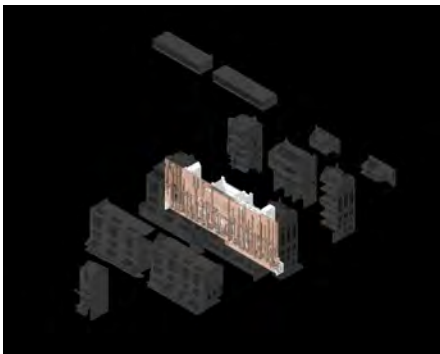
The brick spine wall defines the northern side of the circulation and houses vertical services

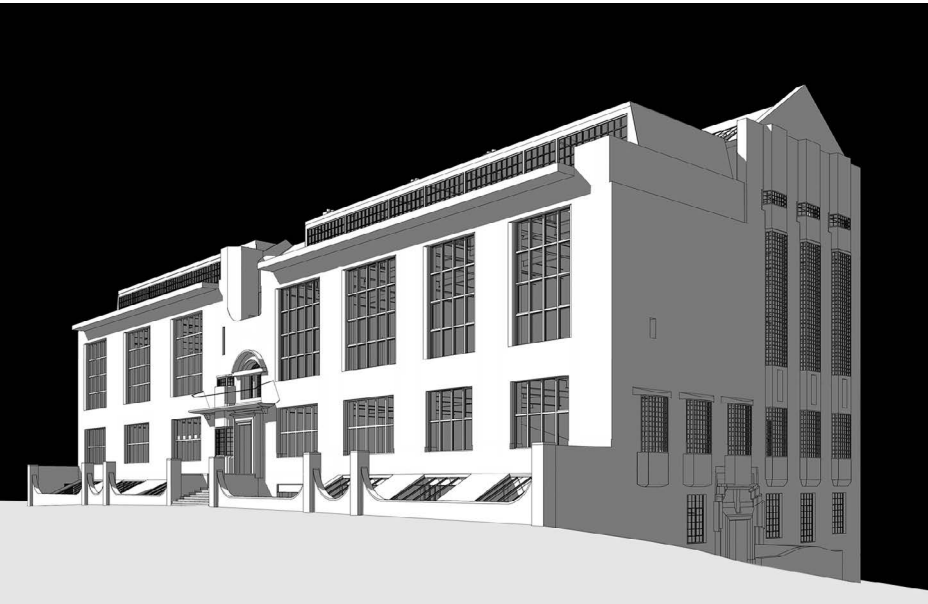
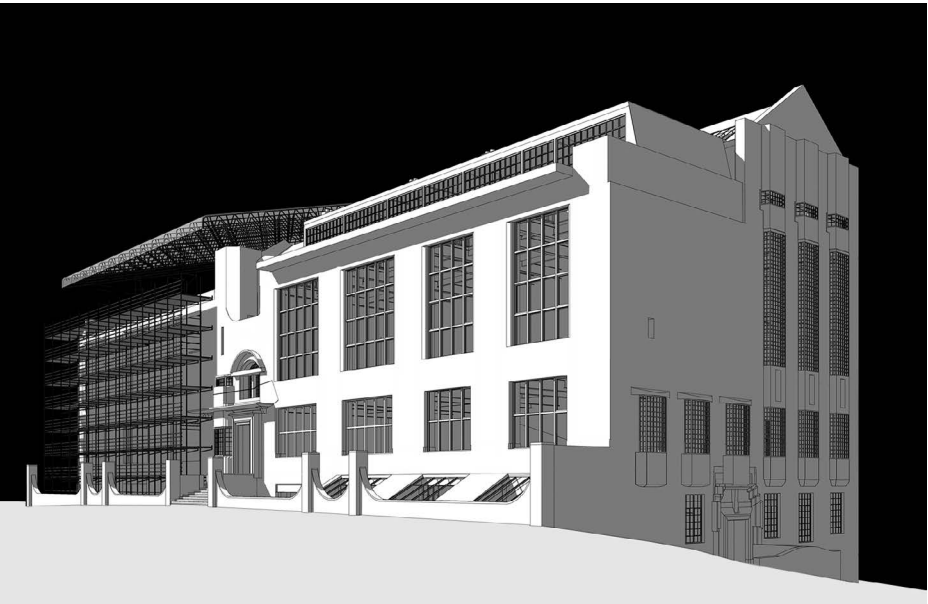
## Scenario 1a / 1b - Full Reinstatement of West/East and Core

Either the West or the East Wing is completed first (*1a shown below*). The remaining wing follows at a later stage. The option requires Scenario 3 to be completed in full and for the Central Service Core and Stairs to be installed. Either scenario would deliver 60-70% of the building.

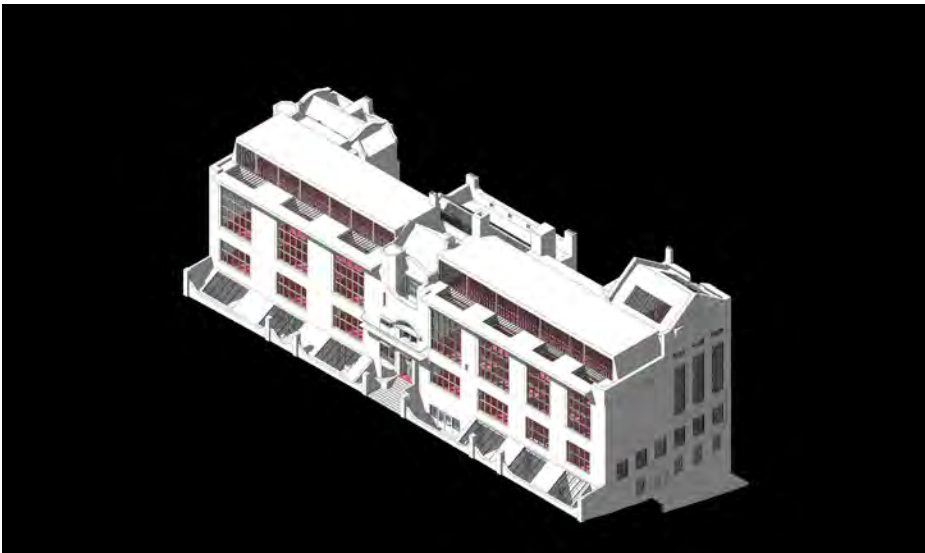
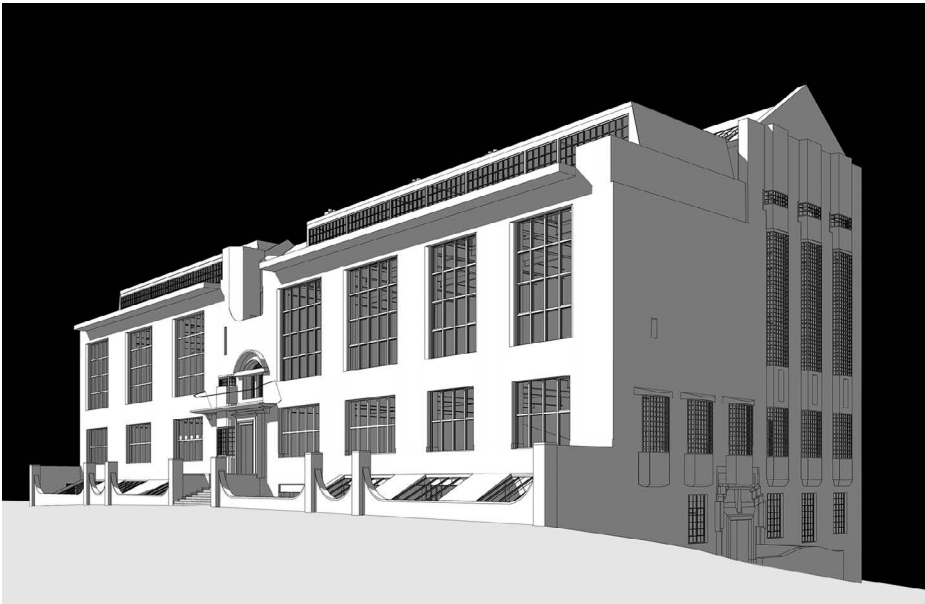
## Scenario 2 - Faithful Studio

A scenario providing a fully occupiable building. The external walls, windows, roofs, floor slabs, stairs, toilets, fire doors, primary plant would be constructed. Interior timber linings to walls, plaster finishes to interior walls, floorboards, plastered ceilings, non-loadbearing partitions, fitted furniture, the library joiner work and balcony would all be excluded. All spaces within the building would be useable.

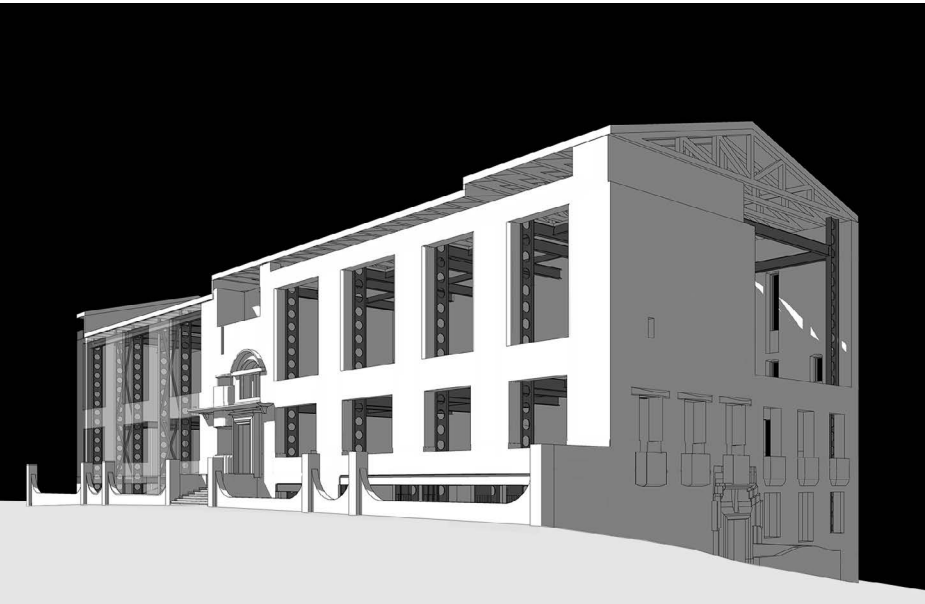
## Scenario 4 - High Level Consolidation

Similar to Scenario 3 but only essential stabilisation works are carried out. Concrete floors and some temporary steelwork inserted to facilitate the removal of the internal scaffolding and bracing and also to allow for the removal of the external scaffolding. Temporary roof over, installed with lightweight support structure and no wrapping to protect the internal spaces but provide views of the building.

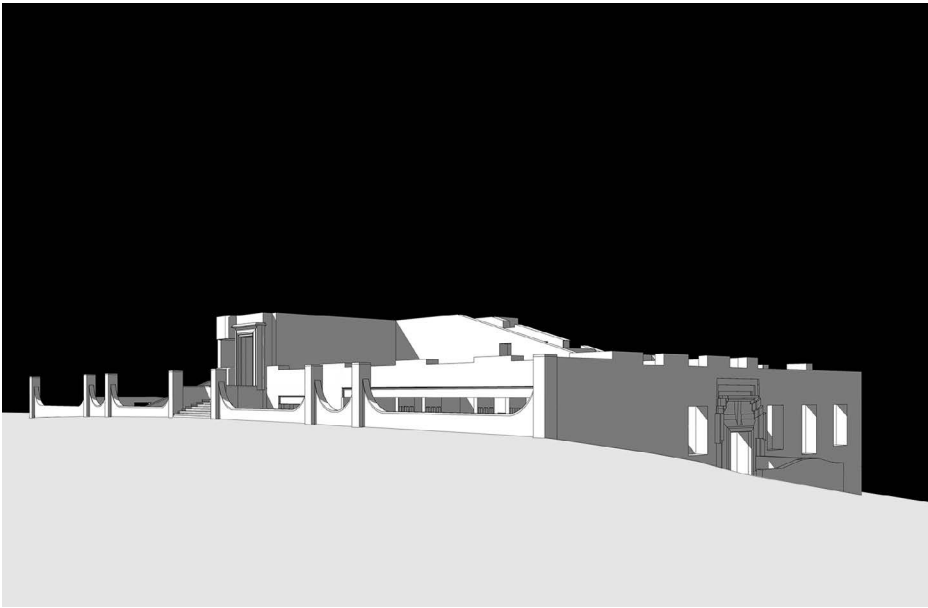
## Scenario 5 - *Low Level Consolidation*

The support scaffolding/temporary structure is removed. The walls are taken down to a self-supporting level – typically from basement level up to ground floor level. Some walls at the entrance could rise several metres from ground floor level. The entrance doorway stonework is stabilised. Public access could be formed into a small area at the entrance, although The building is left unroofed.

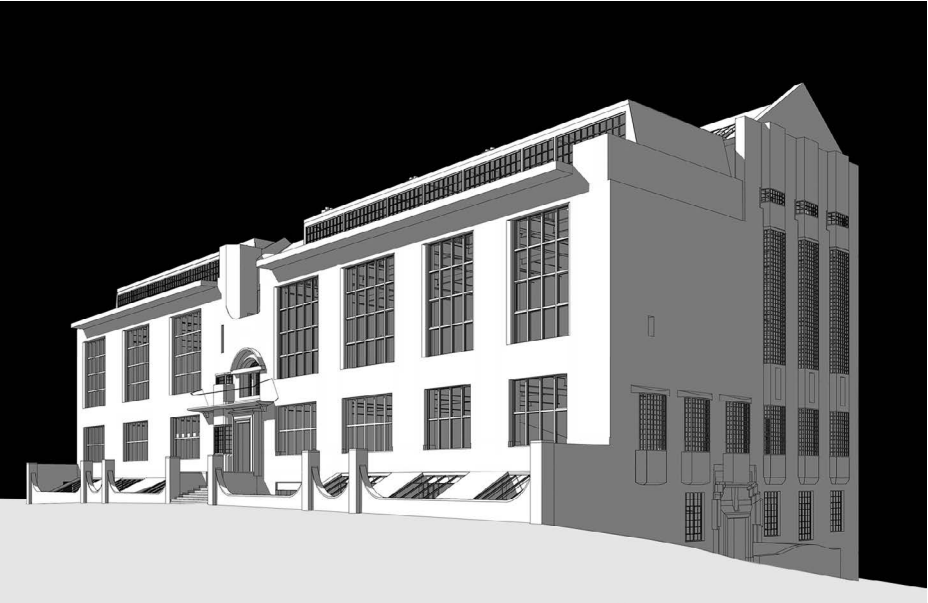
Street view from NW of Scenario 1 - The building would be complete with all elements visible (diagram note: ironwork omitted)

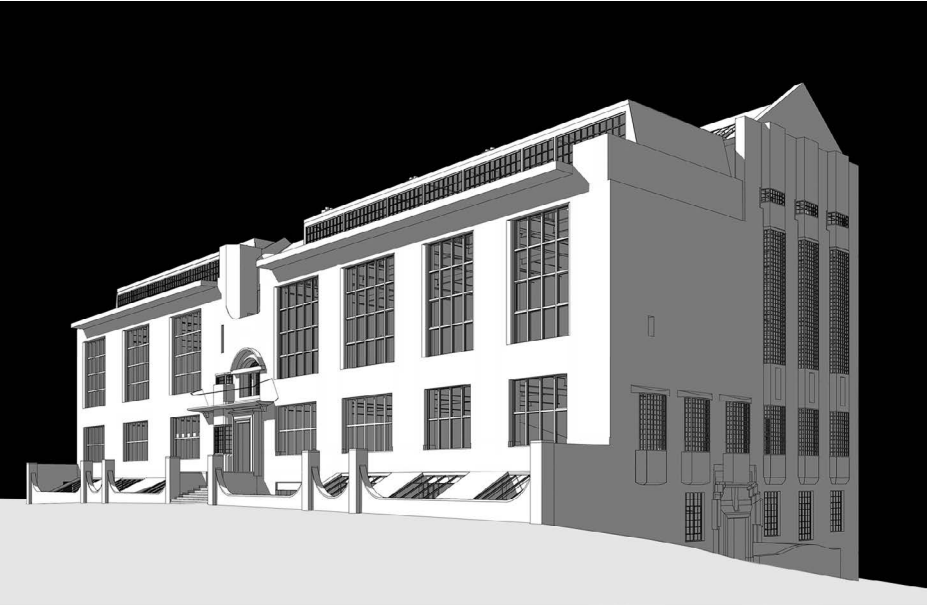
Street view from NW of Scenario 2 - The exterior of the building would be complete with all elements visible, while the interiors are not yet fully reinstated

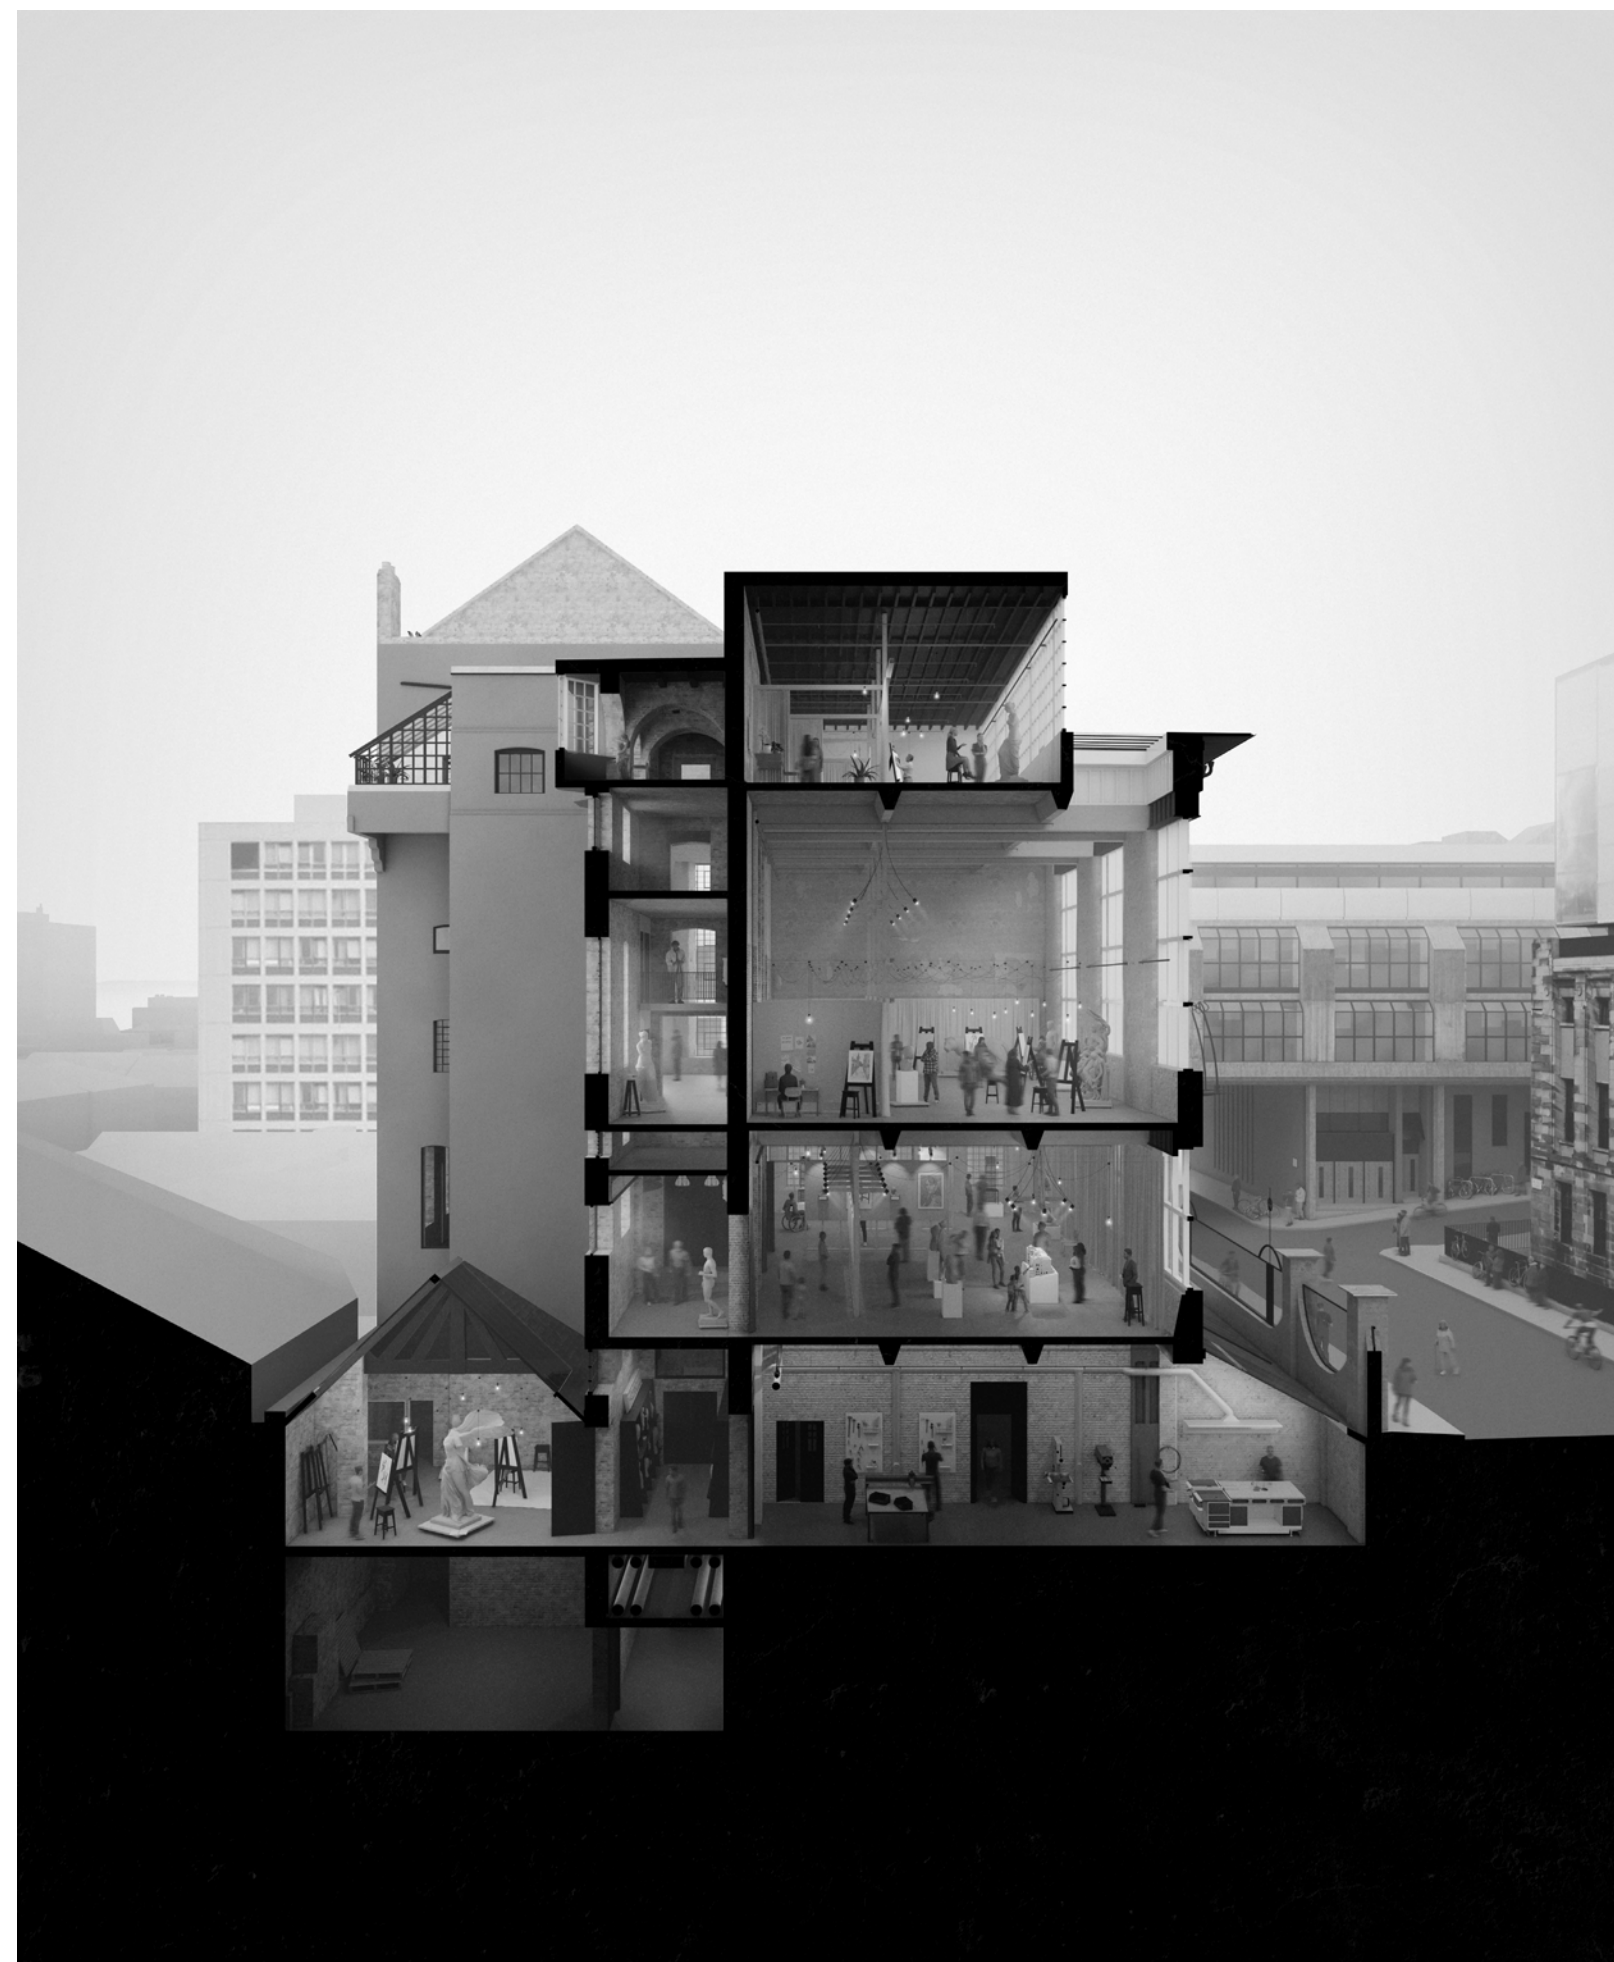
Sectional perspective illustration looking West. Shows building inhabited after Scenario 2

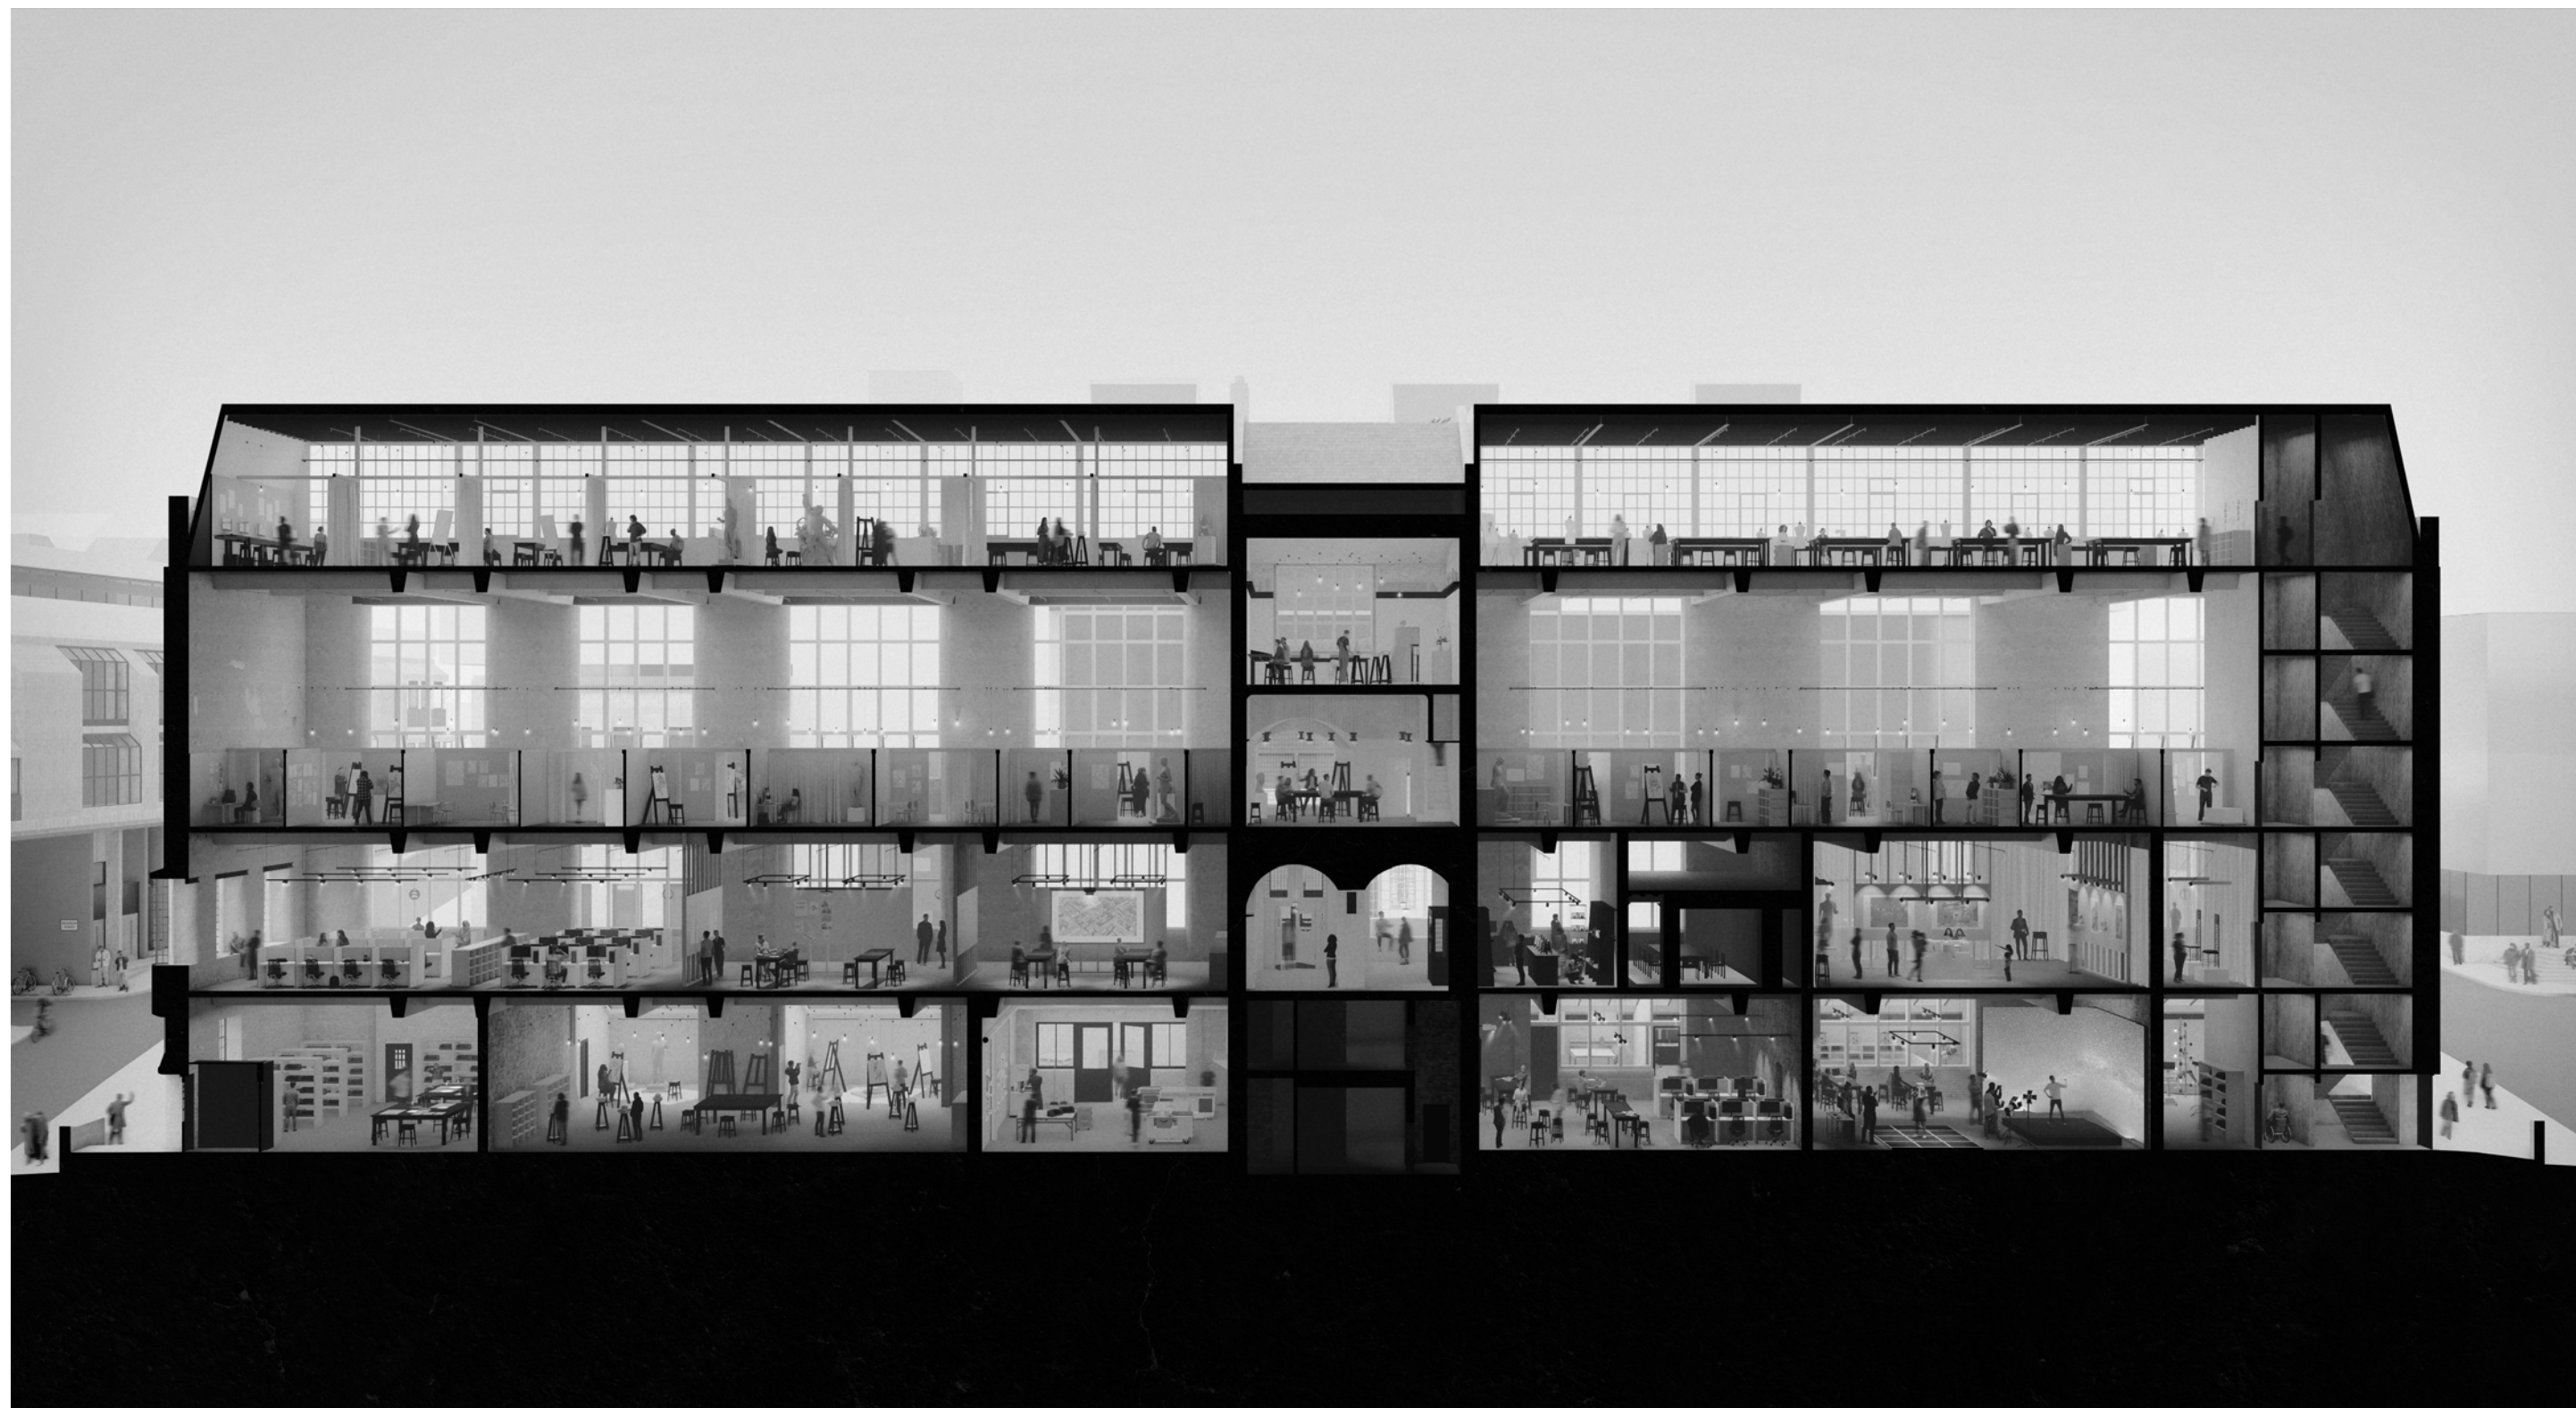
Sectional perspective illustration looking North. Shows building inhabited after Scenario 2

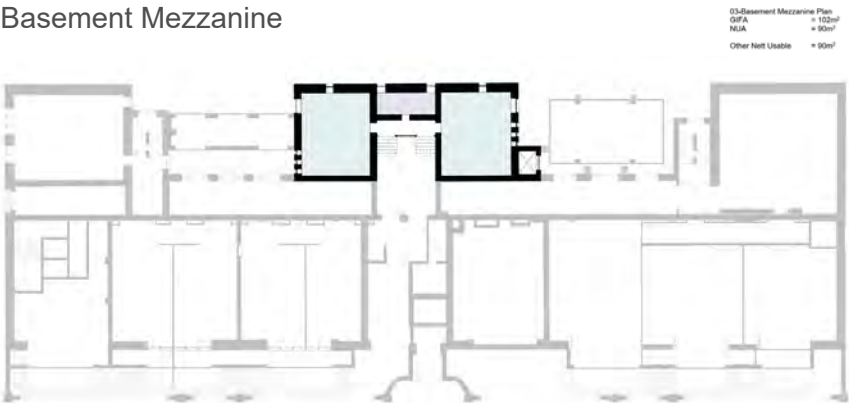
Basement Mezzanine

Delivery Scenario 2 Area Plans
